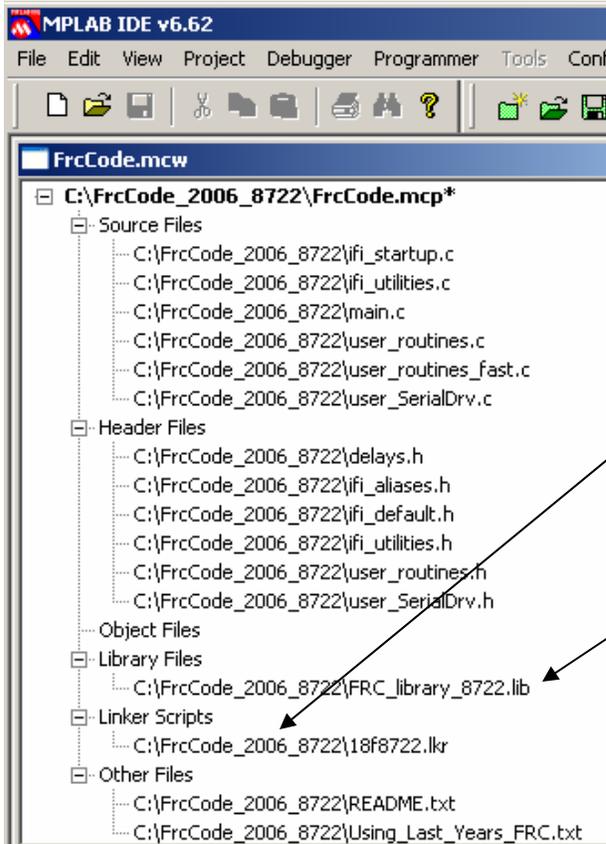
Update : Data appears to be shifted. The displayed battery voltage is actually the Port4_Aux value. If nothing is connected (on this port) the voltage gets converted to 8.2-8.3 volts.

In Work: There appears to be a location on the 8722 chip that causes this problem. The following procedure is a recommended way to protect this memory area.

Note: You will not experience this problem with last years controllers because the user processor is an 8520.

Double click on the 18f8722.lkr file in your project.

Add the word **PROTECTED** to the line containing gpr15.

Make sure you are using the new library file "FRC_Library_8722.lib" as well. This will fix possible data corruption issues.

After the update, do a make (F10 or CTRL+F10) then re-download your code.

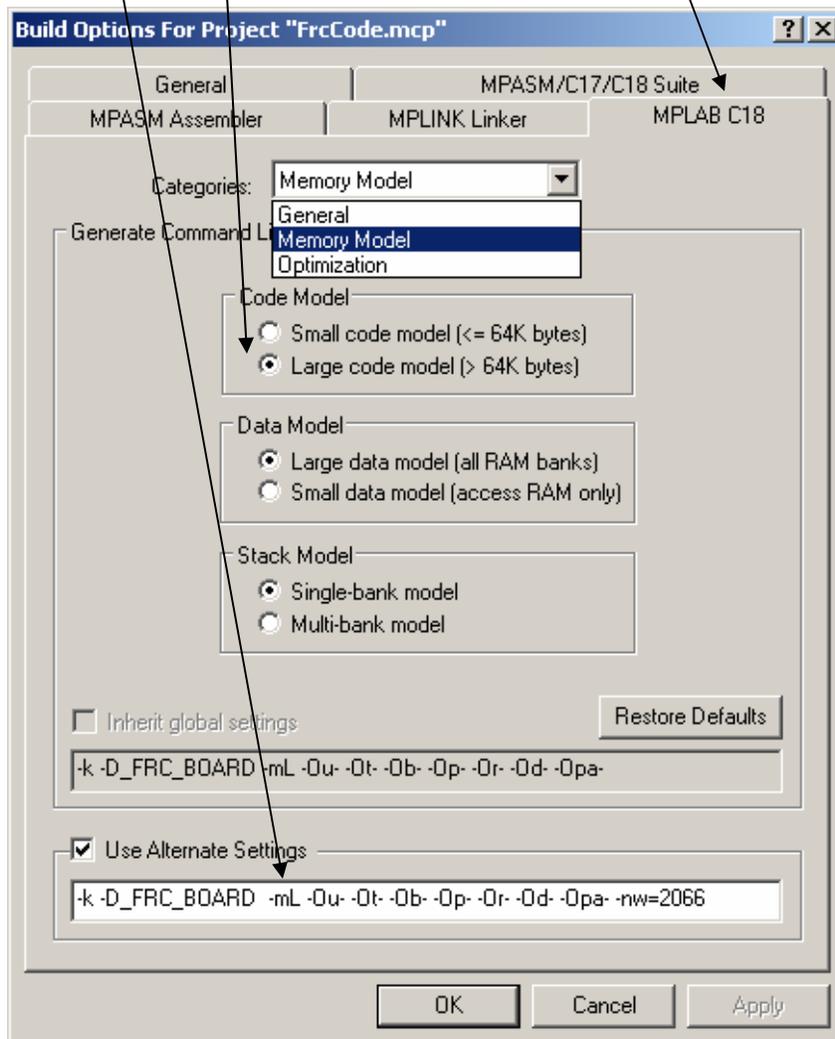
Update : Programs don't seem to work when they pass the 64K byte boundary.

Resolution: Change the Code Model from small to large. To do this do the following:

1. In MPLAB, open the Build Options window (Project->Build Options->Project)
2. Click on the MPLAB C18 tab.
3. Select Memory Model (from the combo box).
4. Select the Large code model.
5. Verify that a "-mL" appears in the settings text box.
6. Click on APPLY or OK then recompile and redownload your code.
