Understanding Common Moisture Problems

Three case studies illustrate the importance of controlling humidity and air leakage

by Marc Rosenbaum

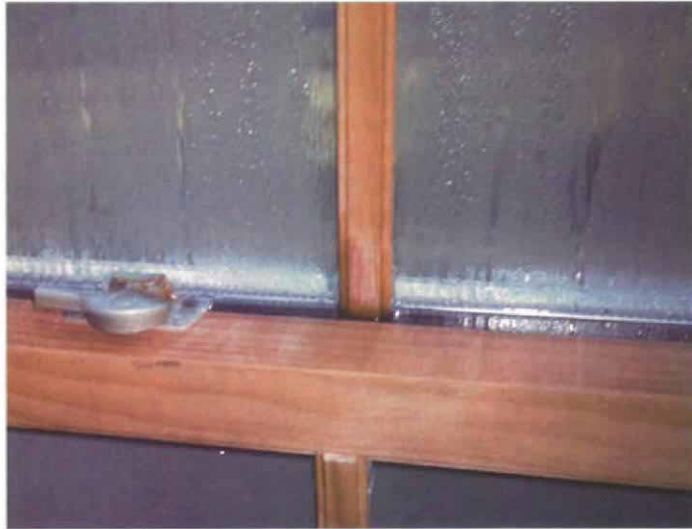
The low outdoor temperature meets high indoor moisture.

Condensation on this window could be prevented by lowering the relative humidity inside the house, increasing the window's R-value or both.

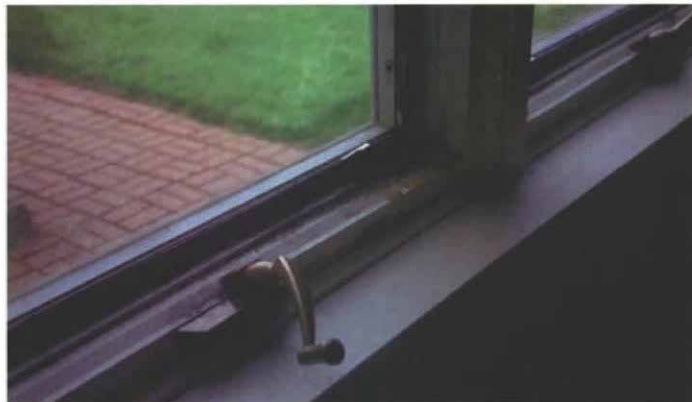
Excessive indoor humidity causes mildew growth and peeling paint.

Water running off this window has saturated the sash, damaging its finish. The moisture content of wooden windows in this passive-solar house was as high as 28%, as compared with the normal level of around 10%.

Moisture is the culprit—Virtually all of the interior problems could be corrected by substantially lowering winter moisture levels. This house needed reliable ventilation, so I suggested a new heat-recovery ventilator having adequate capacity (at least 100 CFM), and operating it enough to maintain 35% to 40% relative humidity in the heating season. The original ventilator was neither well-designed nor well-installed. Mold needed to be removed and the millwork repainted.

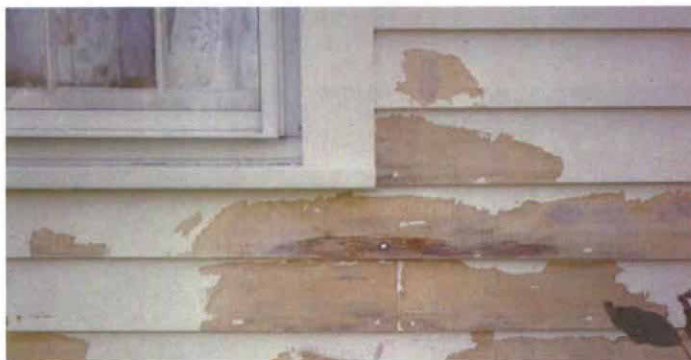
Paint doesn't adhere well to a moving surface.

Wood siding that has not been back-primed or otherwise sealed can expand and contract as it takes on and gives off moisture. As the wood siding moves, its painted finish cracks and peels.

The peeling of the exterior paint appeared to be caused by water penetrating from the outside (top photo, p. 61). The house had minimal overhangs on the gable ends, and the grading around the foundation put the wood too close to the ground in many places. Neither the trim nor the siding had been back-primed before installation, so water drawn up between the clapboards by capillary action could soak readily into the wood. The expansion and contraction of clapboards as they get wet and then dry eventually causes the paint film to fail. One clue suggesting an exterior problem—unrelated to high indoor-humidity levels—was that the unheated garage showed the same peeling-paint symptoms.

On the exterior, regrading would move water away from the building, and rotten trim could be replaced with wood primed on all sides. The gutter downspouts should be disconnected from the footing-drain system, and the drains should be checked for blockage. The clapboard laps could be wedged open with plastic wedges (Shur-Line Inc., 2000 Commerce Parkway, Lancaster, N. Y. 14086; 800-828-7848) and allowed to dry. (Some cracking of the clapboards is likely to occur as the wood dries out.) Once dry, they could be repainted with a good latex paint.

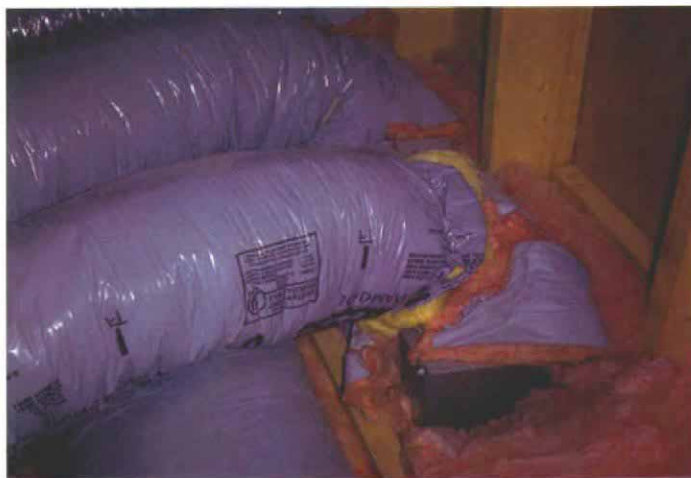
In the case at hand, the major source of heat in the attic came from a different source. The heating ducts for the second-floor rooms were in the attic, and they were unsealed. The metal ductwork was not insulated, and the flexible ductwork had 1 in. of fiberglass insulation, not much for ducts carrying 120°F to 130°F air in what is nominally an outdoor space (center photo). In addition, the attic-duct trunk came up through a basement chase that was unsealed top and bottom. This chase allowed warm basement air (the

Losing heat on the way to the living space.

Heatsupply ducts in this attic were poorly sealed and underinsulated. As a result, the temperature inside the attic was 47°F, substantially warmer than the outside air. This situation prompted the formation of ice dams.

The proposed solution is twofold—I recommended that all attic ductwork first be sealed with latex mastic and then well-insulated. This task could be accomplished by covering the ductwork with loose-fill cellulose, a type of insulation made from recycled newspapers that have been shredded and treated with a fire retardant. Another alternative would have been to create a sealed duct chase out of foil-faced fiberglass duct board, laying the flexible duct in it and backfilling the space around the ducts with cellulose. I

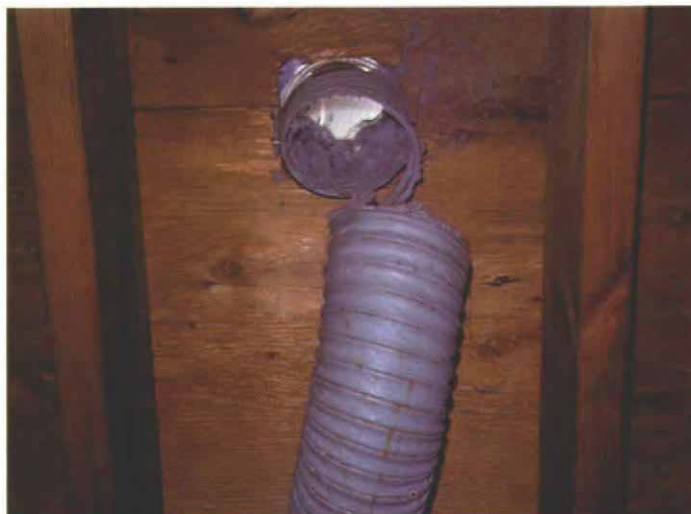
The source of moisture wasn't hard to find.

This clothes-dryer duct, torn and hanging by a wire rib, is supplying warm, moist air directly to the attic.

In the attic, I found the source of moisture causing the condensation. A recent kitchen and bath remodel had added a number of recessed lights and two bathroom-ceiling exhaust fans. The insulation around each fixture and fan had been removed, and not the faintest attempt had been made to seal the ceiling penetrations (bottom photo, p. 62; top photo, p. 63). Most of the insulation in the attic was black with dirt, indicating rampant air leakage from the rooms below. Both fans had been vented with 3-in. flexible plastic duct, which had been flattened so that very little air actually made it outdoors. To top things off, the dryer had been vented through the roof, also with plastic duct. The duct was torn and hanging only by a wire rib to the roof vent cover (bottom photo, p. 61). And the vent cover was screened and plugged with lint. The net result: All of the moisture from the dryer was venting to the attic.

Ductwork should be sealed with latex mastic. Return ducts using standard joist bays should be lined with metal and sealed. Insulation should be added to ductwork in kneewall areas after it is sealed. Insulating basement ductwork would increase comfort by maintaining air temperature on the long duct runs. The dryer vent should be replaced with sealed metal ductwork. The long-term strategy would include replacing the low-efficiency furnace.

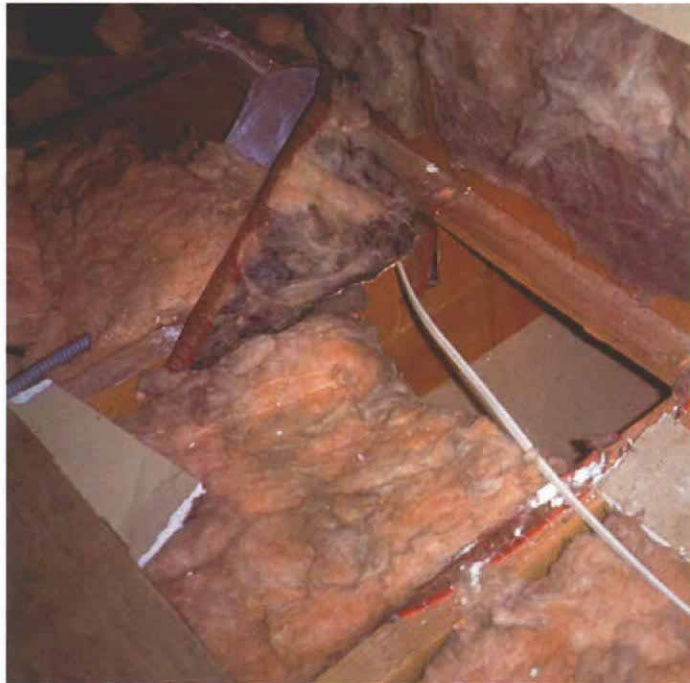
Insulation is no good if it's not continuous. Cold air from this crawlspace has a clear path to the floor of the adjacent bedroom through this and other uninsulated joist bays. Dirt in the insulation could mean that air is escaping from the living space.

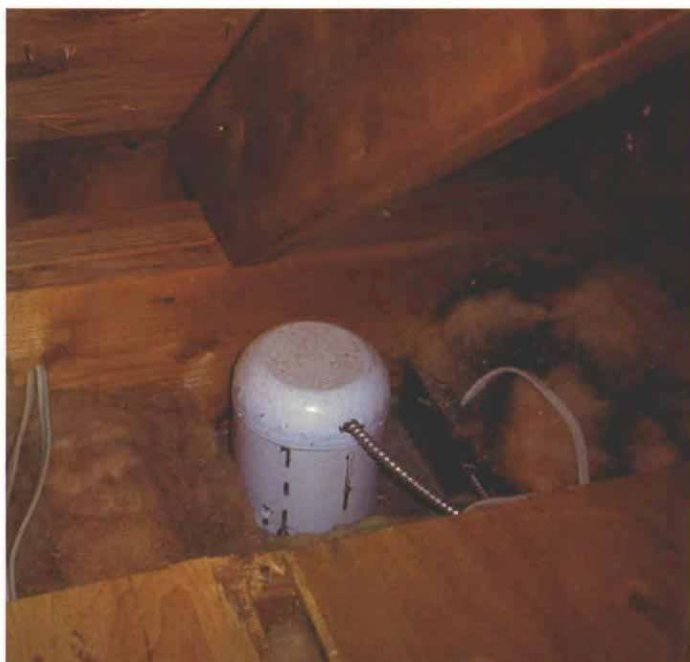
Ceiling fixture provides light below and heat above. This recessed ceiling light, installed during a remodeling job, provides a conduit for warm, humid air to flow from the living space into the attic. The preferred alternative in cases such as this one is to install the type of light fixture that can be covered with insulation completely, without causing a fire hazard.

Stem the flow of air on all fronts—To reduce air leakage in the house, I recommended the bath fans and recessed light fixtures be sealed. The insulation could be improved by filling the second-floor joists with blown-in, densepack cellulose insulation, or by sealing the joists from the kneewall area with rigid-foam insulation, foamed in place. The back of the kneewalls should be sealed with housewrap or drywall. Plastic sheeting should not be used on the cold or attic side of insulation because it can trap moisture inside the wall (see *FHB* #88, pp. 48-53). Another alternative would be to insulate the sloped portions of the roof with dense-pack cellulose, bringing the kneewall areas within the heated envelope.

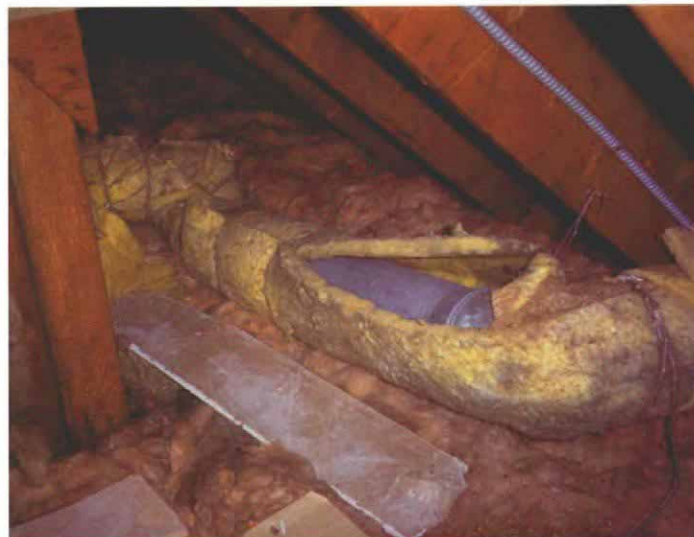
Don't forget to replace the insulation. In his work, the author commonly finds conditions such as this uninsulated bathroom exhaust fan. The insulation, cleared away to make room for the retrofit fan and duct, was never replaced.
