Hubble Space Telescope

(HST) Archive System

NASA Langley Research Center
Hampton, Virginia

The purpose of the Hubble Space Telescope (HST) Hardware Archive System is to make information available concerning the returned hardware from HST on-orbit servicing missions. The Introduction of this archive gives a general background about the archive while the First Servicing Mission and Post-Retrieval Analysis sections provide explicit details regarding the on-orbit servicing mission, the people who are affiliated with the post-flight investigations of the returned hardware, and a detailed disposition of the HST hardware following its returned to Earth. Images and descriptions of the HST return hardware is discussed in the Returned Hardware section. The Technical Diciplines areas address scientific research with returned hardware, while the Photographs area provides a small sampling of on-orbit HST photographs. The Workshops section lists various workshops that included topics realtedto HST Returned Hardware, and provides the opportunity to make available data and initial results which may or may not be published or reside in the public domain. Lastly, a list of related HST online sour

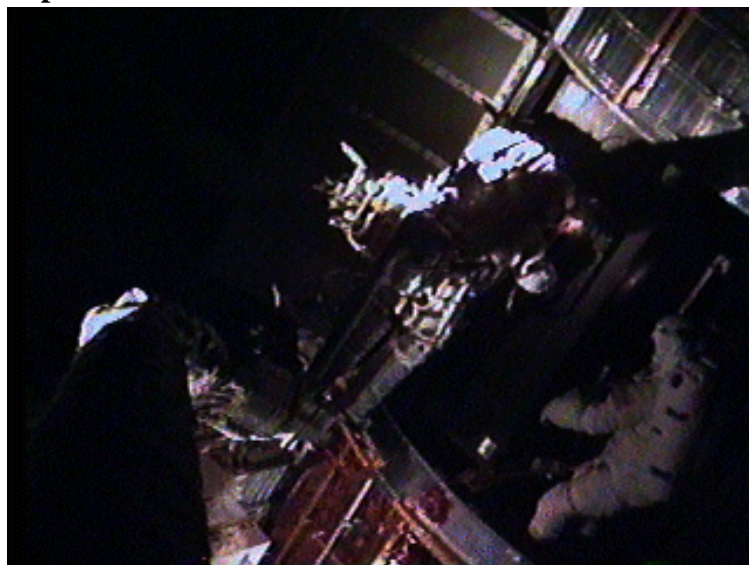
Astronauts remove the HSP from HST berthed in the payload bay.

the lip of the HSP rubbed on the multi-layer insulation (MLI) blanket during HSP deintegration from HST. Aside from the HSP rubbing the MLI, the HSP came out easily from the bay with a slight pitch up, which was expected. The bay of the HSP/COSTAR looked pristine and there was good visibility in the chamber with the HSP removed. The astronauts noted that the latch lubrication appeared to be fairly well distributed.

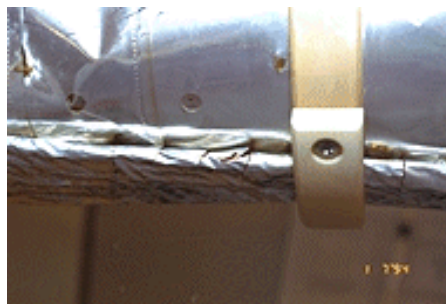
Photos of the deterioration of the MLI plate.

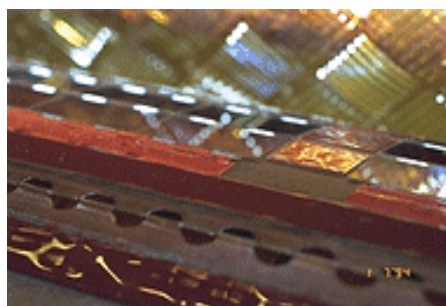
Photos of the solar array RTV.

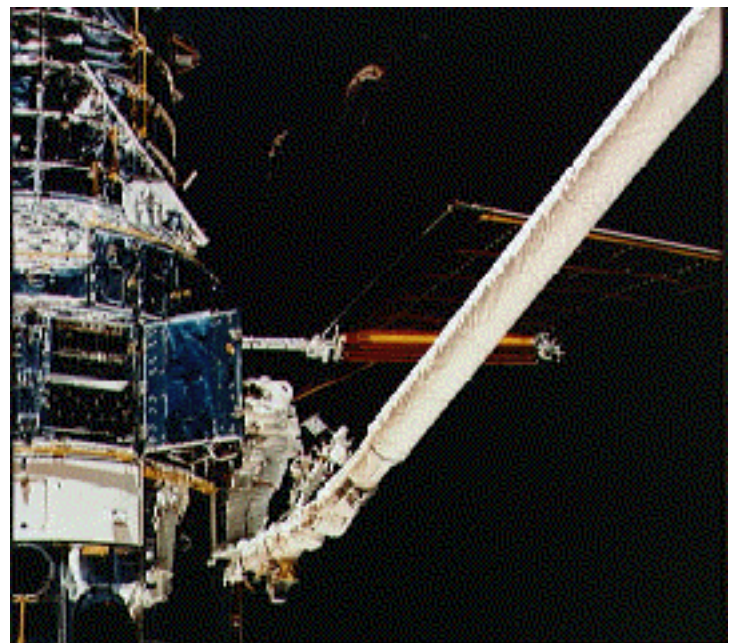
Astronaut Hoffman replacing the fuses in HST berthed in the payload bay.

A flight spare P-16 module was found to be miswired during ground testing. Two of the four P-16 modules replaced during the servicing mission were miswired. All 20 amp fuses in S/N's 1006 and 1007 were shunted by the twin low-resistance leads such that negligible current could flow through the fuse. Ground test verified open fuse elements in the P-15 Fuse module (S/N 1012). Ground test verified miswiring of two P-16 fuse modules (S/N's 1006 and 1007). No additional discrepancies or degradation of the modules were observed.

There are three different fuse-module configurations (four each) in the HST Support system Module (SSM). The P-15 and P-16 fuses were replaced with upgraded versions. Four P-15 Modules (3 and 5 amp fuses) were replaced since one had opened, and the [Rate Sensing Units \(RSU\)](#) fuses were increased in size from three amps to five

amps. Four P-16 modules (10 and 20 amp fuses) were replaced since their configuration was questionable. Spare P-17 and Optical Telescope Assembly (OTA) fuses were carried as contingency but were not replaced. The original plugs were returned for ground examination. The fuses were visually inspected and photographically documented before the DC milliohm and high-voltage tests occurred as part of the ground examination procedure. Resistance and current characterization tests were also part of the examination.

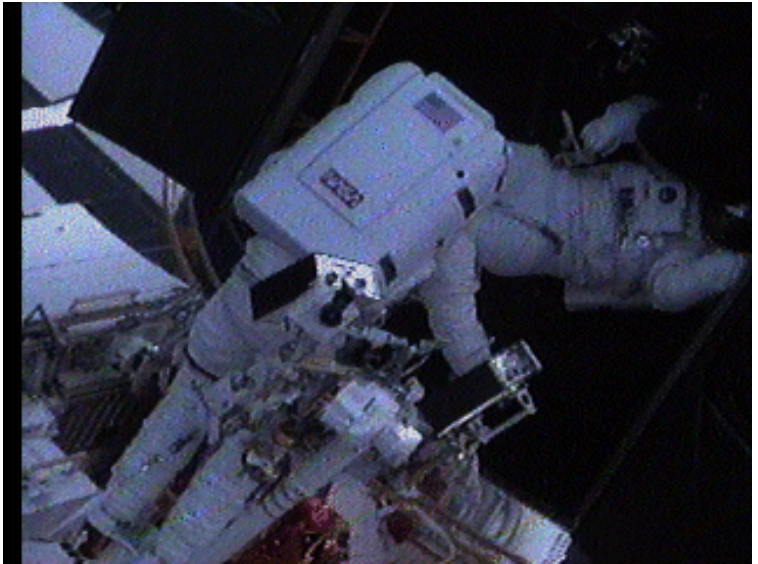
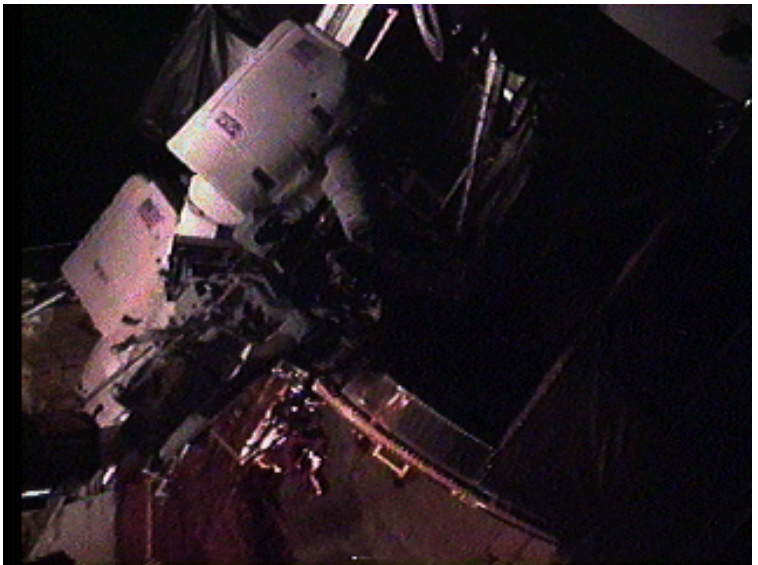
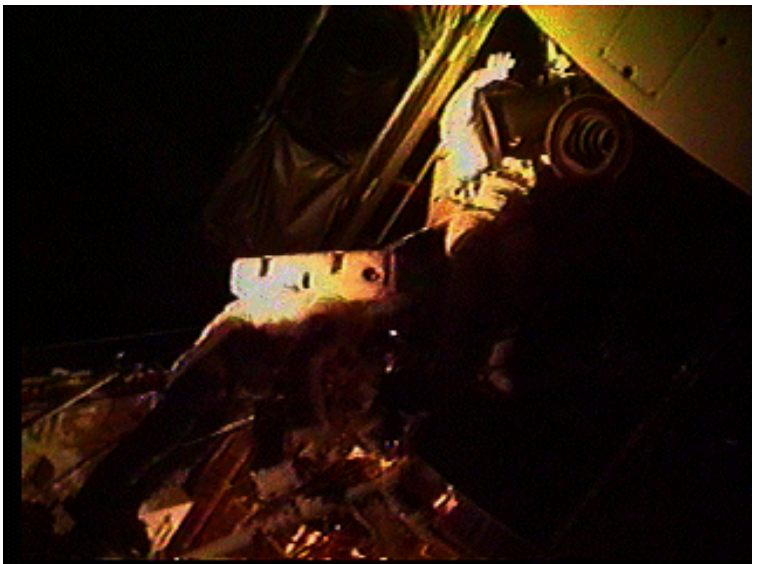
Two pairs of the gyros suffered apparent failures during the HST mission. The rate-sensing units will be visually inspected with particular attention to the connector pins. Photographs and contamination samples will be taken. Electrical interface continuity and isolation tests will be performed. The units will then be returned to Allied Signal for functional testing and evaluations. After testing is completed, the rate sensing units will be refurbished and reflown.

Astronauts remove RSUs during Servicing Mission.

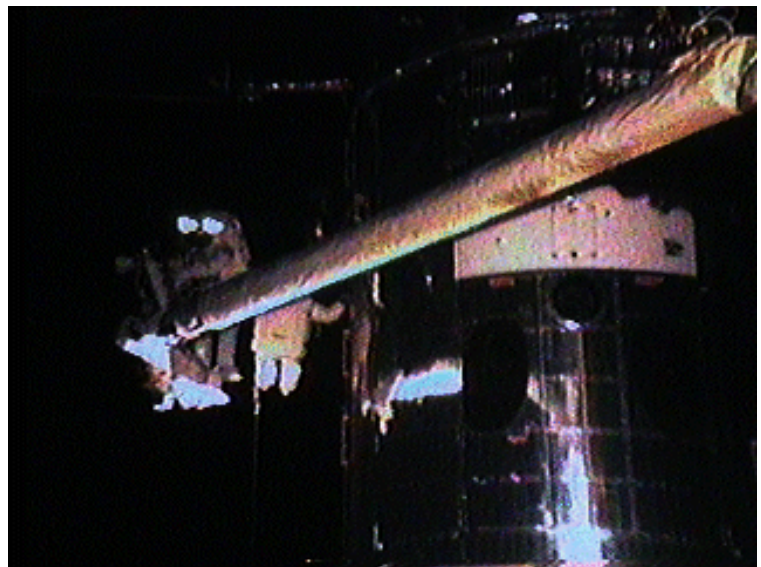
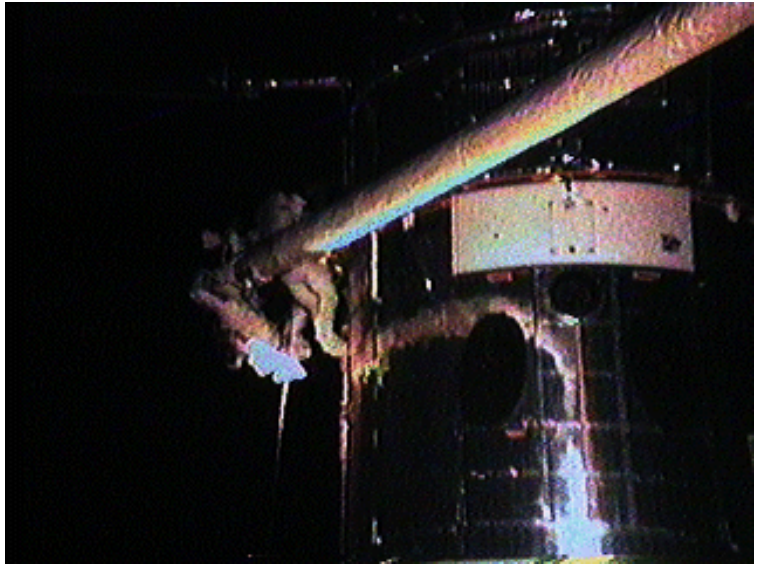
Two Electronic Control Units (ECUs) were believed to have failed and were retrieved during the first HST servicing mission. The ECUs will be visually inspected, particularly the connector pins. While full function tests are desired, they are not planned at Goddard Space Flight Center.

Astronauts removing ECUs during servicing mission

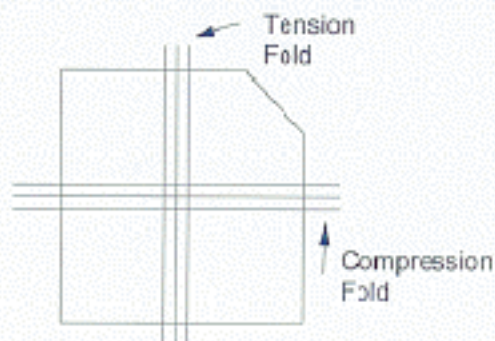
HST SA-I Drive Arm MLI Tensile Bending Test Results

Sample #	Cracked	Notes
31, 32, 33	Yes	High solar exposure
34	Yes	Bottom half of sample cracked, top half of sample likely covered with cable bundle
35, 36	No	Likely covered with cable bundle
37, 38	No	Lower solar exposure

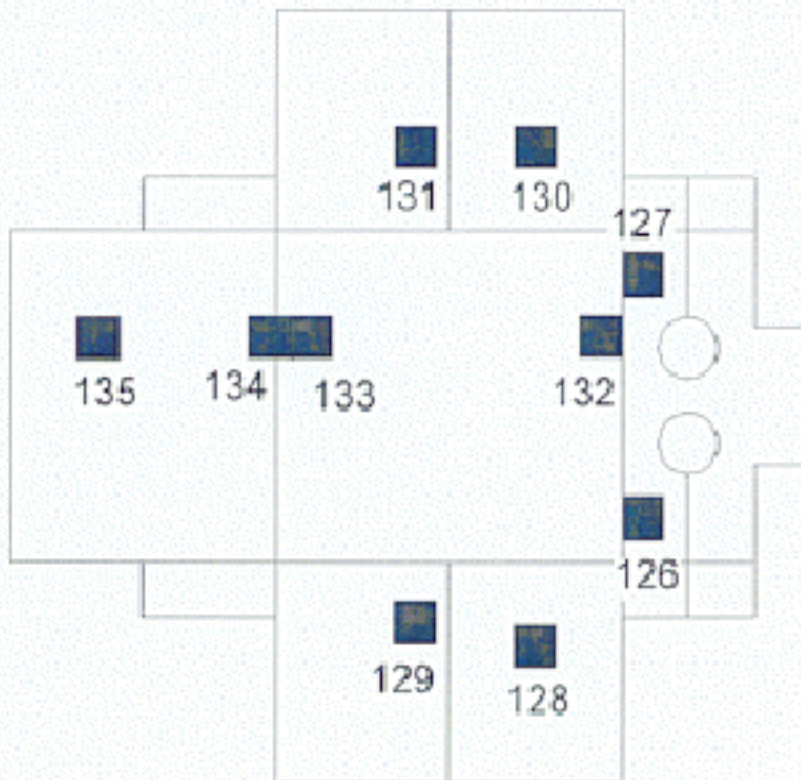
MSS MLI Sampling Diagram

- Milky colored haziness.
- Cracking is evident on the material with high solar fluence.
- Adhesive failure is noted for the FEP/Acrylic interface.
- Increase of surface hardness.

Sample #	Solar Exposure*	Received Condition
134, 135	0.511	bent, not cracked
128, 129	.0722 or 1.049	slightly bent, few cracks
130, 131	1.049 or 0.722	bent, extensive cracking
132, 133	1.294	slightly bent, little to extensive cracking
126, 127	1.903	bent, extensive cracking

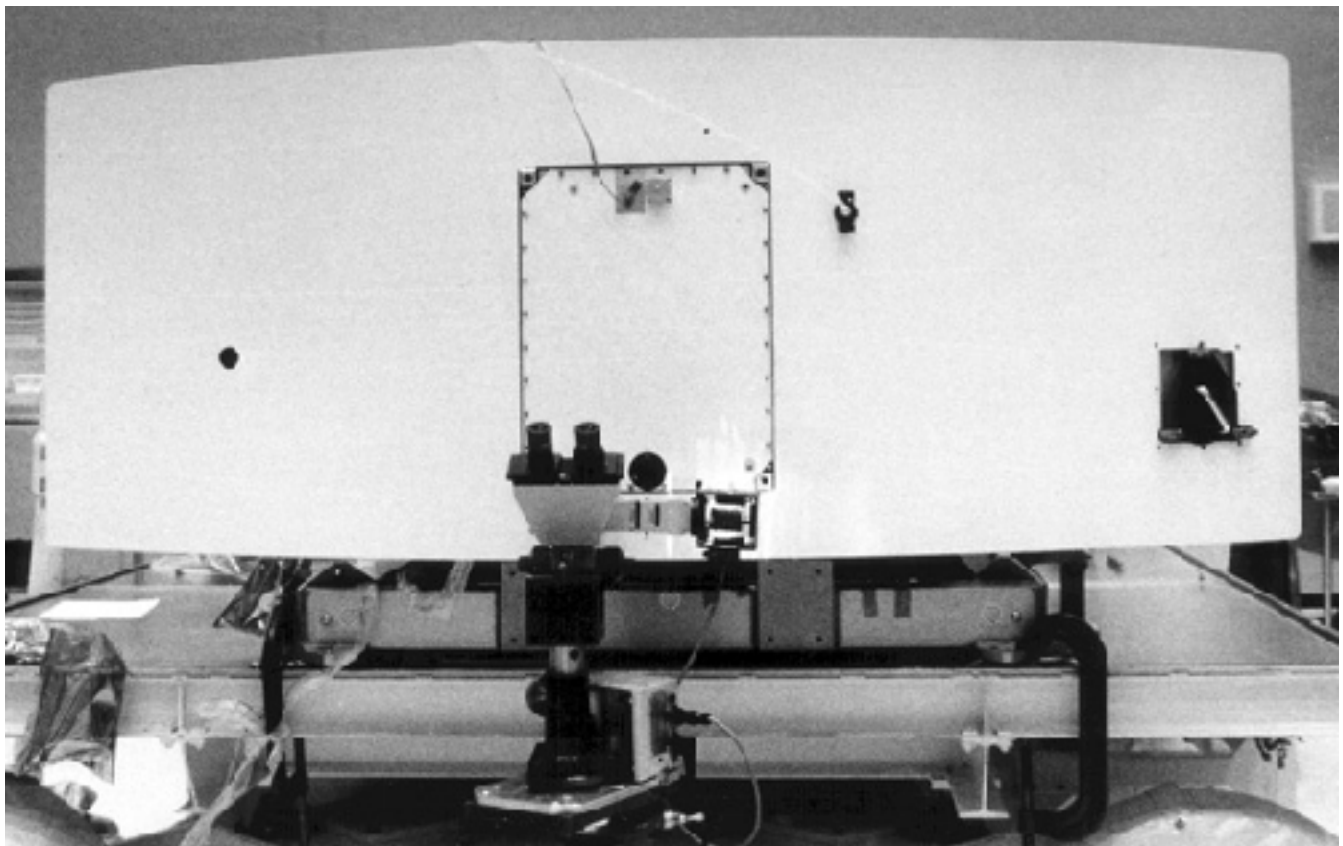
We spent two days in the clean room at Goddard examining the WF/PC-I radiator with a microscope to measure the damage done by meteoroids and man-made orbital debris during its 3.6 years in orbit.

WF/PC-I radiator in clean room at NASA GSFC, with microscope in front.

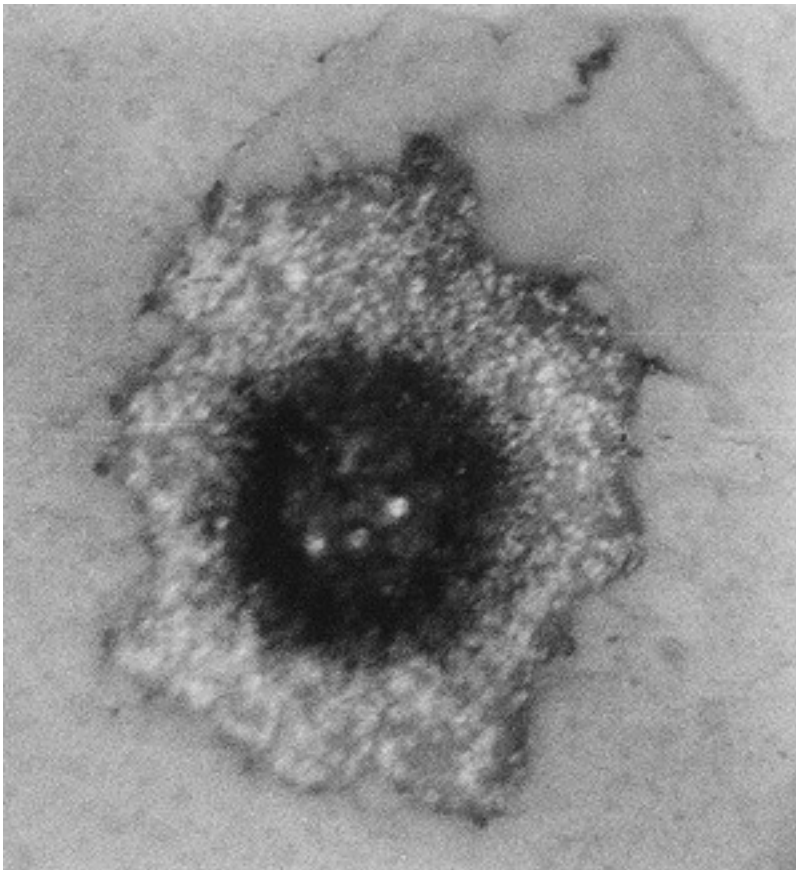
3. Humes3.pit 61 - Crater on WF/PC-I radiator. Dimensions: lip, 500 x 540 microns; at plate surface, 370 x 460 microns; depth, 185 microns. Paint spall area around crater, 1320 microns. Cracks in paint can also be seen.

Crater on WF/PC-I radiator. Dimensions: lip, 500 x 540 microns; at plate surface, 370 x 460 microns; depth, 185 microns. Paint spall area around crater, 1320 microns. Cracks in paint can also be seen.

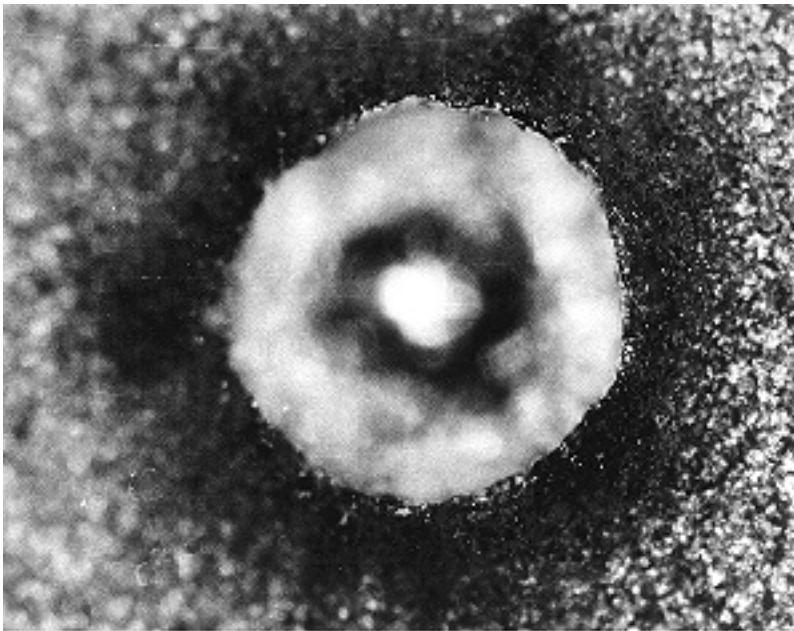
Dimensions: lip, 980 micron diameter; at plate surface, 900 micron diameter; depth, 360 microns. Paint spall area around crater, 5400 micron diameter (not shown).

The largest crater found in the WF/PC I radiator was 900 microns in diameter. It is nearly round and resembles craters found in unpainted aluminum on the LDEF, except that the lips are poorly developed.

Largest crater on WF/PC-I radiator. Dimensions: lip, 980 micron diameter; at plate surface, 900 micron diameter; depth, 360 microns. Paint spall area around crater, 5400 micron diameter (not shown)
