# The October 17, 1989, Loma Prieta, California, Earthquake—Selected Photographs

*by* By J.K. Nakata, C.E. Meyer, H.G. Wilshire, J.C. Tinsley, W.S. Updegrove,  
D.M. Peterson, S.D. Ellen, R.A. Haugerud, R.J. McLaughlin, G.R. Fisher, *and*  
M.F. Diggles

Photographs and descriptions to accompany  
Digital Data Series DDS-29  
Version 1.1  
1999

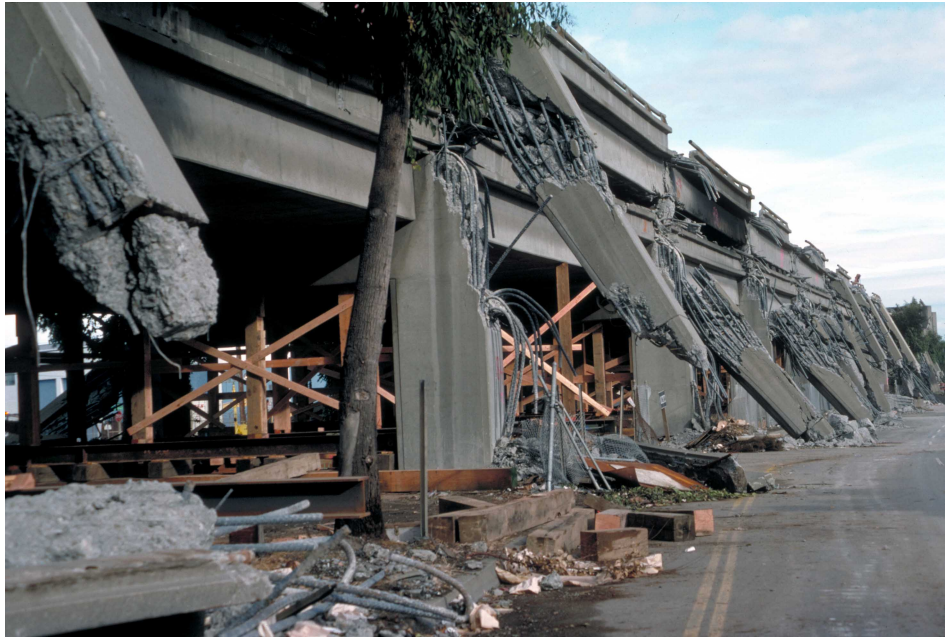
21. Remnant portion of the north- and south-bound Cypress viaduct exposing box girders near 14th Street. [J.K. Nakata, U.S. Geological Survey]

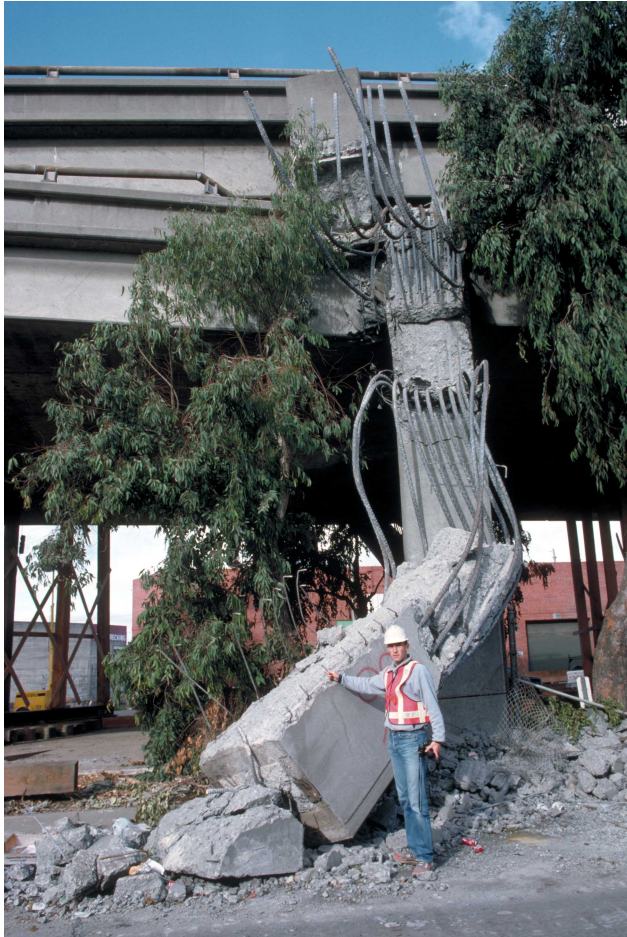
22. Side view of support-column failure and collapsed upper deck, Cypress viaduct.  
[H.G. Wilshire, U.S. Geological Survey]

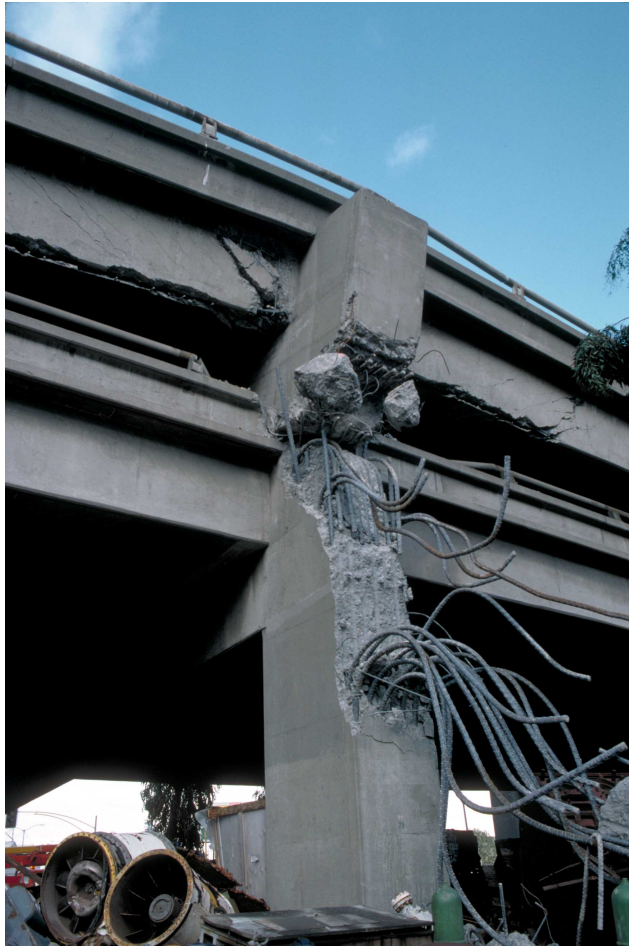
23. Support-column failure and collapsed upper deck, Cypress viaduct. [H.G. Wilshire, U.S. Geological Survey]

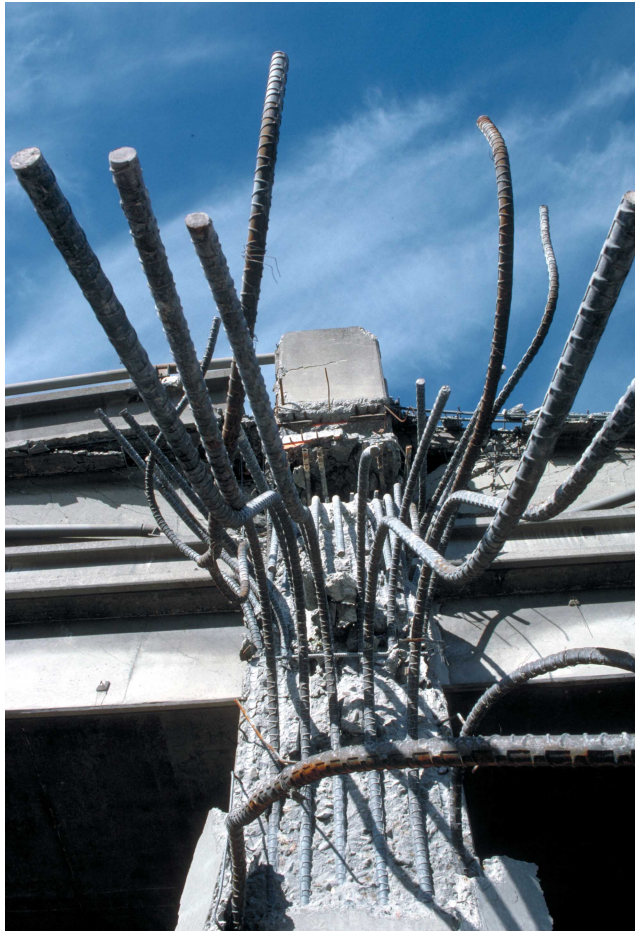
24. Bent reinforcement bars in failed support column, Cypress viaduct. [H.G. Wilshire, U.S. Geological Survey]

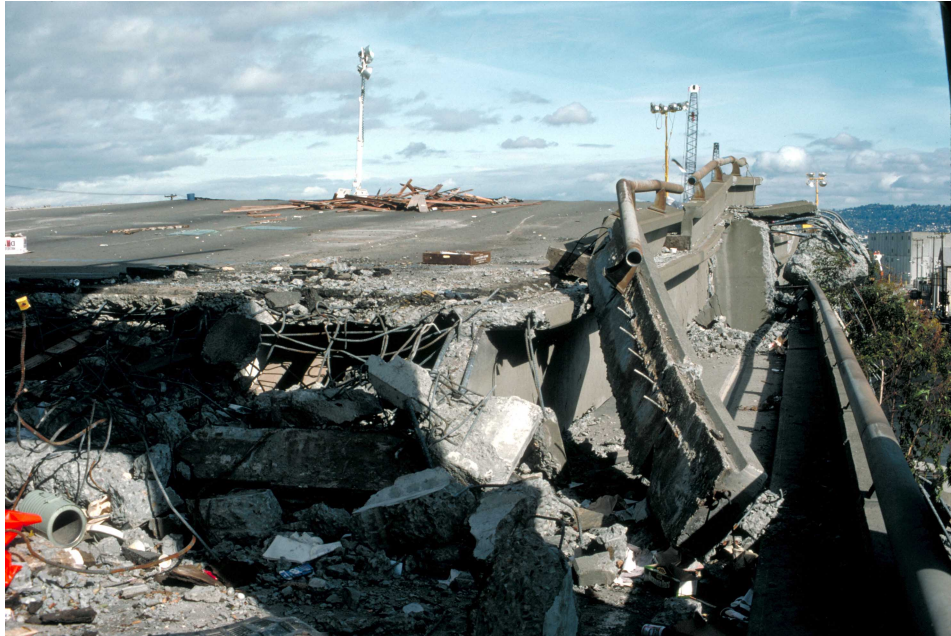
25. Closeup of damaged reinforcement bars from a Cypress viaduct support column.  
[H.G. Wilshire, U.S. Geological Survey]

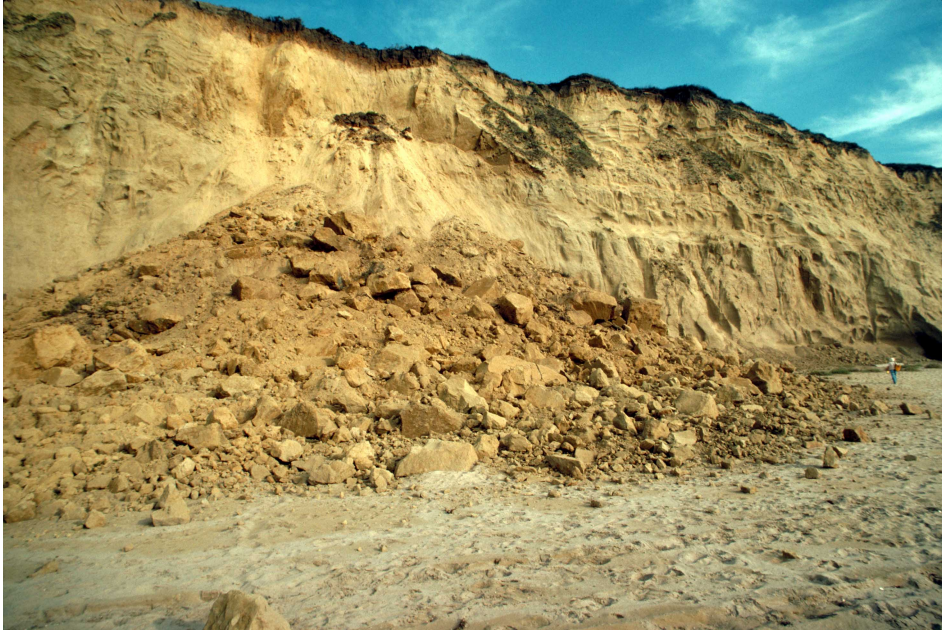
31. Cliff failure just south of San Gregorio Beach. Slide is 18.3 meters (60 ft) high and displaces approximately 6881 cubic meters (9,000 cubic yards) of material. Large boulders are 1 m (3 ft) across. [D.M. Peterson, U.S. Geological Survey]

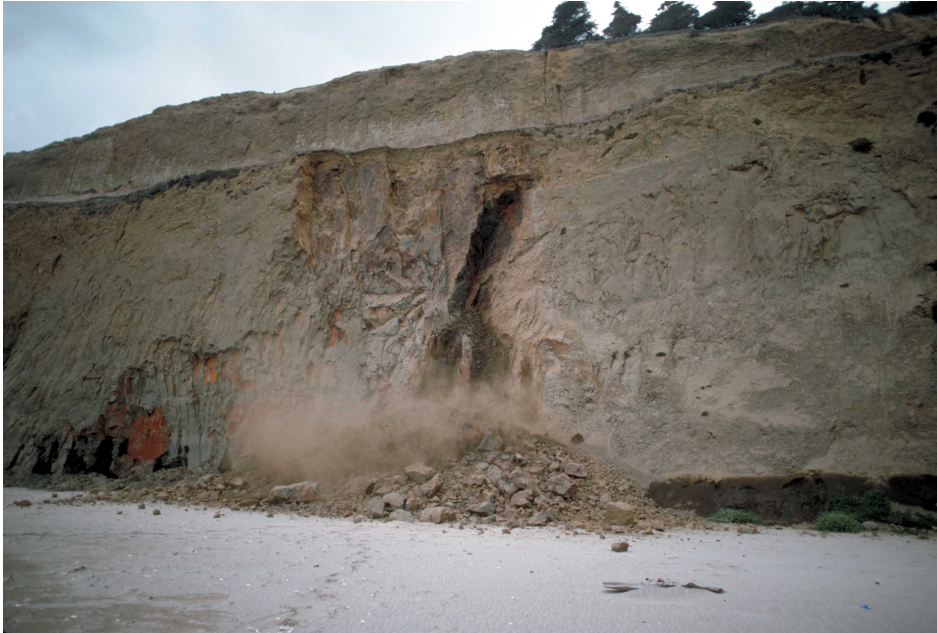
32. Cliff failure north of Tunitas Creek. This face continued to slide for a few days after the earthquake. The event in progress exposed dark cliff material. [D.M. Peterson, U.S. Geological Survey]

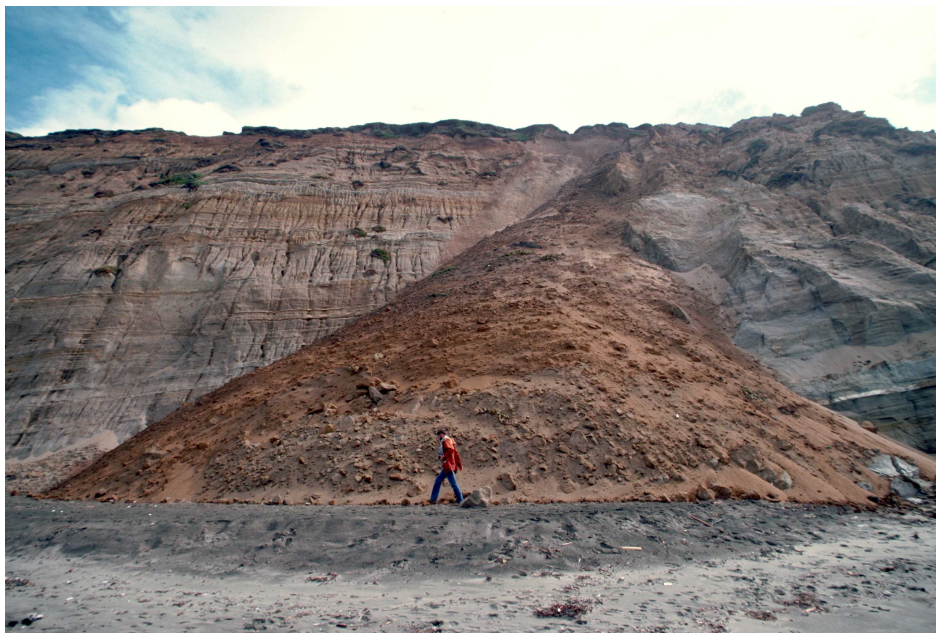
33. Landslide north of Fort Funston. Slide mass contains approximately 2,830 cubic meters (3,700 cubic yards) and is 30 m (100 ft) high. Photo 35 provides an aerial view of this slide. [D.M. Peterson, U.S. Geological Survey]

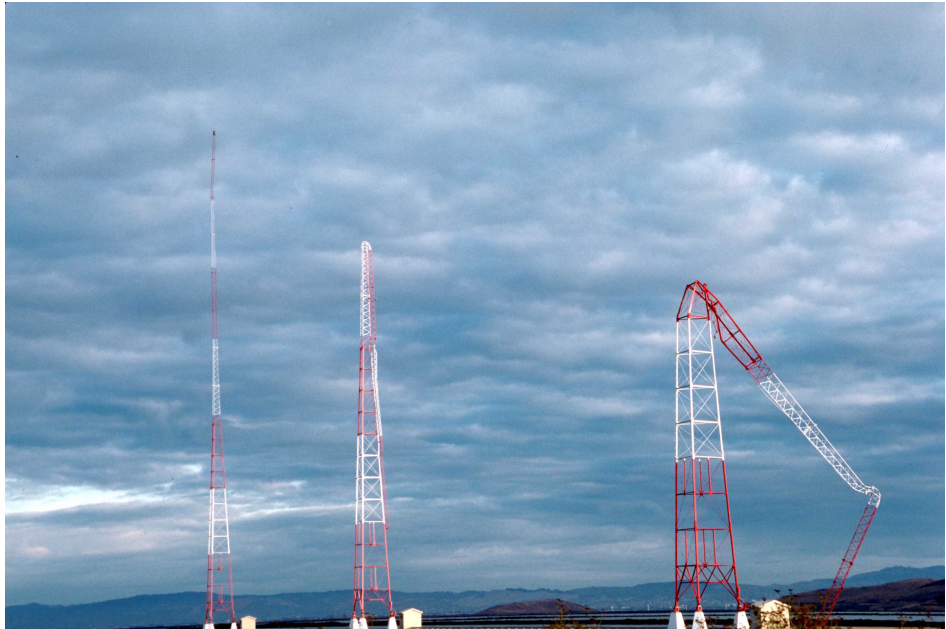
38. KGO radio transmission towers. [H.G. Wilshire, U.S. Geological Survey]

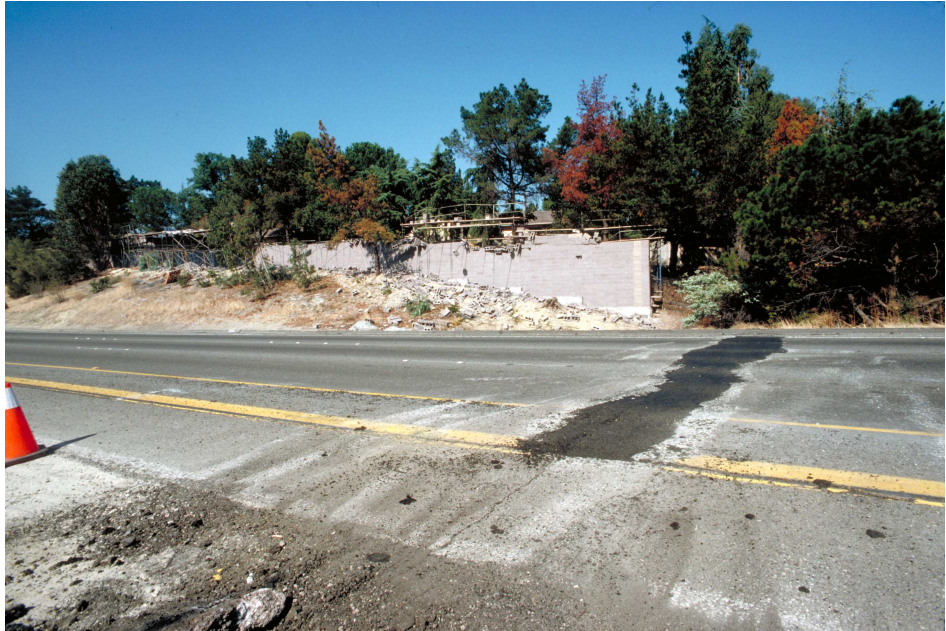
44. Nontectonic surface rupture across Highway 280 at the interface of a roadcut and fill area 2.5 km (1.5 mi) north of Foothill Expressway. [J.K. Nakata, U.S. Geological Survey]

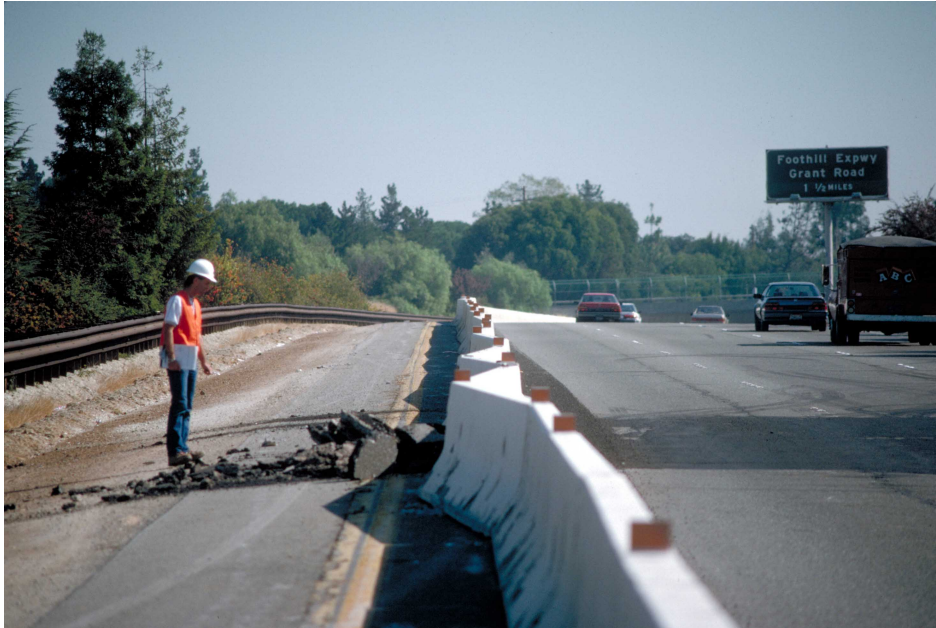
45. The cement retaining walls along Highway 280 deformed in accordion-like pattern as a result of lateral compression. [J.K. Nakata, U.S. Geological Survey]

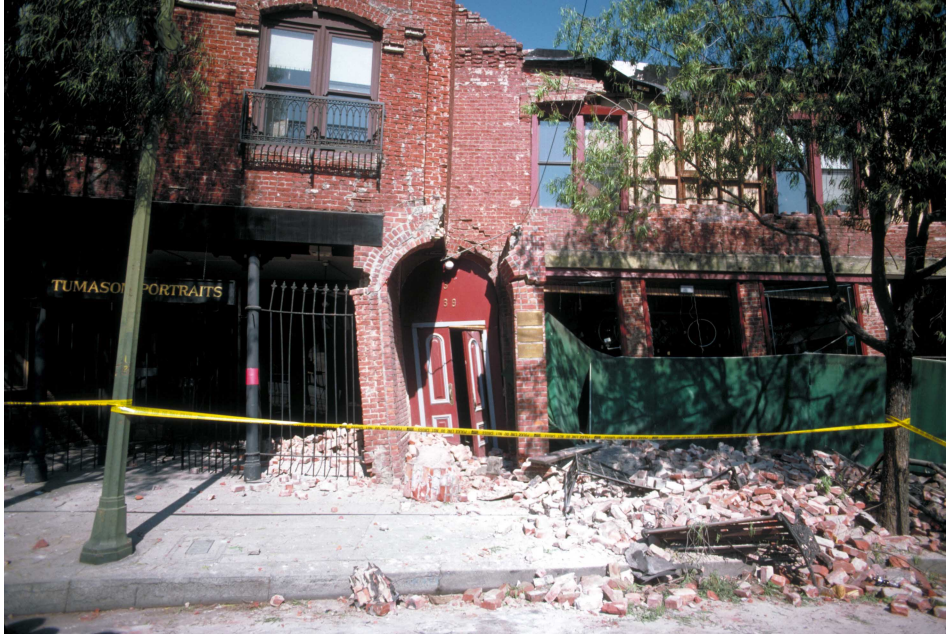
46. Failure of unreinforced brick masonry caused collapse of the upper floor in downtown Los Gatos. [J.K. Nakata, U.S. Geological Survey]

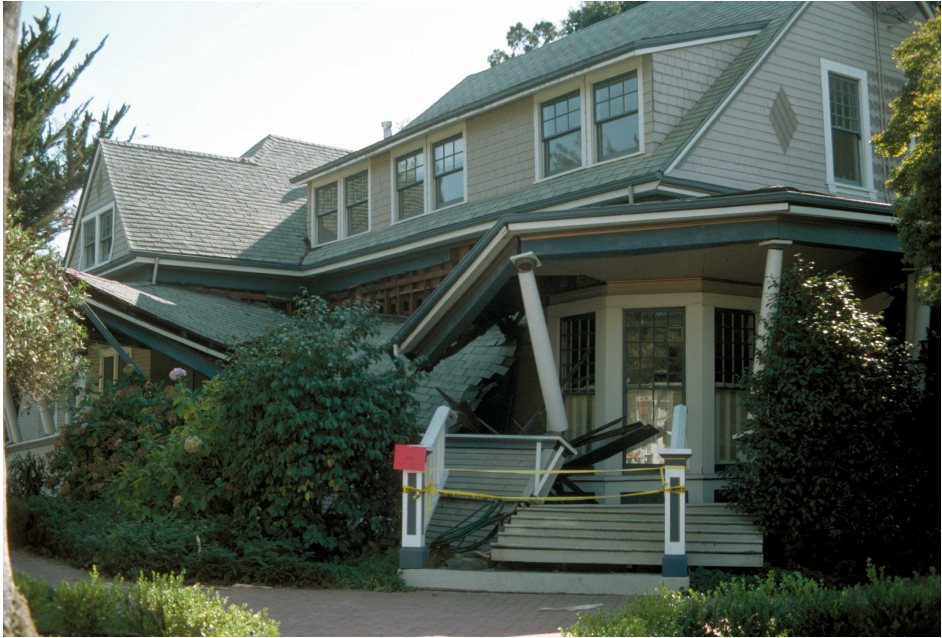
52. Failure of porch on frame house. [H.G. Wilshire, U.S. Geological Survey]

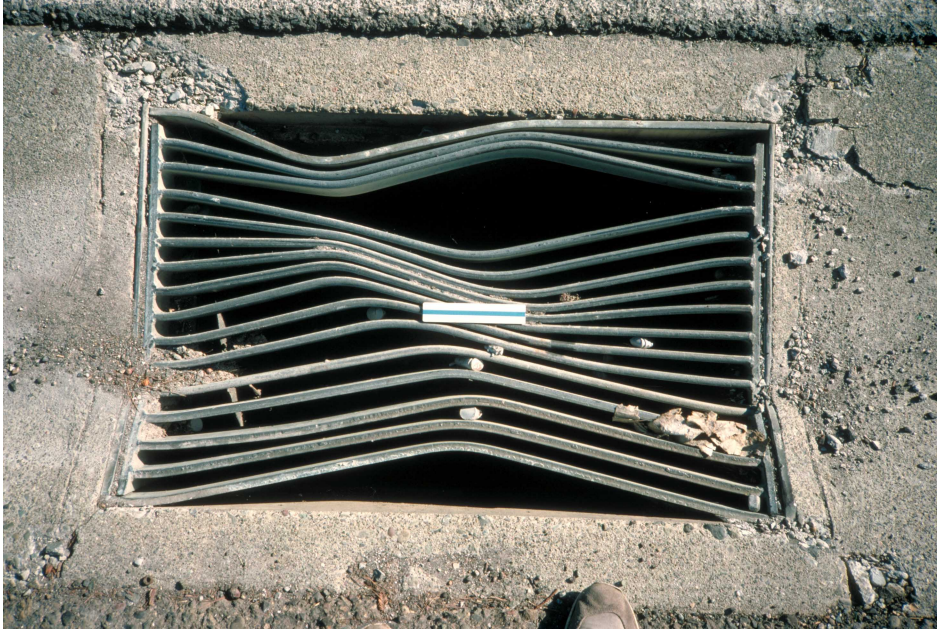
53. Drain grating shows the effects of lateral compression. [R.A. Haugerud, U.S. Geological Survey]

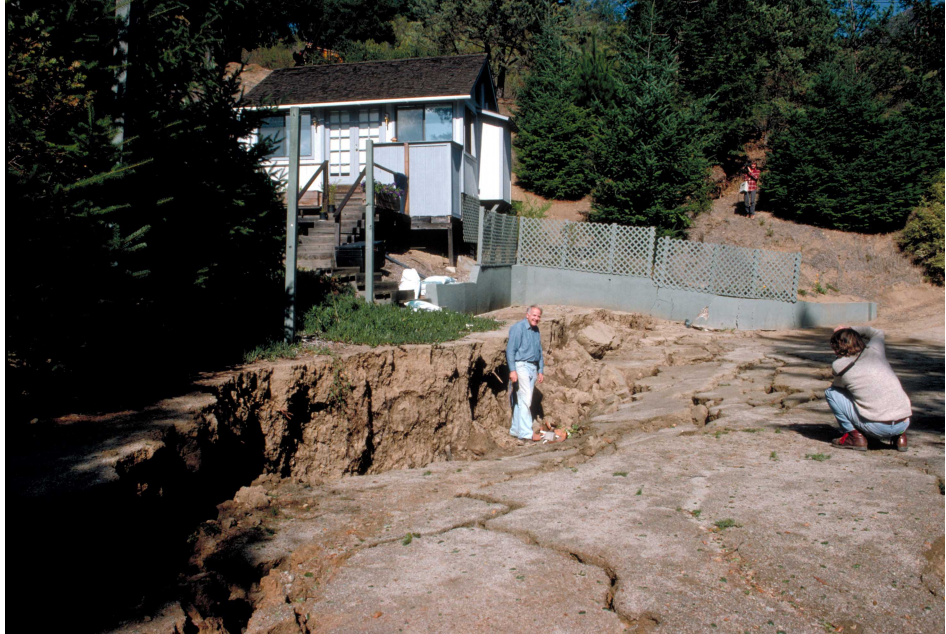
55. Crack system with 1.2 m (4 ft) of vertical displacement across a clay tennis court; fracture passes across retaining wall and up slope beyond view. West of Summit Road, southeast of Highway 17. [H.G. Wilshire, U.S. Geological Survey]

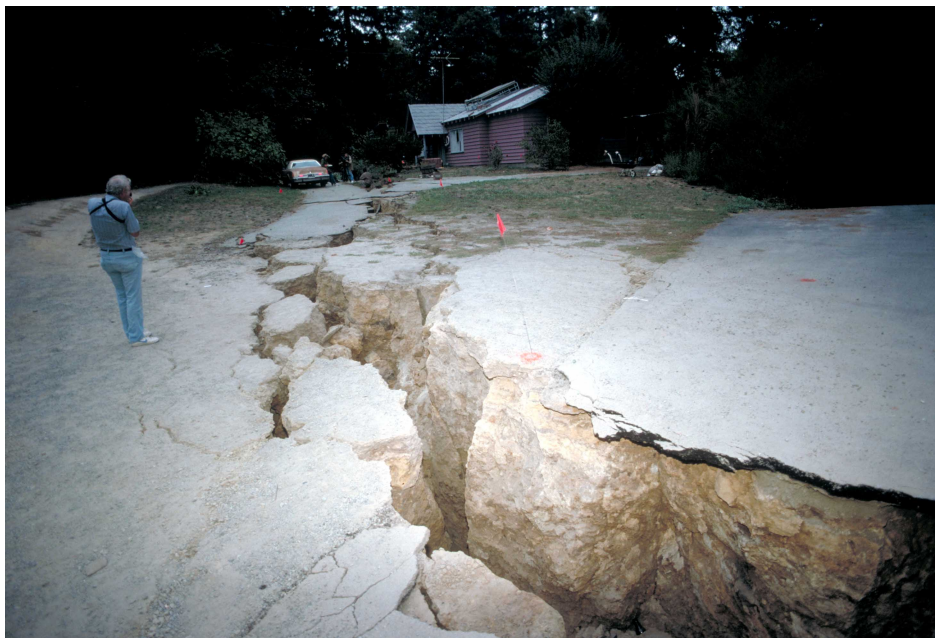
56. A crack system destroys driveway adjacent to summit road 0.8 km (1/2 mi) southeast of Highway 17. [J.K. Nakata, U.S. Geological Survey]

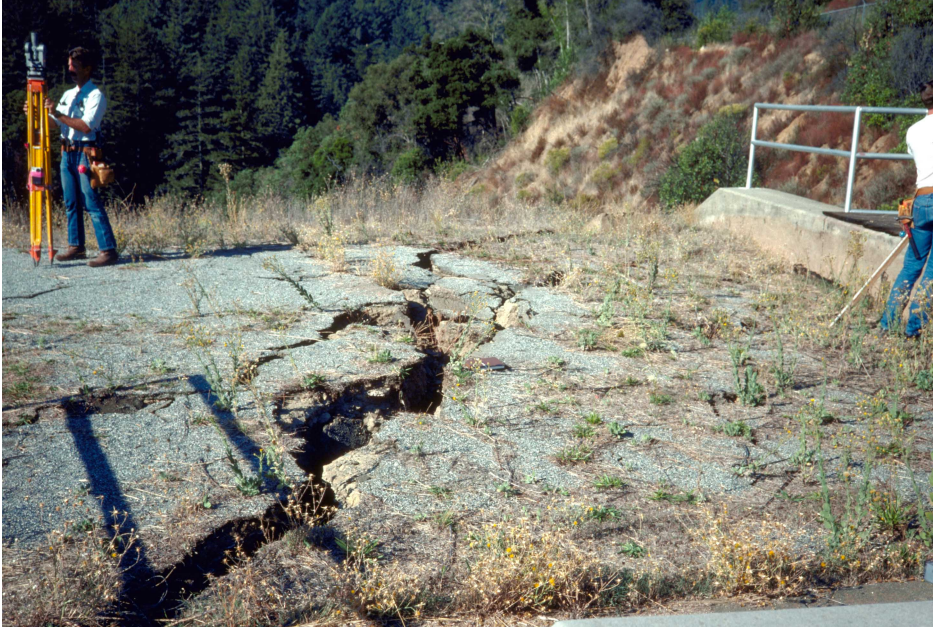
58. Northwest-trending extensional crack where dam fill settled about 0.6 m (2 ft) and pulled away from concrete spillway and north abutment of Austrian Dam. [R.J. McLaughlin, U.S. Geological Survey]

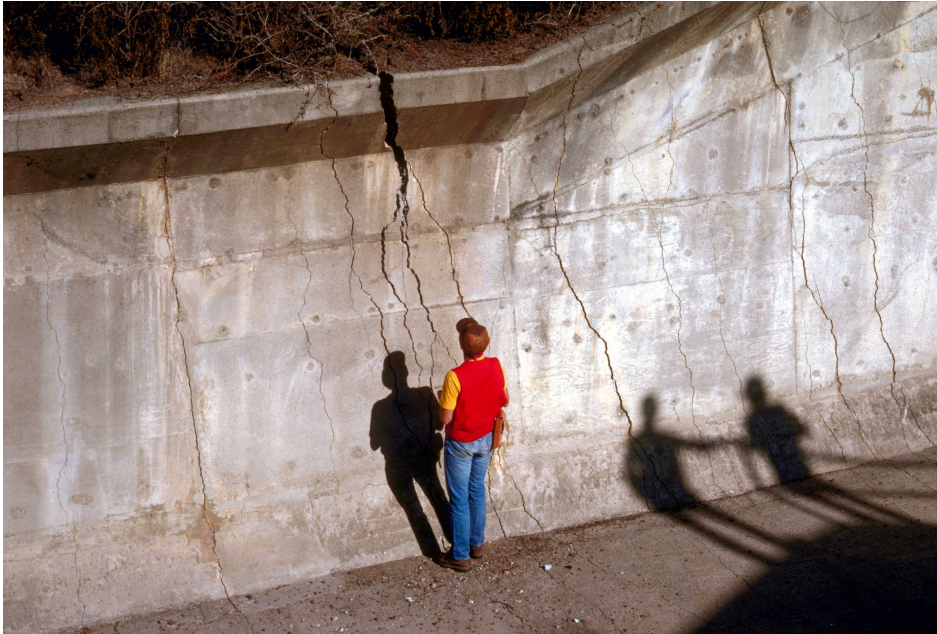
59. Prominent N. 15<sup>o</sup> W.-trending extensional cracks up to 12 cm (4.7 in.) wide in concrete spillway to Austrian Dam, north abutment. [G.R. Fisher, U.S. Geological Survey]

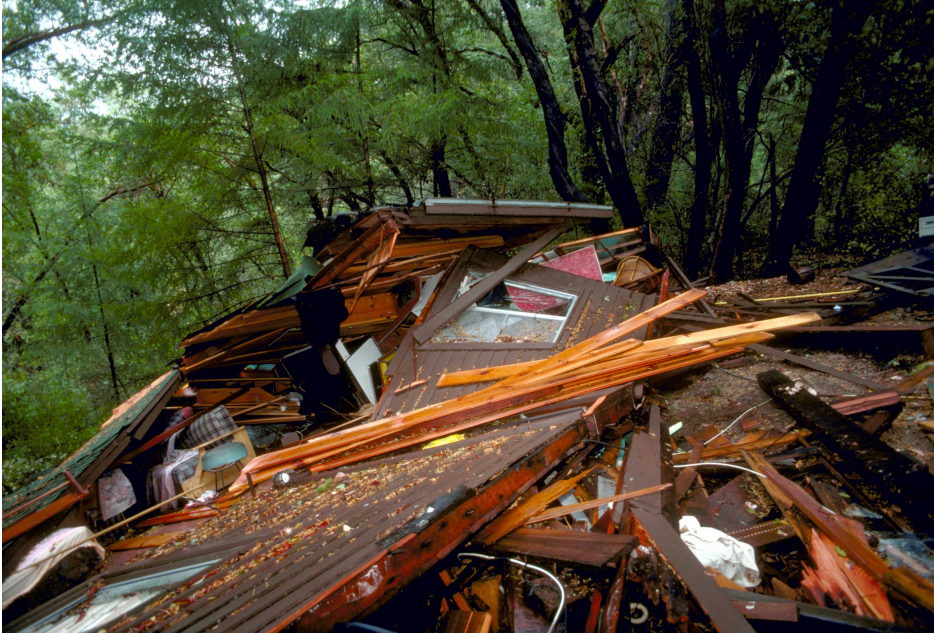
62. House destroyed by failure of downslope support piers. [J.K. Nakata, U.S. Geological Survey]

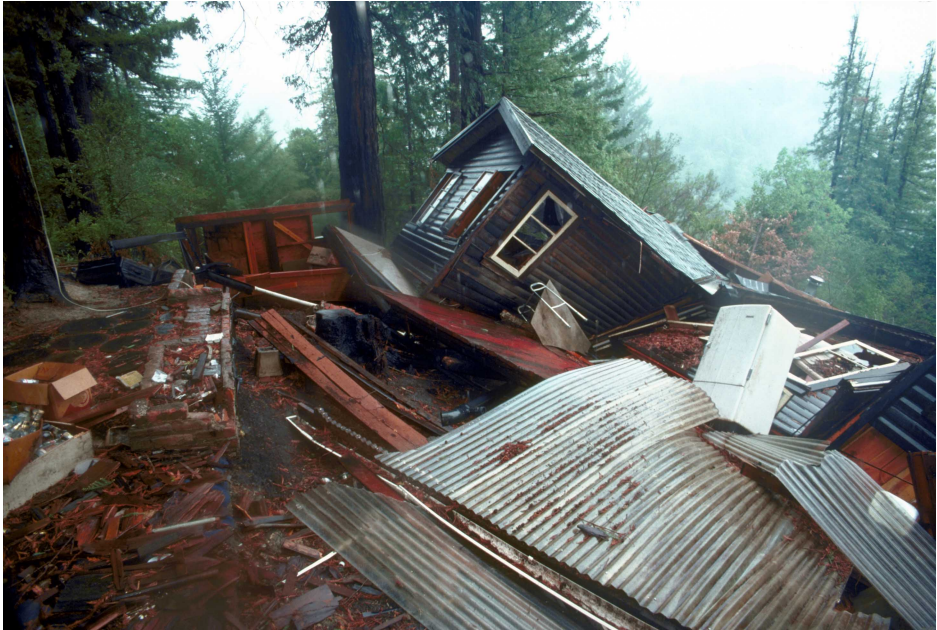
63. House moved laterally off cement foundation. [J.K. Nakata, U.S. Geological Survey]

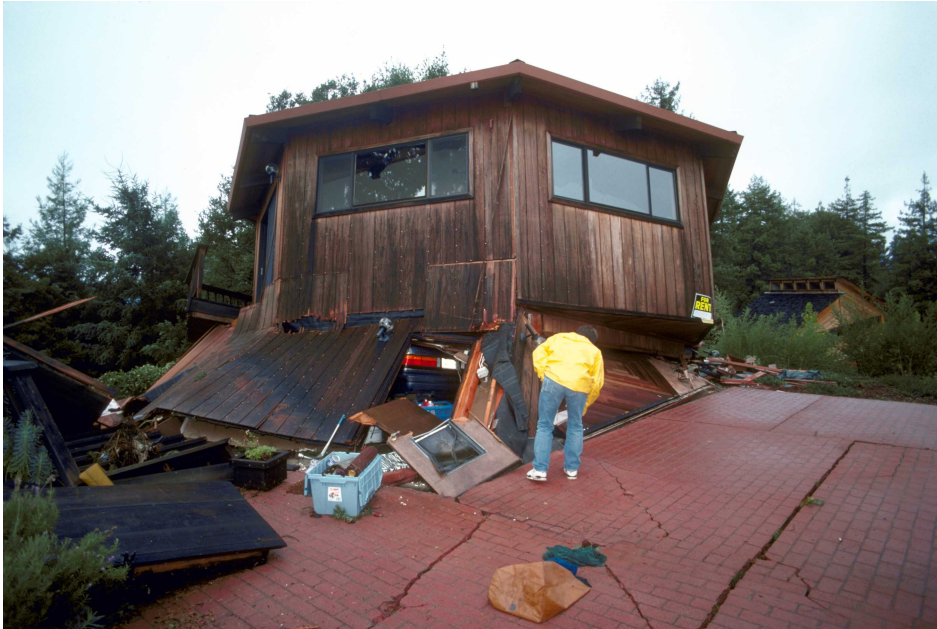
64. Collapsed garage built on fill. [J.K. Nakata, U.S. Geological Survey]

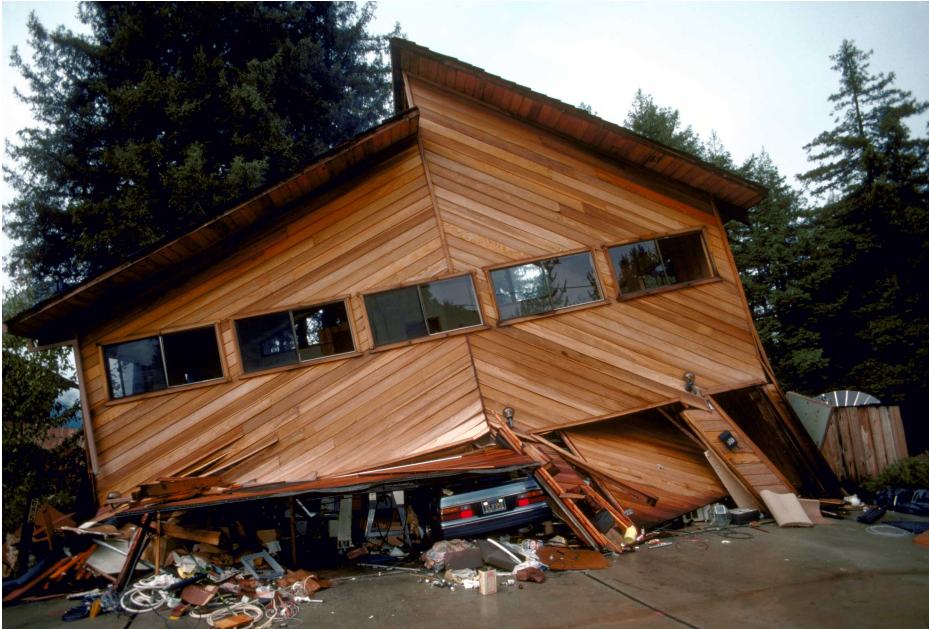
65. Construction on fill and the absence of adequate shear walls contributed to the failure of this structure. [J.K. Nakata, U.S. Geological Survey]

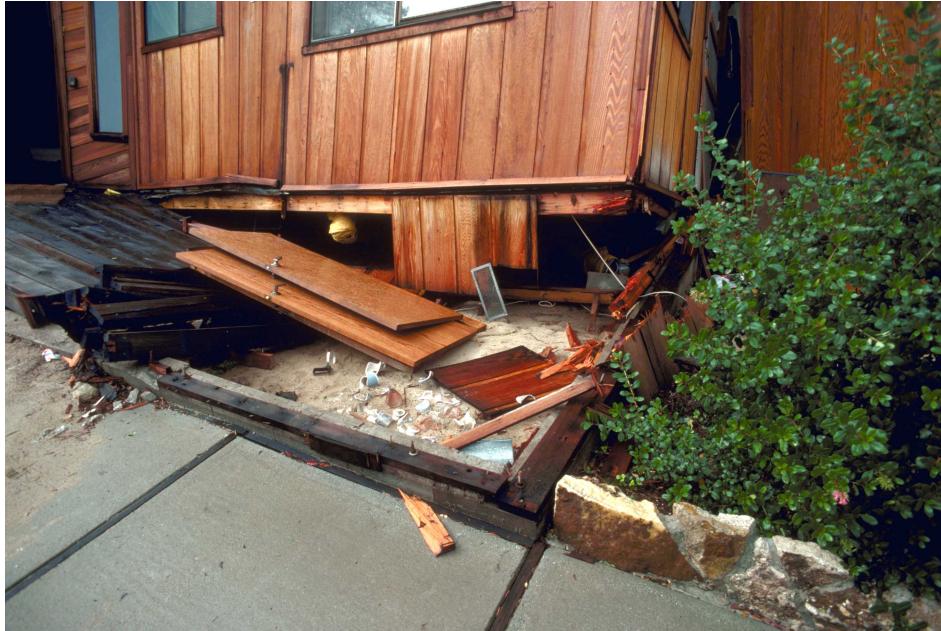
66. House torn off its foundation by the main shock. [J.K. Nakata, U.S. Geological Survey]

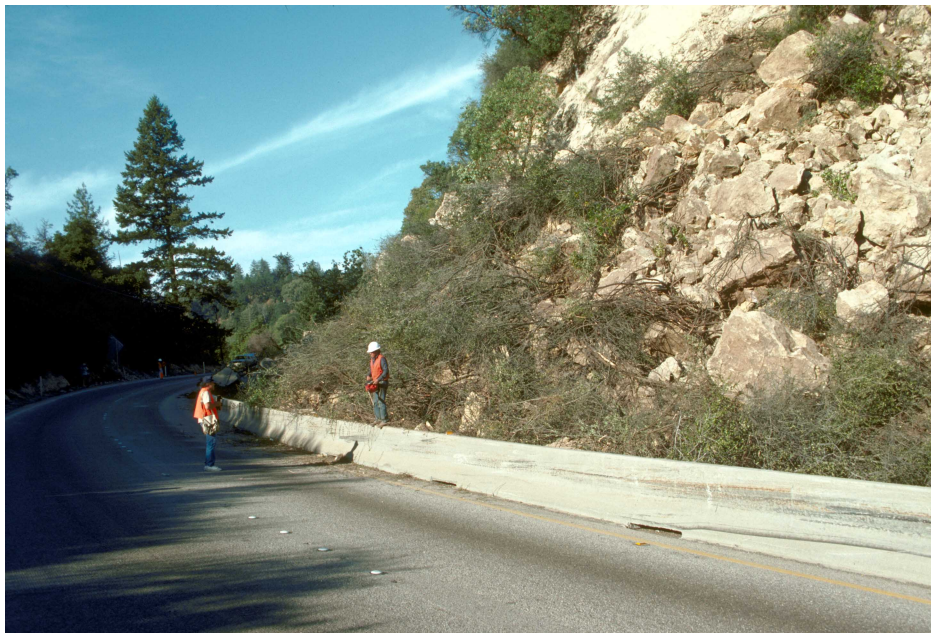
67. Landslide debris blocks both eastbound lanes of Highway 17 near Summit Road.  
[C.E. Meyer, U.S. Geological Survey]

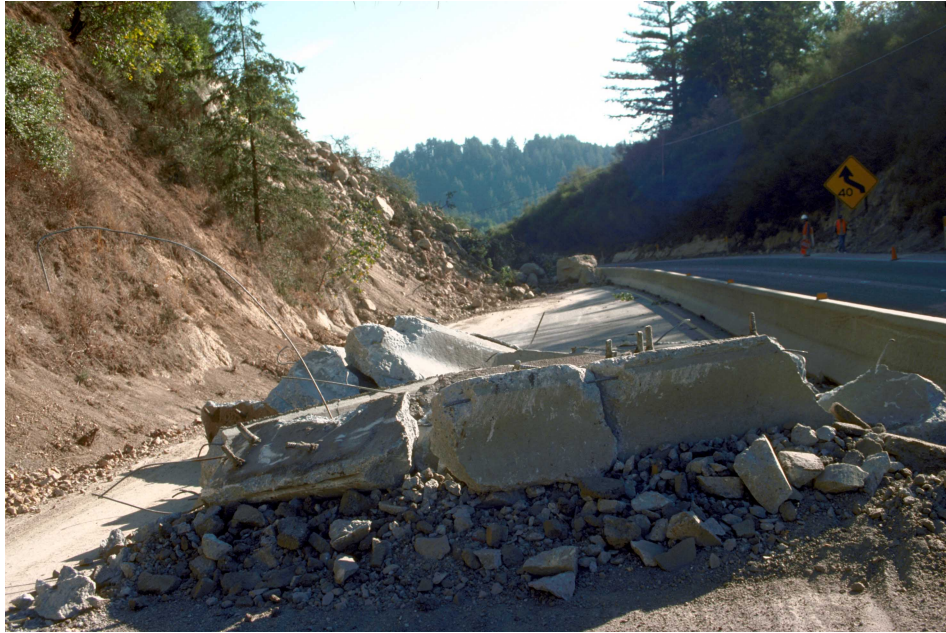
68. Landslide debris blocks both eastbound lanes of Highway 17 near Summit Road. Foreground material is damaged lane separators. [C.E. Meyer, U.S. Geological Survey]

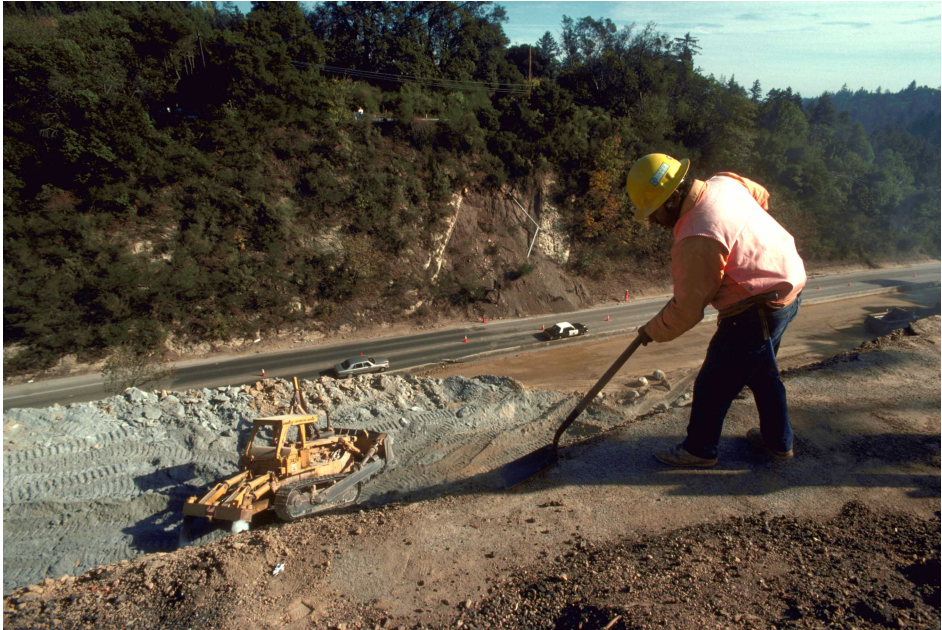
69. This roadcut near Summit Road failed during the initial earthquake and subsequent aftershocks. To mitigate further sliding, Caltrans decreased the slope angle. [J.K. Nakata, U.S. Geological Survey]

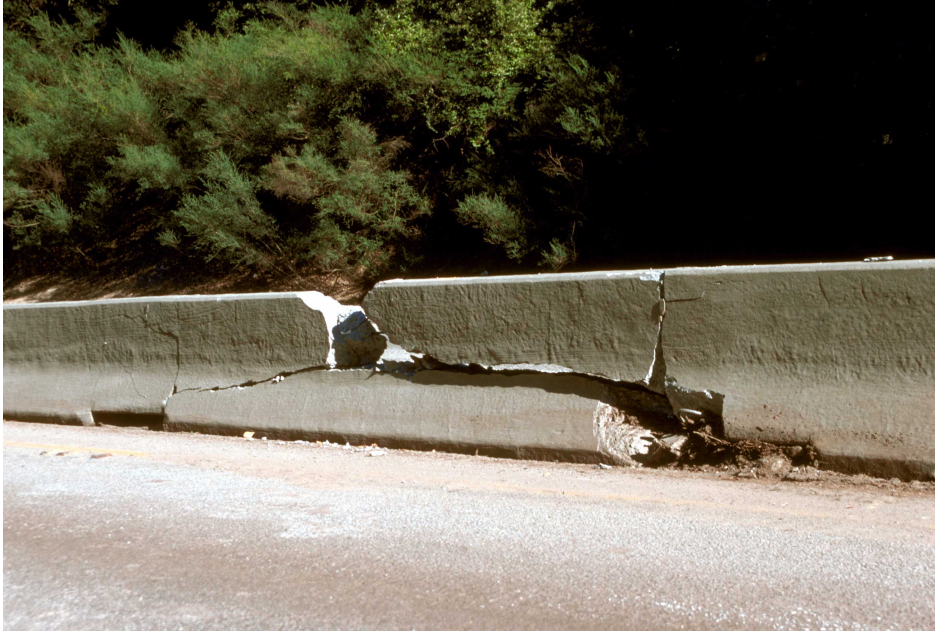
70. Damaged lane separators, Highway 17. [C.E. Meyer, U.S. Geological Survey]

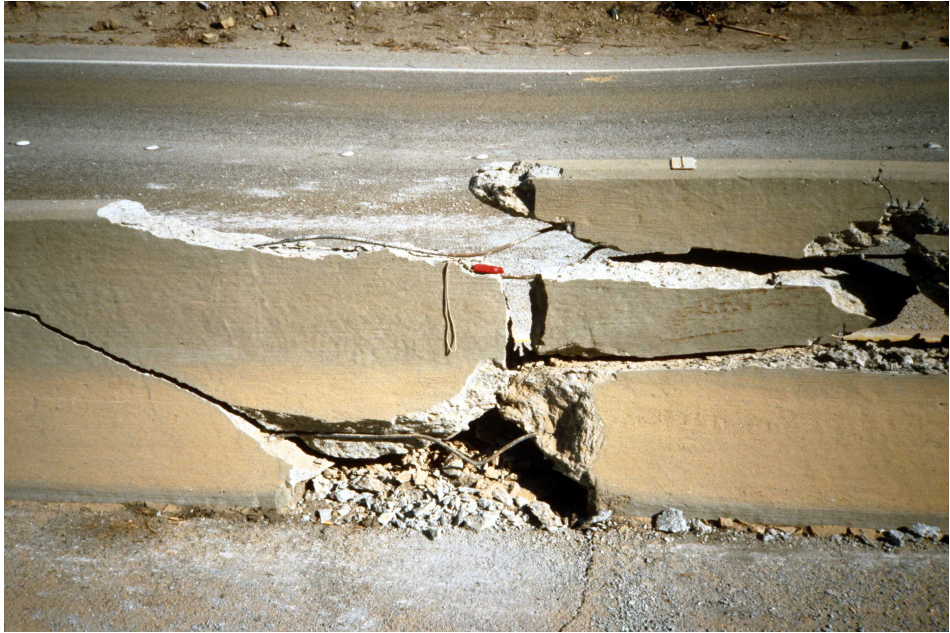
71. Broken concrete divider near the intersection of Summit Road and Highway 17.  
[R.A. Haugerud, U.S. Geological Survey]

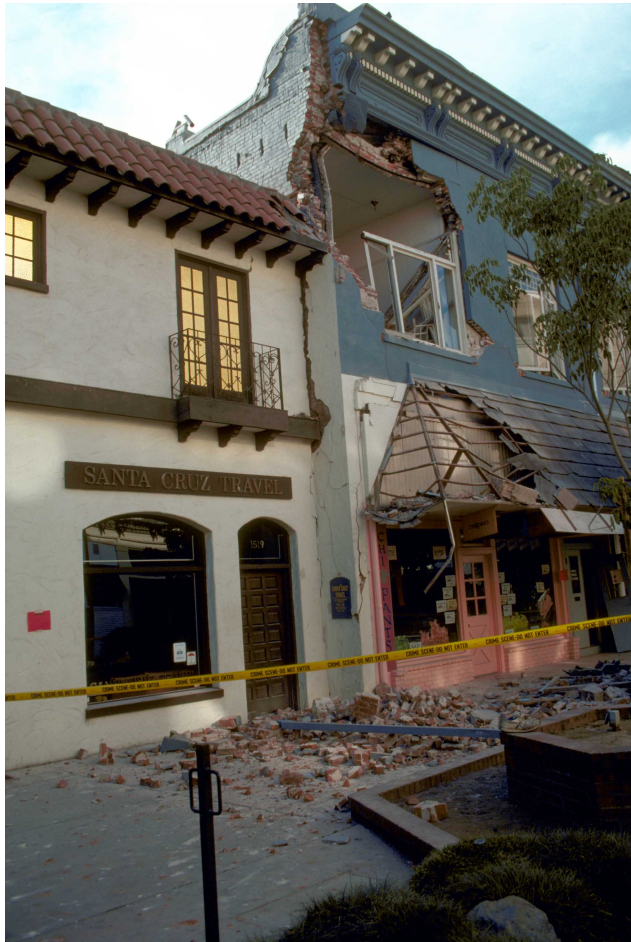
78. Storefront damage, Pacific Garden Mall. [C.E. Meyer, U.S. Geological Survey]

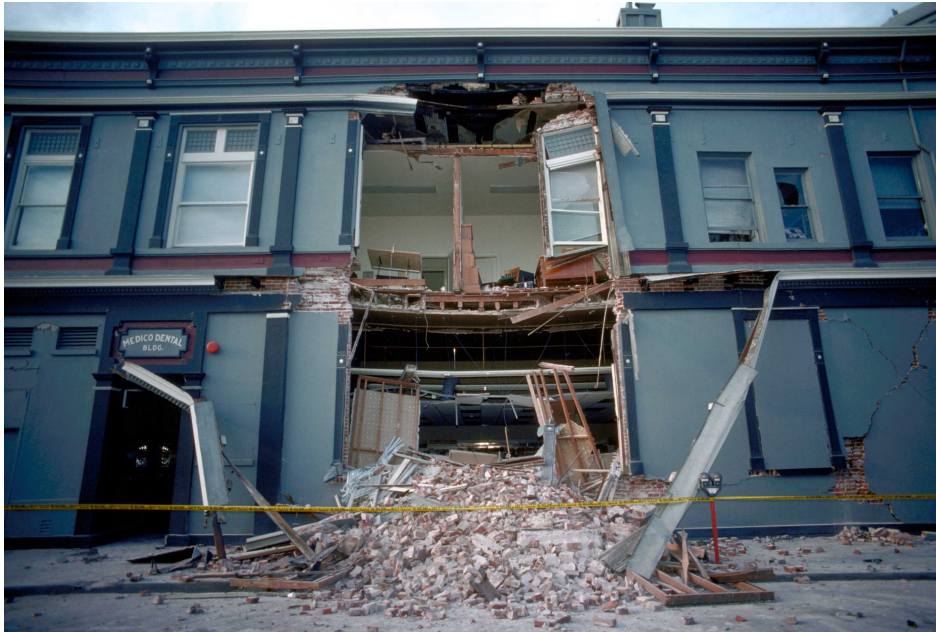
80. Collapsed outer wall of the *Medico Dental Building*, Pacific Garden Mall. [J.K. Nakata, U.S. Geological Survey]

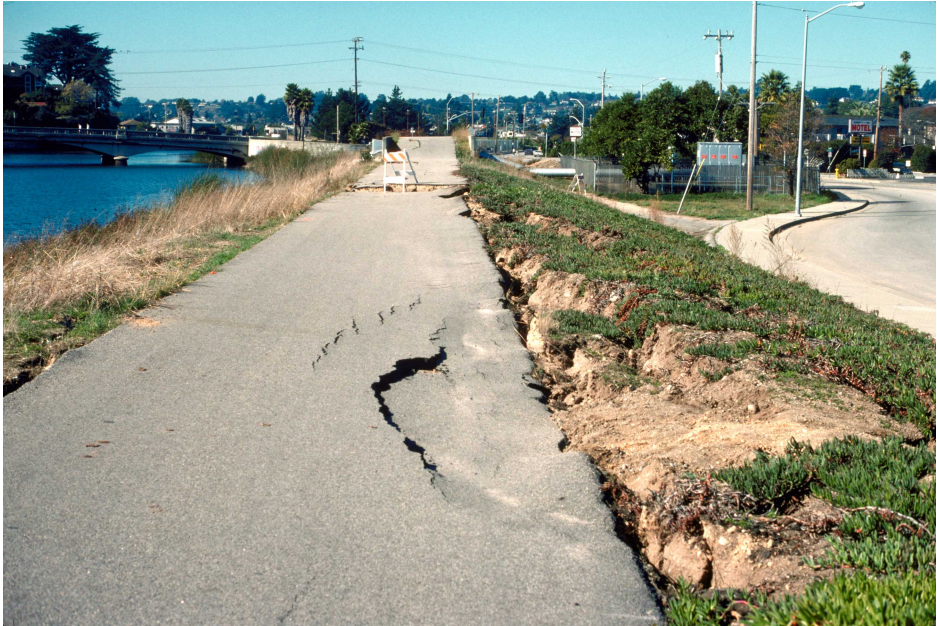
82. Liquefaction in recent deposits of San Lorenzo River caused cracking and differential settling of river levee southeast of Riverside Avenue Bridge. Bridge piers and the north abutment area were also damaged by liquefaction. [J.C. Tinsley, U.S. Geological Survey]

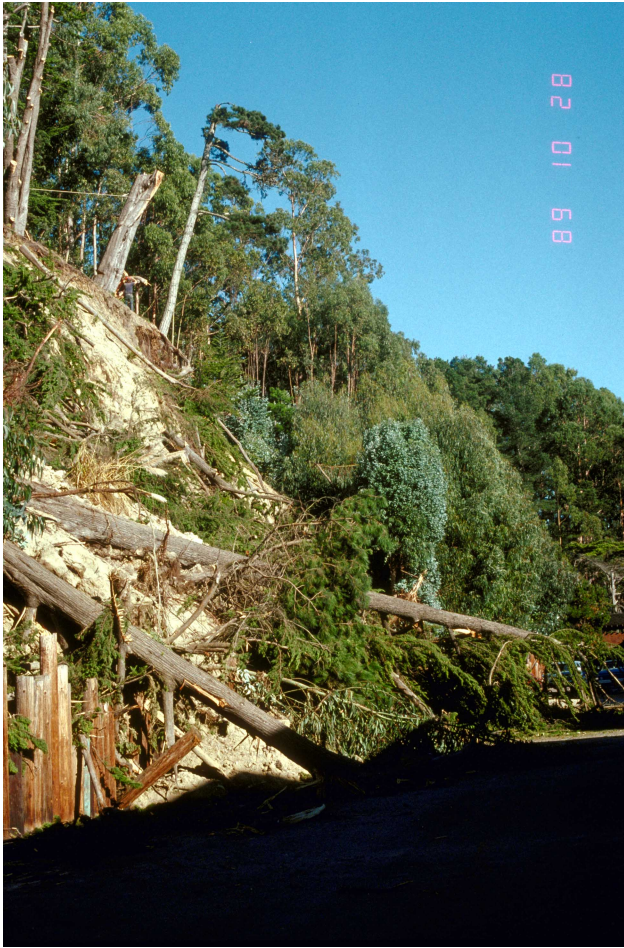
83. Landslide-displaced trees reflect earthquake-triggered slope failure along coastal bluff, New Brighton Beach area, Santa Cruz County. [J.C. Tinsley, U.S. Geological Survey]

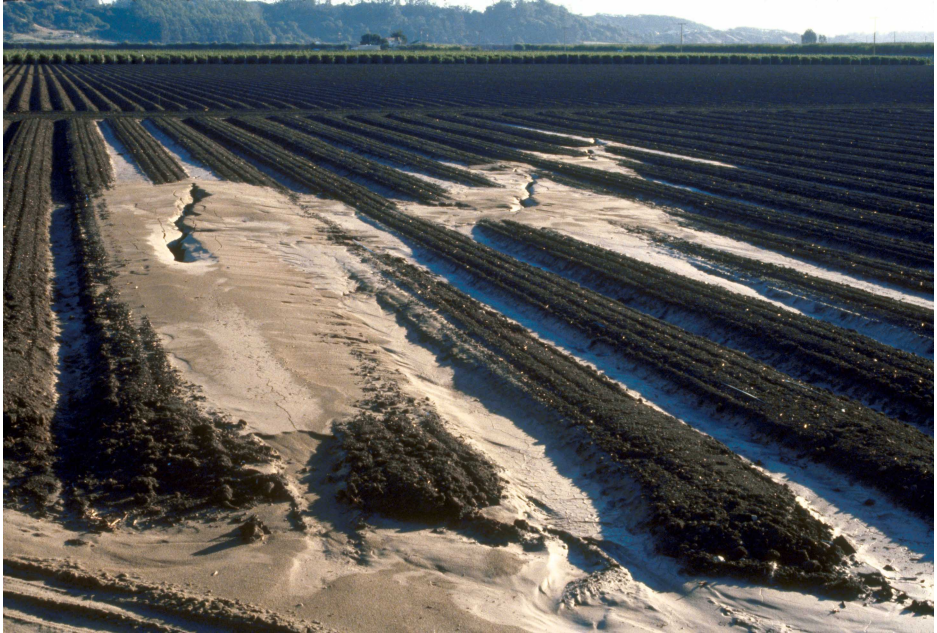
84. Liquefaction in recent deposits of the Pajaro River formed these sand volcanoes along extensional fissures in a field prepared for autumn planting near Pajaro, across the Pajaro River from Watsonville. Furrows are spaced about 1.2 m (4 ft) apart. [J.C. Tinsley, U.S. Geological Survey]

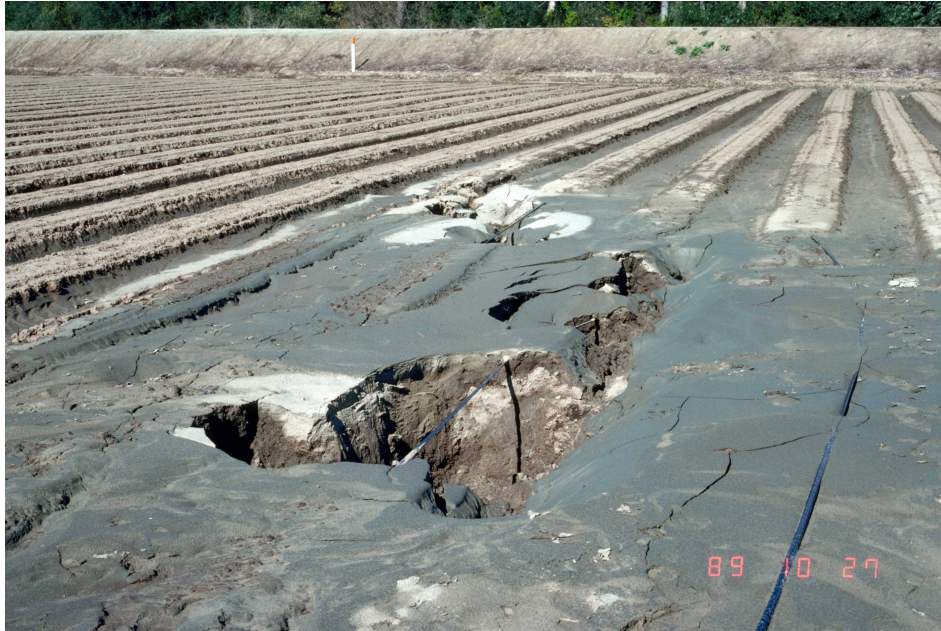
85. Vent of sand volcano produced by liquefaction is about 4 ft across in strawberry field near Watsonville. Strip spanning vent is conduit for drip irrigation system. Furrow spacing is about 1.2 m (4 ft) on center. [J.C. Tinsley, U.S. Geological Survey]

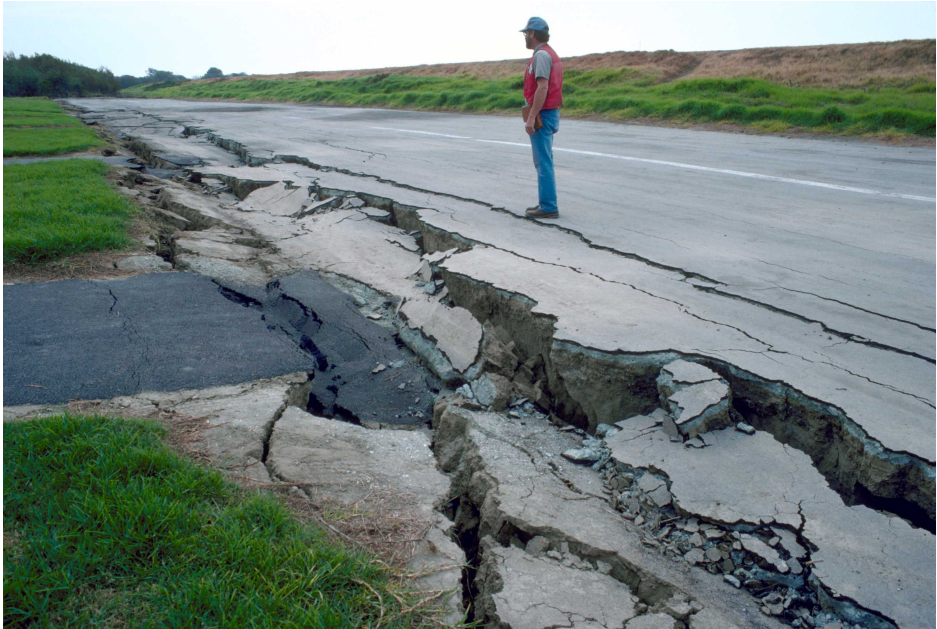
87. Ground shaking triggered liquefaction in a subsurface layer of sand, producing differential lateral and vertical movement in a overlying carapace of unliquified sand and silt, which moved from right to left toward the Pajaro River. This mode of ground failure, termed “lateral spreading,” is a principal cause of liquefaction-related earthquake damage. [S.D. Ellen, U.S. Geological Survey]

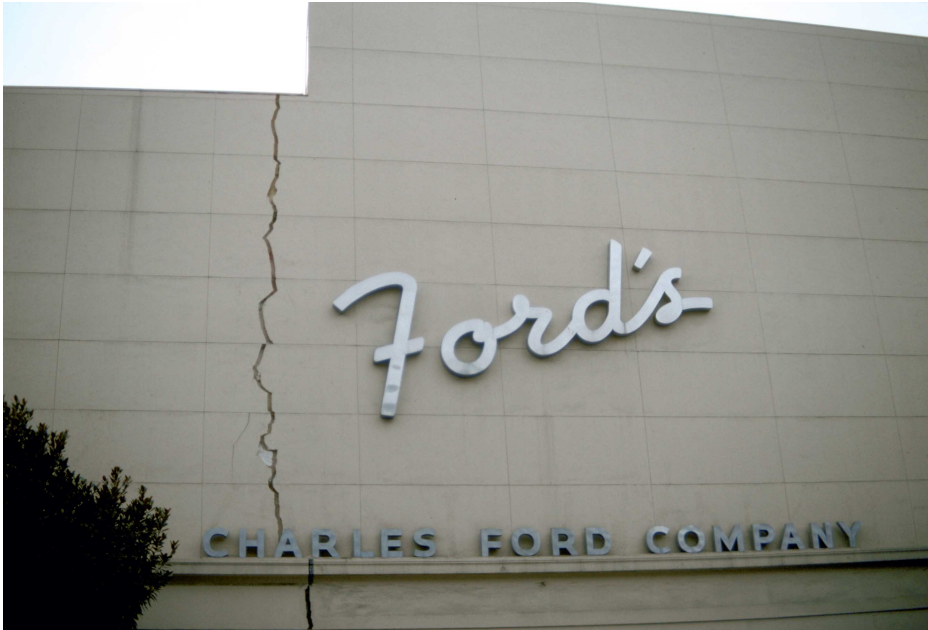
88. Crack down front of Ford's Department Store, downtown Watsonville. Although this fracture appears minor, the building was significantly damaged. [H.G. Wilshire, U.S. Geological Survey]
