# The October 17, 1989, Loma Prieta, California, Earthquake—Selected Photographs

*by* By J.K. Nakata, C.E. Meyer, H.G. Wilshire, J.C. Tinsley, W.S. Updegrove,  
D.M. Peterson, S.D. Ellen, R.A. Haugerud, R.J. McLaughlin, G.R. Fisher, *and*  
M.F. Diggles

Photographs and descriptions to accompany  
Digital Data Series DDS-29  
Version 1.1  
1999

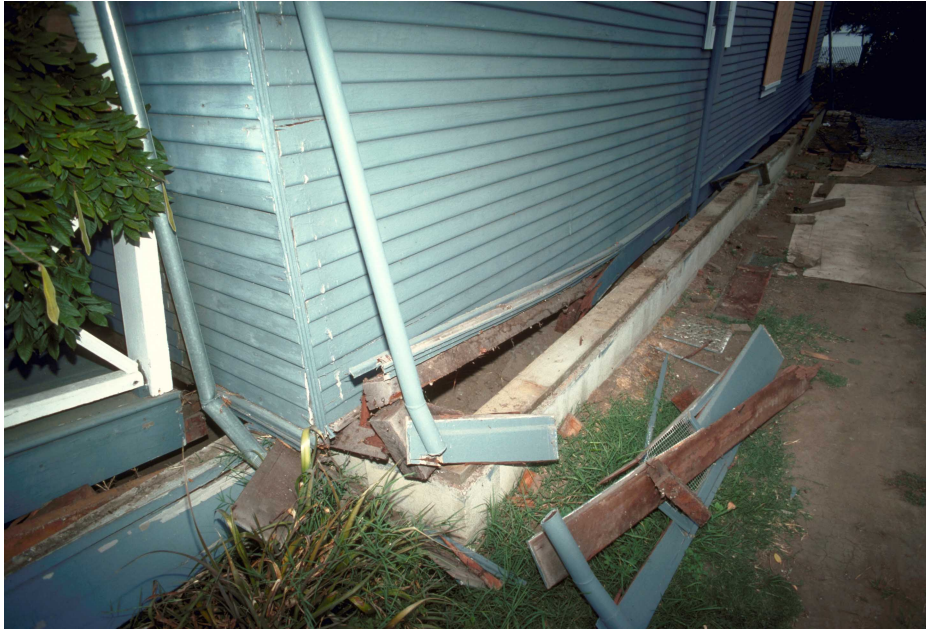
89. Houses not bolted down securely were easily dislodged from their foundations in downtown Watsonville. [J.K. Nakata, U.S. Geological Survey]

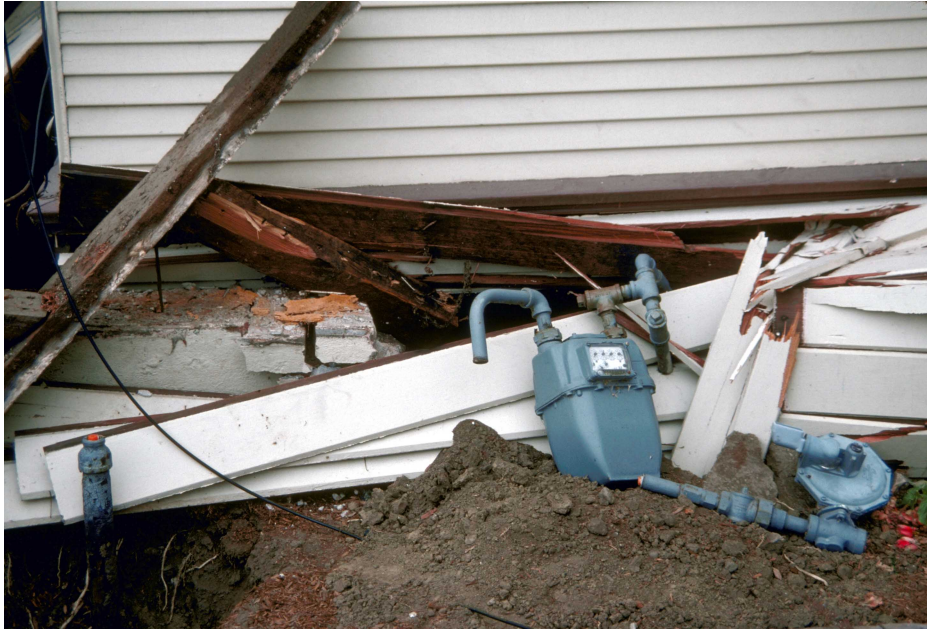
91. Broken utility lines in house that shifted off its foundation, downtown Watsonville.  
[H.G. Wilshire, U.S. Geological Survey]

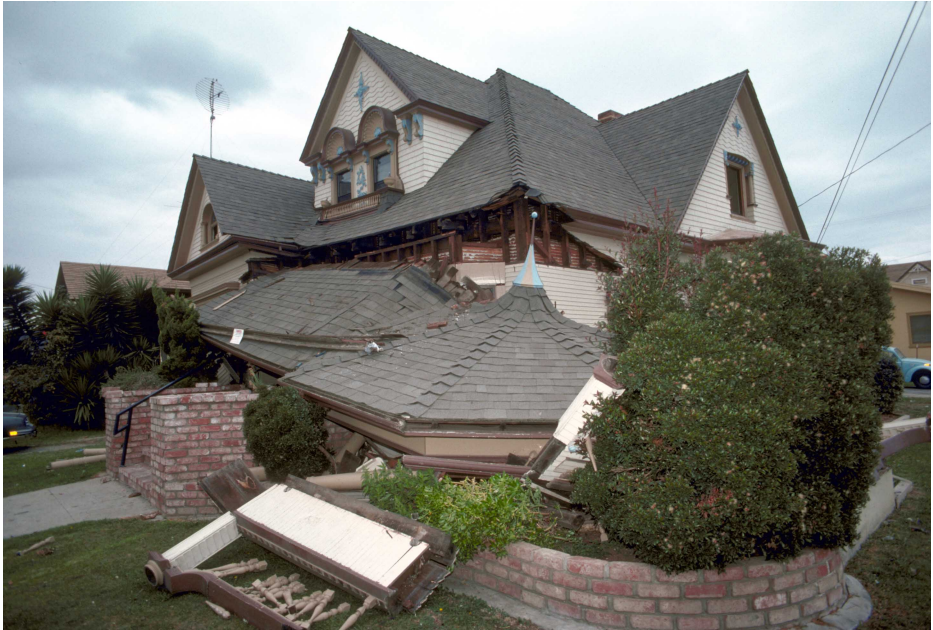
92. Collapsed porch, downtown Watsonville. [J.K. Nakata, U.S. Geological Survey]

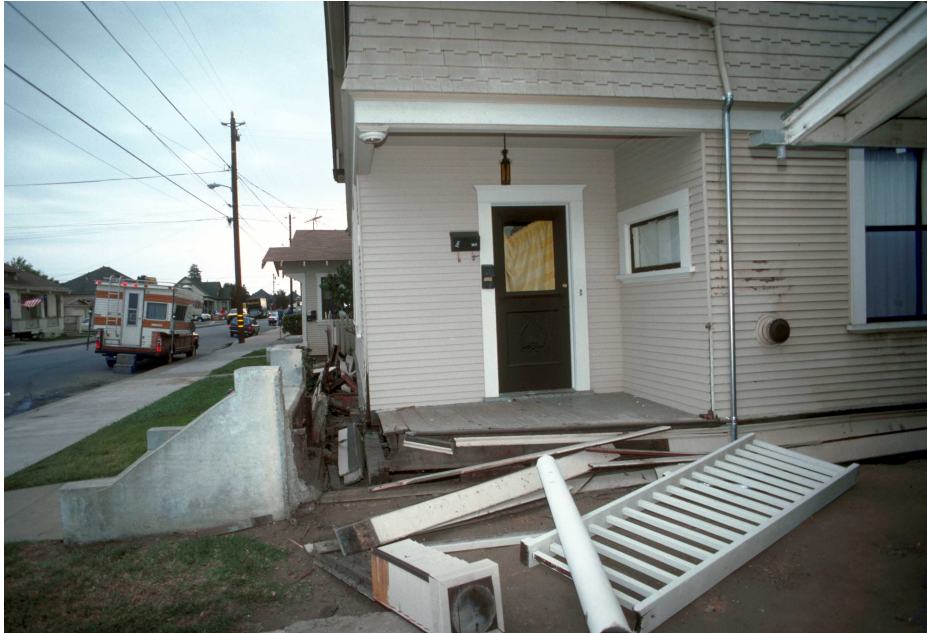
93. This house was dislodged from its foundation and moved 0.75 m (2.5 ft) from the cement stairway, downtown Watsonville. [J.K. Nakata, U.S. Geological Survey]

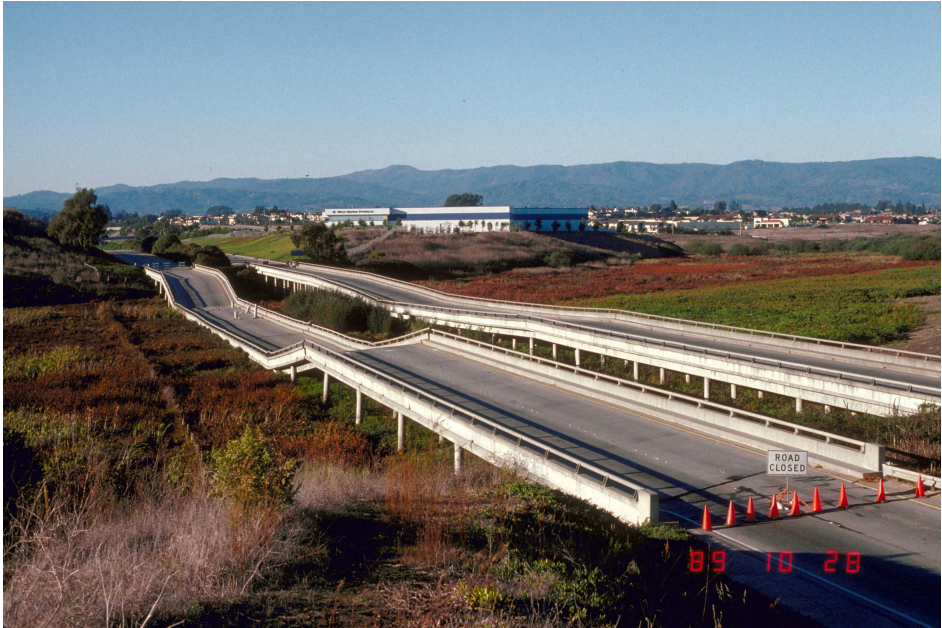
94. Structural failure of twin bridges carrying Highway 1 across Struve Slough near Watsonville. [J.C. Tinsley, U.S. Geological Survey]

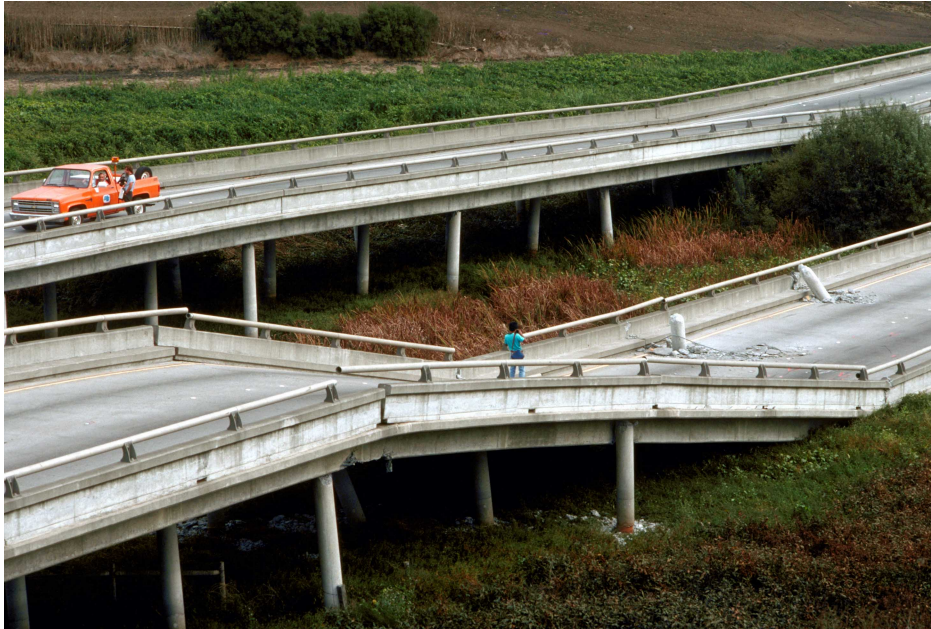
95. Closeup of collapsed bridge section on Highway 1 at Struve Slough. [J.K. Nakata, U.S. Geological Survey]

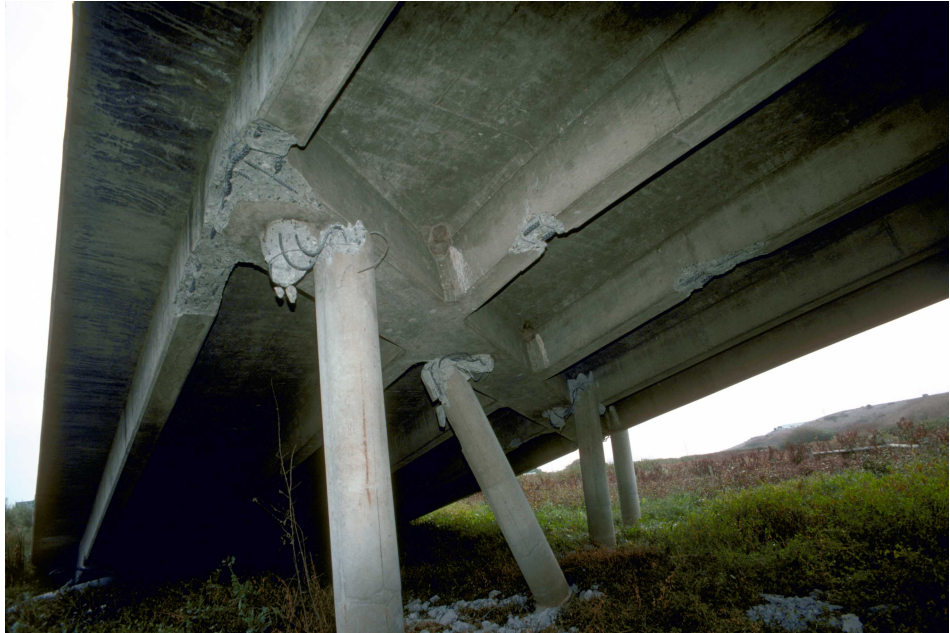
96. Failure at joist/columns interface contributed to the collapse of elevated roadbed on Highway 1. [J.K. Nakata, U.S. Geological Survey]

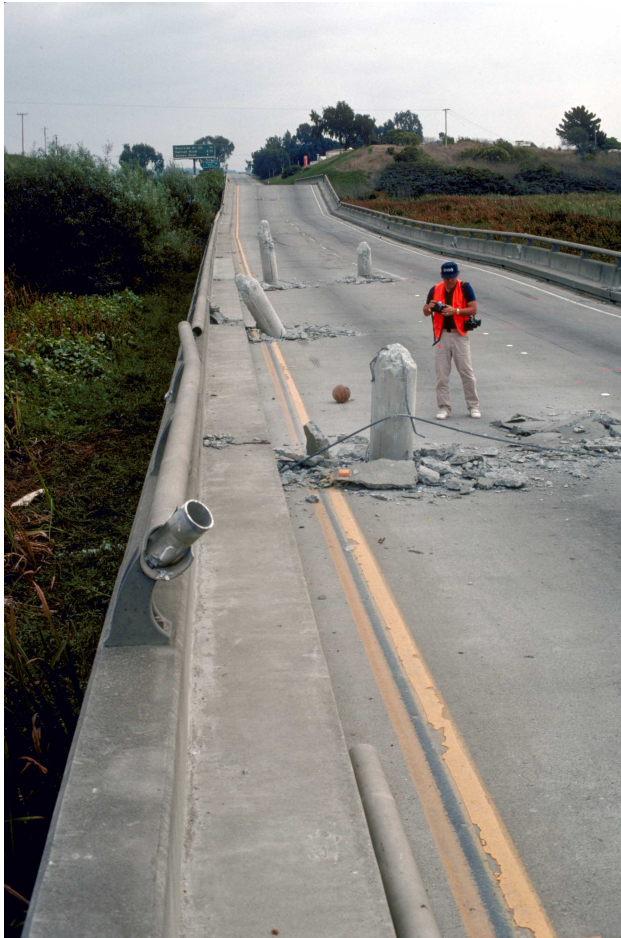
97. Support columns of Highway 1 bridge across Struve Slough protrude through roadbed. This resulted from collapse of the roadbed after the effects of lateral shaking shown in photo 98. [H.G. Wilshire, U.S. Geological Survey]

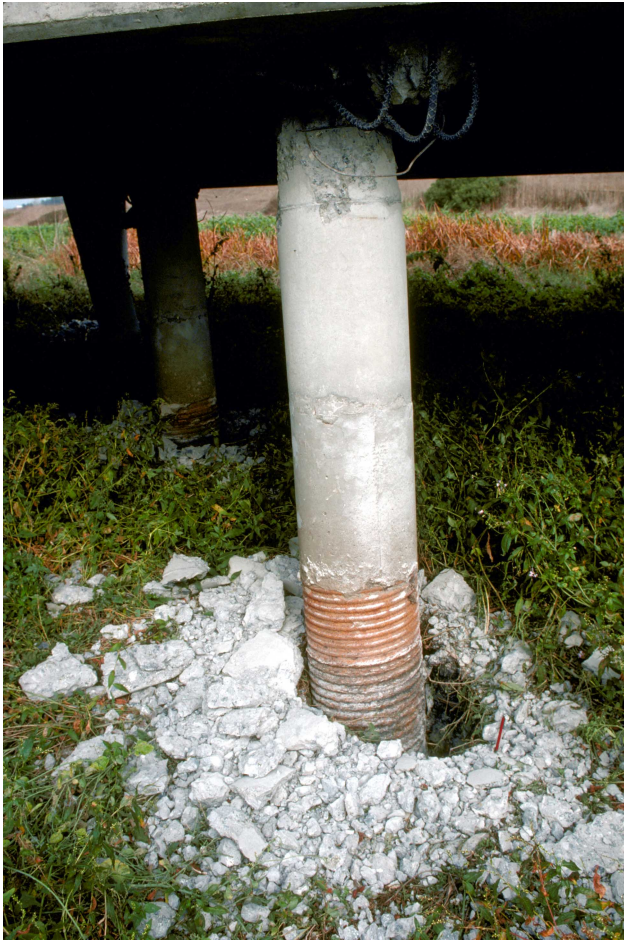
98. Support column of bridge across Struve Slough, Highway 1. Enlargement of hole where support enters the ground is an effect of lateral shaking, which caused the concrete to break up where the column joined the bridge and was instrumental in the roadbed collapse. [H.G. Wilshire, U.S. Geological Survey]

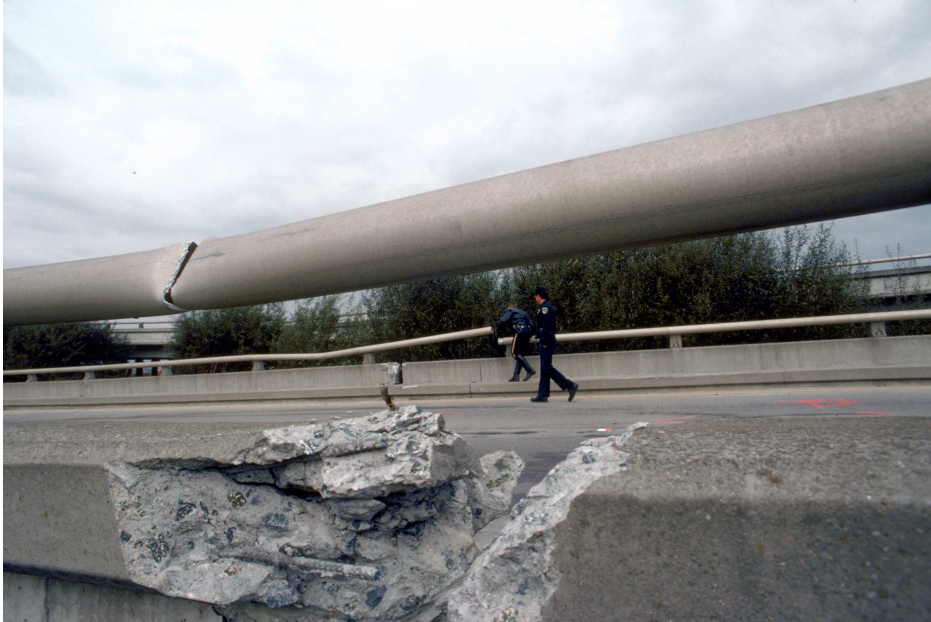
99. A fracture cuts the roadbed, curbs, and railings on the collapsed section of Highway 1 at Struve Slough. [J.K. Nakata, U.S. Geological Survey]

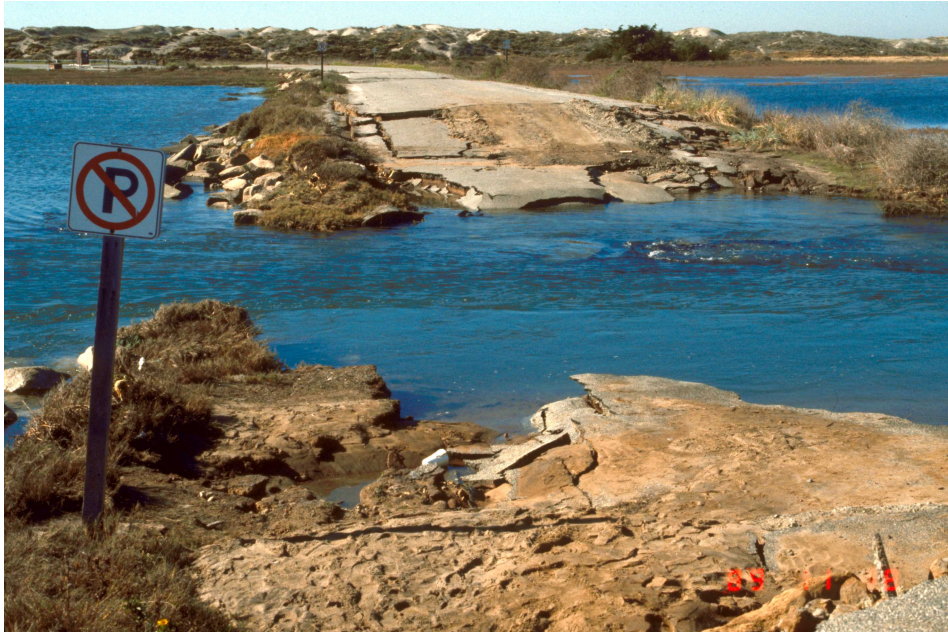
100. Liquefaction and subsequent strong tidal action destroyed a causeway carrying the Moss Beach access road across tidewater basin near Moss Landing. [J.C. Tinsley, U.S. Geological Survey]

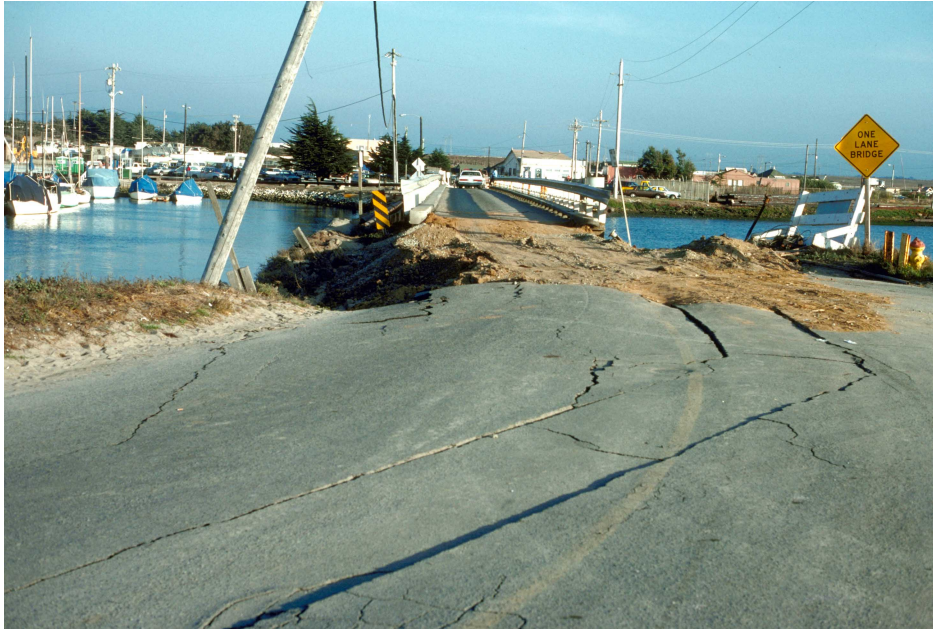
101. Ground cracking and differential settlement due to liquefaction of beach and Salinas River deposits damaged approach and abutment of bridge linking Moss Landing spit to the mainland, near Moss Landing Marine Laboratory. [J.C. Tinsley, U.S. Geological Survey]

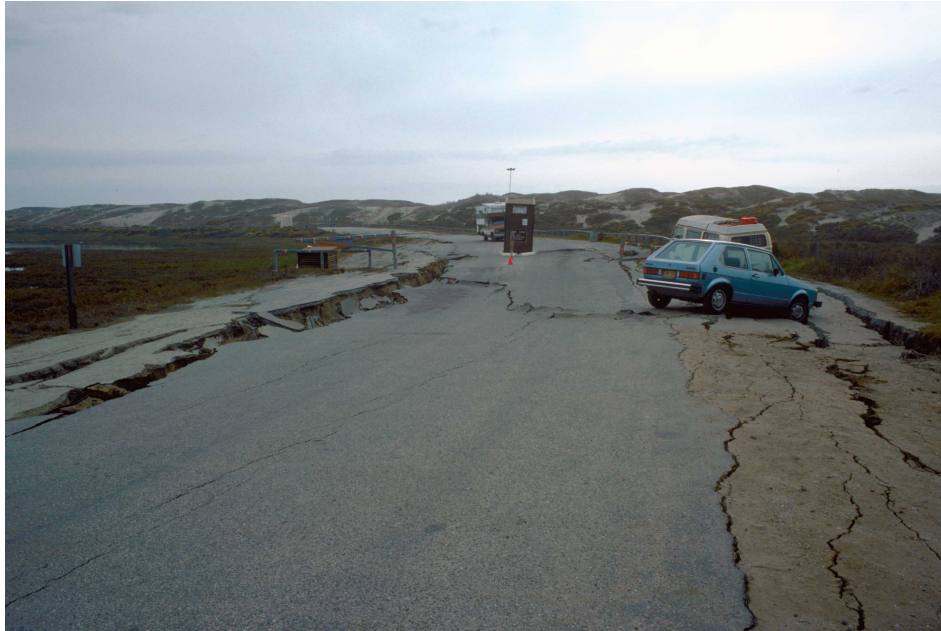
102. Differential settlement due to liquefaction caused cracking of paved road on Pauls Island. [S.D. Ellen, U.S. Geological Survey]

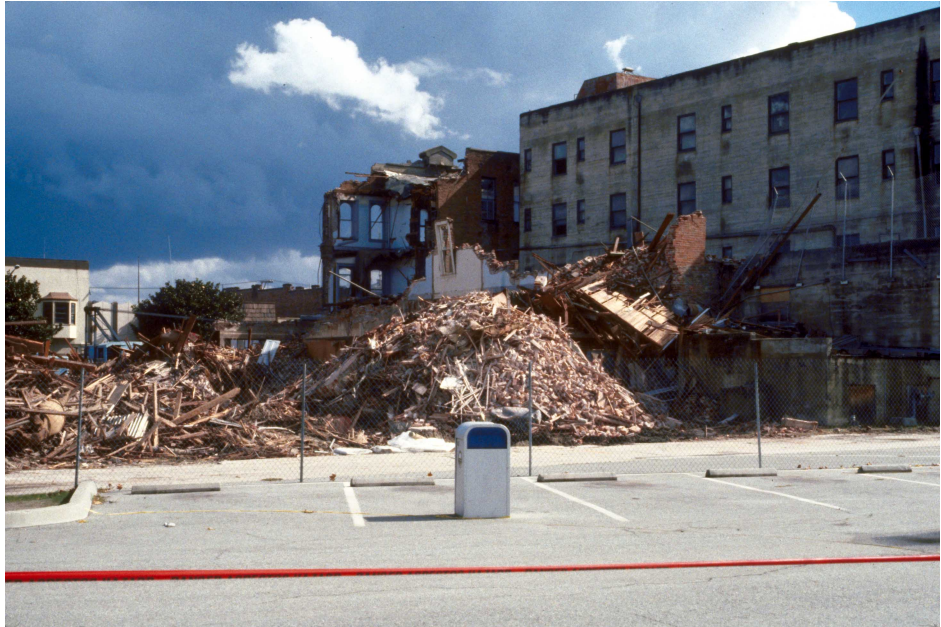
103. Partially razed earthquake-damaged unreinforced-masonry buildings in Old Town historical district, City of Salinas. [J.C. Tinsley, U.S. Geological Survey]
