Vertical Line Straightness (VLS).

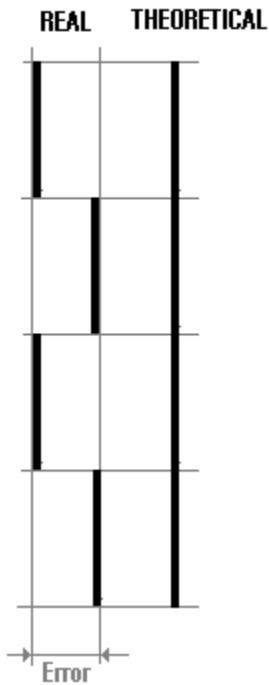
Bi-directional

The error shown below is called a bi-directional error. If you print the same plot using a unidirectional print mode, the error should not appear.

This error can occur for various reasons, including:

- Incorrect distance between nozzles and media. (Adjustment: Pen Height Test)
- Encoder-strip slots are damaged or dirty.
- Dirt on the pulley is causing the belt to slip.
- Friction between carriage bushings and slider rod.

- 1- Perform the cartridge alignment.
- 2- Replace the black cartridge.
- 3- Replace the Carriage assy.

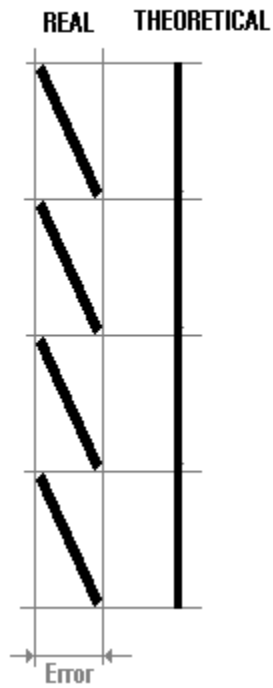
Theta-Zeta

The errors shown below is called Theta Z error. They appear when the rows of nozzles on a cartridge are not perpendicular to the carriage axis (Y-axis).

This error can occur for various reasons, including:

- Badly seated cartridge.
- Faulty cartridge.
- Faulty carriage.

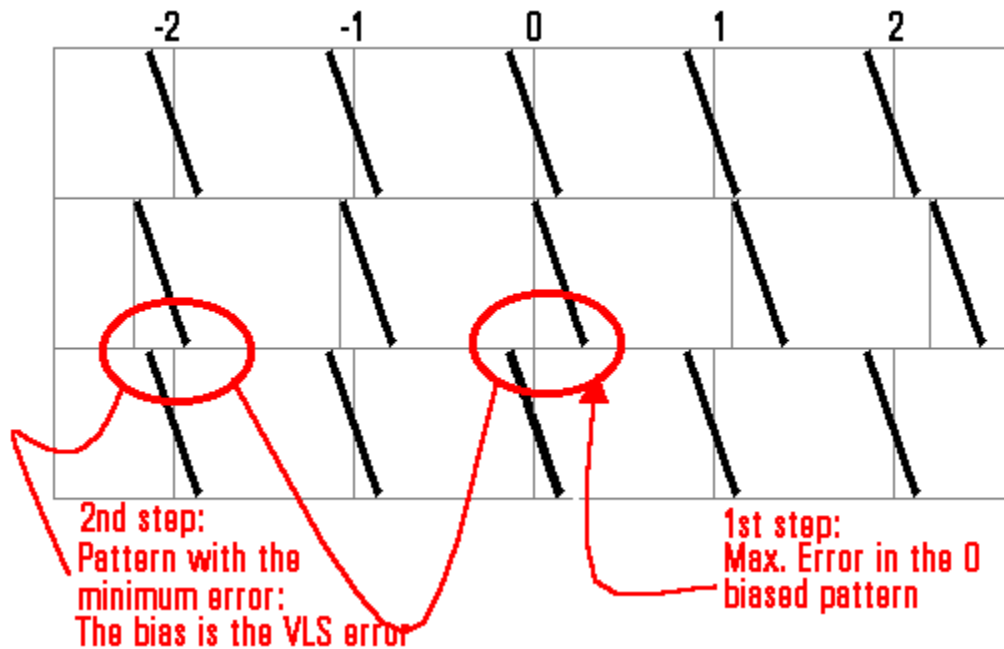
1- In the 0 biased pattern, choose the worst intersection: Between the 1st and 2nd swath or between the 2nd and 3rd swath (When printing in the unidirectional mode, the error is the same in both intersections.)

2- Choose the bias for which the error is least visible: this bias corresponds to the VLS error.
