# Technical Note TN1135

## Dealing with PCI Expansion Chassis Problems

Updated: [Aug 17 1998]

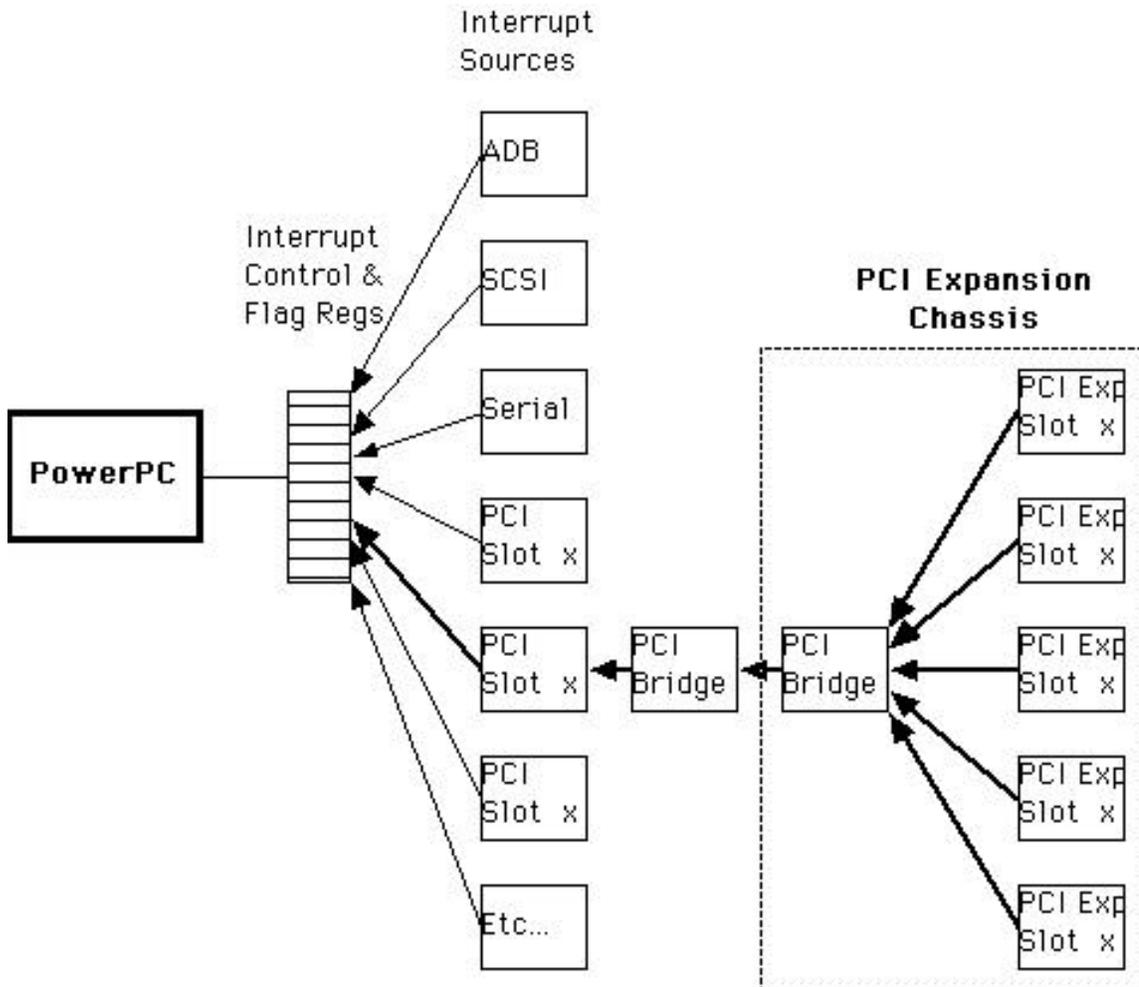
**A Conceptual View Of PowerMacintosh Interrupts**

First, additional propagation delay for the sub-bridge levels is introduced by the expansion chassis. A typical implementation is two sub-bridge levels deep, requiring extra PCI clock cycles for each level. Further delays are experienced if the cards themselves possess additional PCI sub-bridges. These delays are a combination of posting operations and actual propagation delays introduced by the hardware itself.

When cards are plugged into a host expansion slot, hardware exists in the host that provides information about which device slot is interrupting. On the other hand, all interrupts from an expansion chassis are funneled into a single interrupt slot line. This concept is known as "interrupt sharing." With interrupt sharing, the driver needs to ensure it does not depend solely on the hardware slot indicator for interrupt association. Instead, a well-behaved driver should follow the rules set forth in *Designing Cards and Drivers for Power Macintosh Computers*:

- Poll its own hardware to determine whether it is to provide service or not.
- If it is not to provide service, quickly return with `KIsrIsNotComplete`.
- If it is, service the routine then return with `KIsrIsComplete`.
