Technote Number 1135

Dealing with PCI Expansion Chassis Problems

By Gary Phillips
Apple Worldwide Developer Technical Support

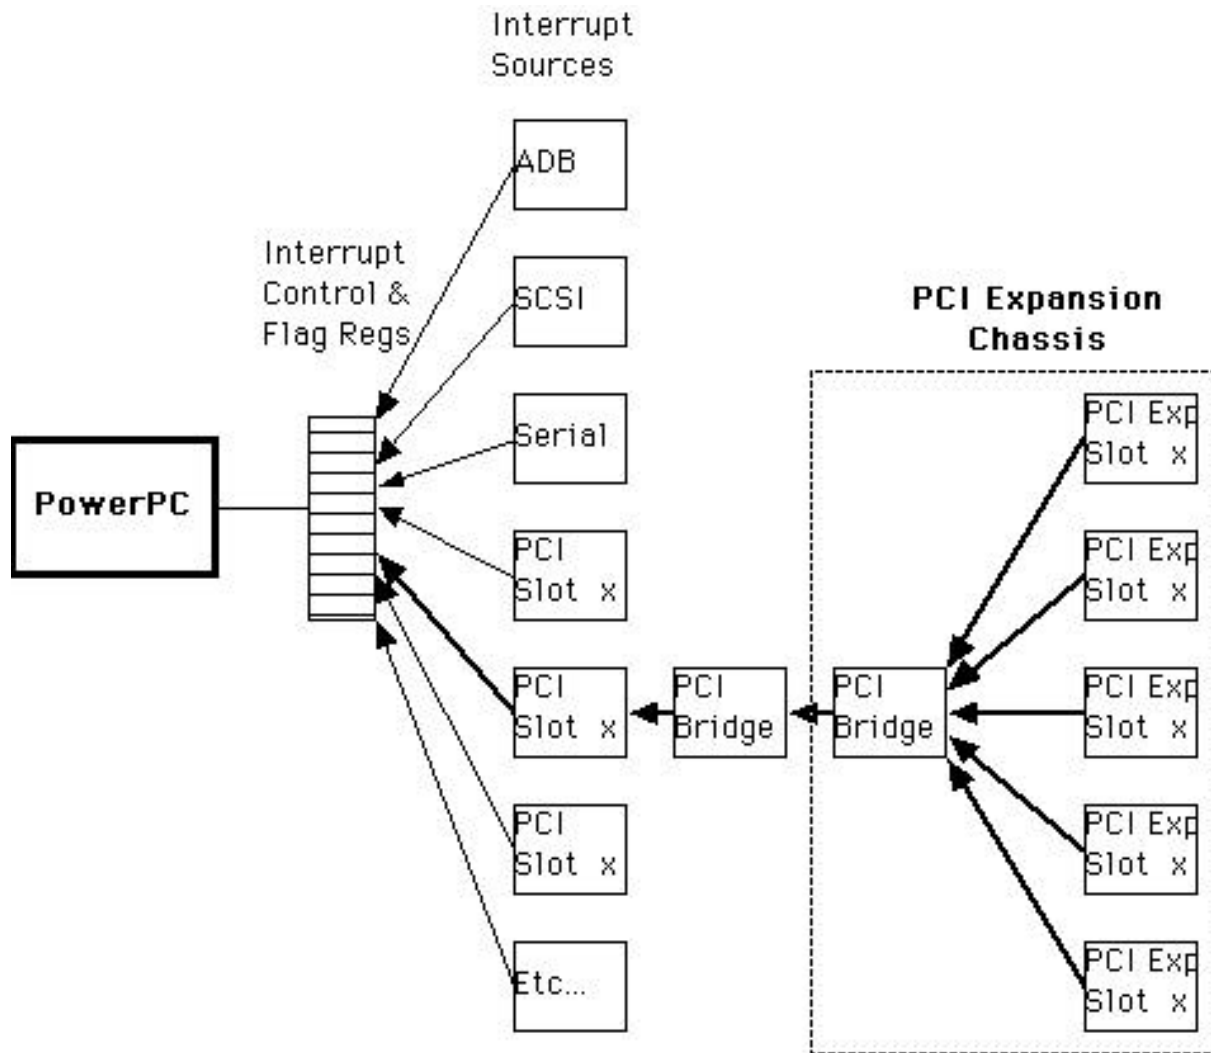
A Conceptual View Of PowerMacintosh Interrupts

First, additional propagation delay for the sub-bridge levels is introduced by the expansion chassis. A typical implementation is two sub-bridge levels deep, requiring extra PCI clock cycles for each level. Further delays are experienced if the cards themselves possess additional PCI sub-bridges. These delays are a combination of posting operations and actual propagation delays introduced by the hardware itself.

When cards are plugged into a host expansion slot, hardware exists in the host that provides information about which device slot is interrupting. On the other hand, all interrupts from an expansion chassis are funneled into a single interrupt slot line. This concept is known as "interrupt sharing." With interrupt sharing, the driver needs to ensure it does not depend solely on the hardware slot indicator for interrupt

association. Instead, a well-behaved driver should follow the rules set forth in *Designing Cards and Drivers for Power Macintosh Computers*:

- Poll its own hardware to determine whether it is to provide service or not.
- If it is not to provide service, quickly return with `KIsrIsNotComplete`.
- If it is, service the routine then return with `KIsrIsComplete`.
