Secondary Deformation Within the Huckleberry Ridge Tuff and Subjacent Pliocene Units Near the Teton Dam: Road Log to the Regional Geology of the Eastern Margin of the Snake River Plain, Idaho

The included road log emphasizes this secondary deformation and its impact on the Teton Dam. Also covered is the regional geology of the eastern margin of the Snake River Plain, Island Park, and the Teton and Big Hole Ranges.

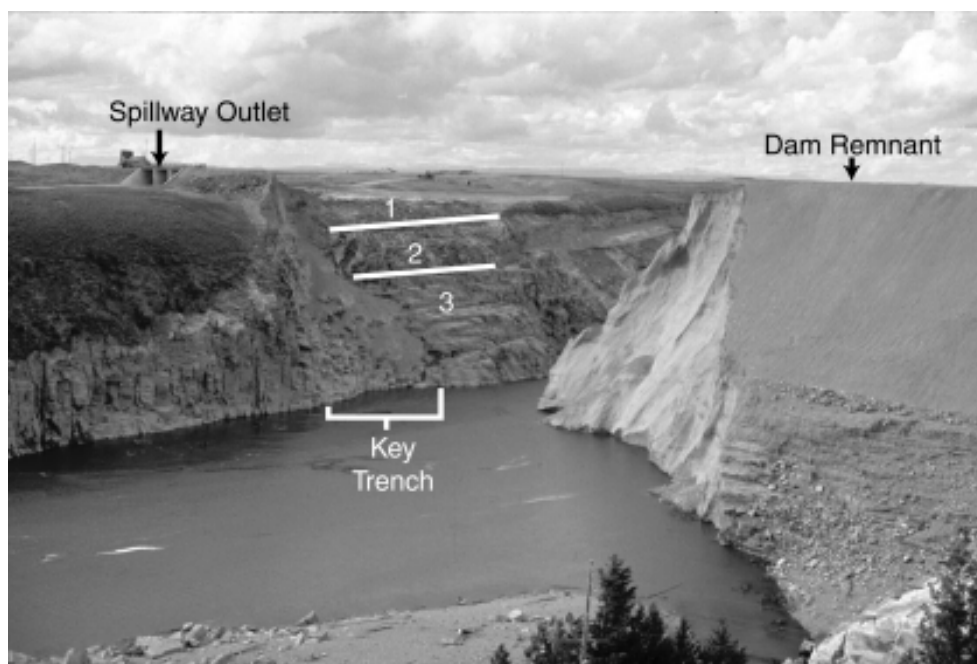
Figure 2. Teton Dam site showing the remnant of northwest end of the dam and joint patterns in Huckleberry Ridge Tuff in the key trench area as defined by Prostka (1978). Zone 1 contains numerous low-angle platy joints and vertical cooling joints; zone 2 is blocky with widely spaced moderately to steeply dipping (30° to 60°) joints and some low-angle joints; and zone 3 is blocky and massive with near-vertical and low-angle joints.

ure studies (Fig. 2) (Prostka, 1977). The boundary between zones 2 and 3 appears to be a significant detachment consisting of an open breccia zone which separates dipping foliation above from horizontal foliation below. The south side of the dam was excavated during post-failure studies to gain additional insight into the causes. The excavated wall exposes the internal structure of the dam.

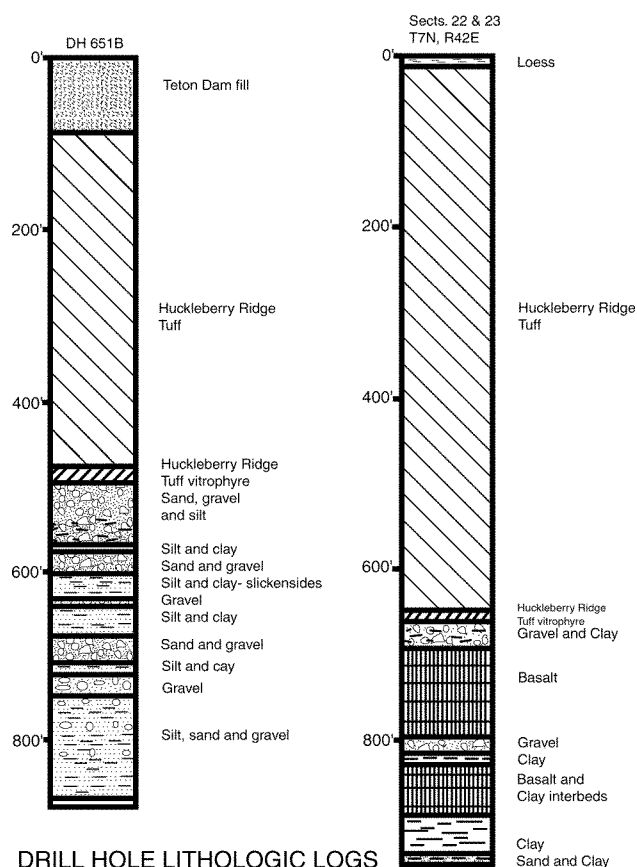
DRILL HOLE LITHOLOGIC LOGS

Figure 3. Stratigraphic sections taken from drill holes in the vicinity of the Teton Dam. DH651B is located 60m north of the spillway. The data for the other section comes from two wells drilled 5 km east of the dam near the south rim of the canyon.

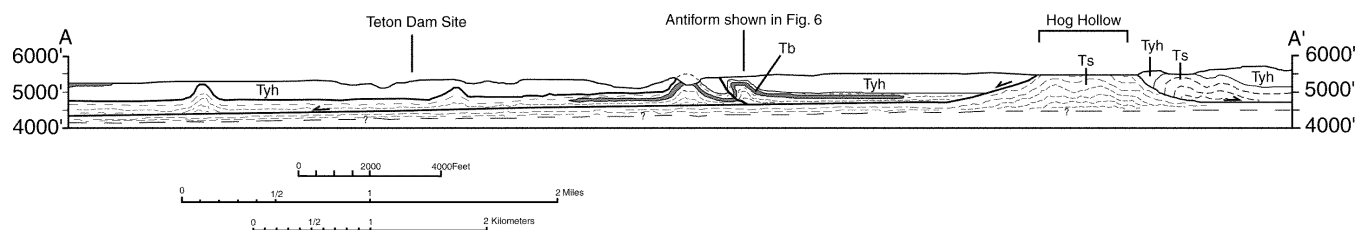
Figure 5. Structure section A-A' from Fig. 8, showing antiforms in the Huckleberry Ridge Tuff (Tyh), pre-Tyh sediments (Ts), and basalts (Tb) in the Teton Canyon area. The large-scale Hog Hollow load-and-pull-apart structure is also shown. A hypothetical detachment surface within the pre-Tyh sediments is the approximate stratigraphic level to which the "rootless faults" penetrate and the plane upon which movement occurred away from Hog Hollow.

The best exposures of these fold-like features are seen in Teton Canyon where large-scale, open antiforms were dissected by the river (Fig. 5). Several of these antiforms have amplitudes of ~100 m and widths of ~200m. The style of deformation ranges from broad open symmetrical antiforms to asymmetrical or even overturned structures (Figs. 6). Although antiforms are abundant in the area, there is a conspicuous absence of synforms. Generally the foliation within the Tyh grades laterally from essentially horizontal into arch or dome-shaped structures. Another unusual characteristic of these antiforms is that the tuff thins over the crests, in many cases leaving only a vitrophyric zone <10 m thick. The result is that the top of the tuff along the canyon rim is essentially flat, with the base of the unit rising and falling to produce the structures (Fig. 5).

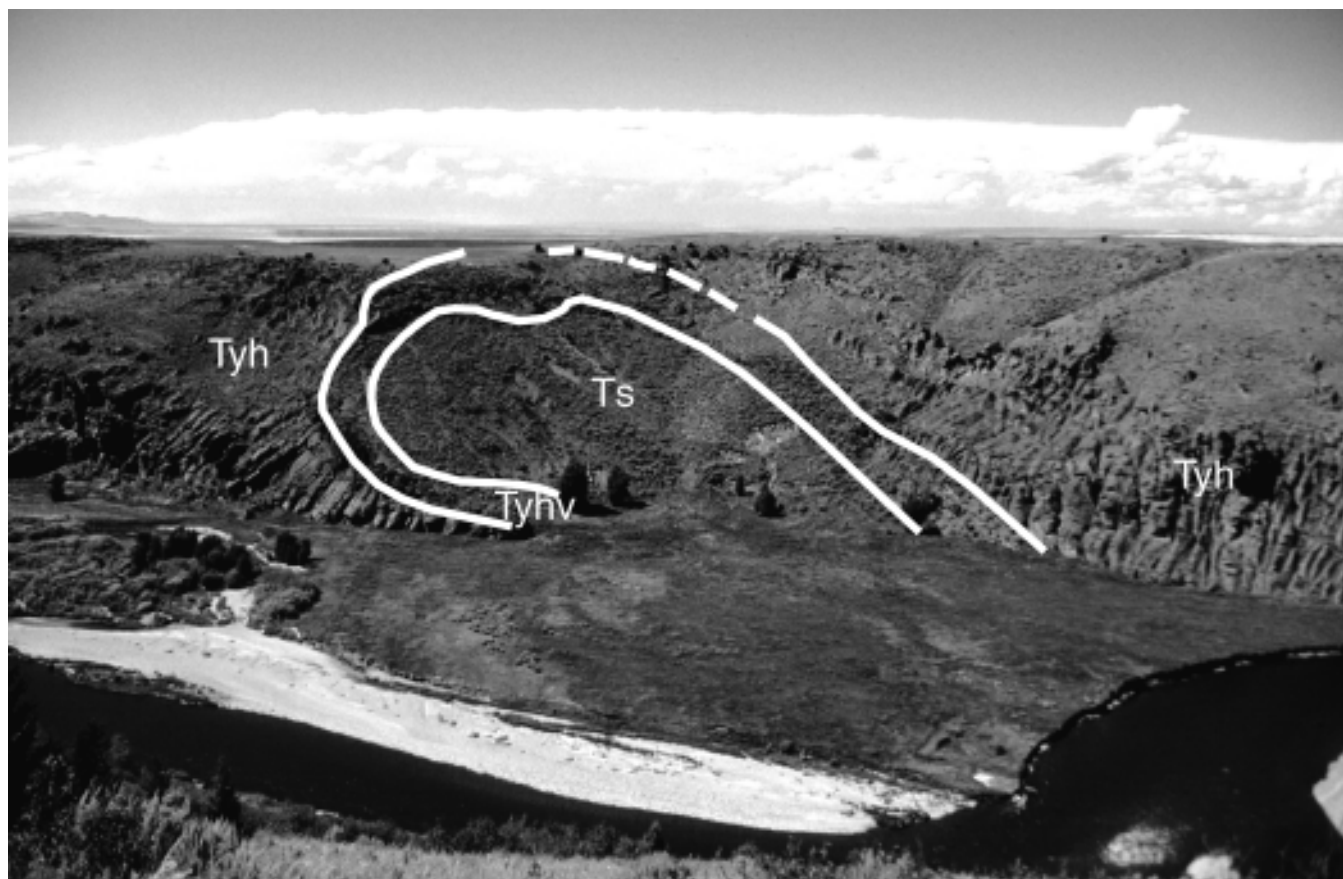
Figure 6. Large overturned antiform within the Huckleberry Ridge Tuff (Tyh) and underlying units, exposed on the north side of Teton Canyon 2.5 km upstream from the dam. Note overturned vitrophyre (Tyhv) at the base of the south (left) limb, and thinning of the tuff at the crest of the antiform. Pliocene sediments (Ts) and basalts are exposed in the core of the fold.

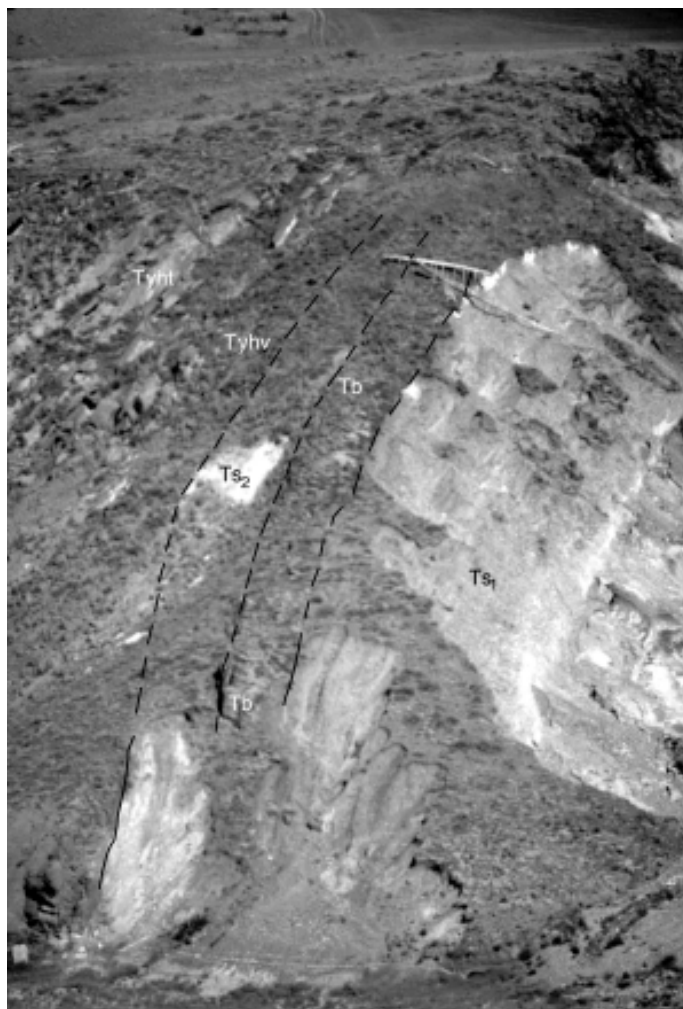
Figure 7. Pliocene gravels (Ts_1), basalt (Tb), and tuffaceous sediments (Ts_2) exposed in the core of an antiform beneath the Huckleberry Ridge Tuff vitrophyre (Ty_{hv}) and devitrified zone (Ty_{ht}). This antiform is located 2 km upstream from the dam on the north side of the canyon. Note fallen fir trees at top of Tb for scale.

Although the Huckleberry Ridge Tuff is the main unit in which this deformation is seen, several of the large-amplitude antiforms have exposed pre-Tyh units in their cores. These units, including sediments and basalts, are nearly vertical in some of the Teton Canyon antiforms (Fig. 7).

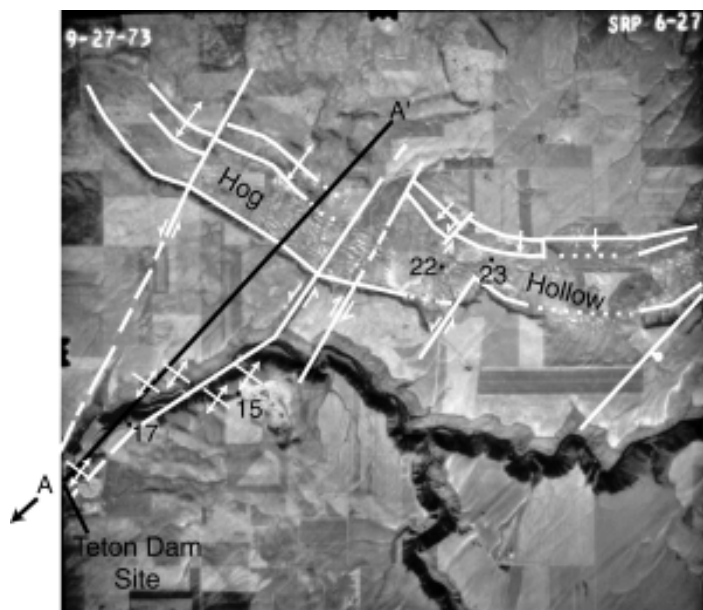
Figure 8. Aerial photo of the Hog Hollow and Teton Canyon area. Boundary faults, "rootless lateral faults", and major monoclinical and antiformal structures associated with Hog Hollow are delineated. Numbered dots indicate locations of field trip stops.

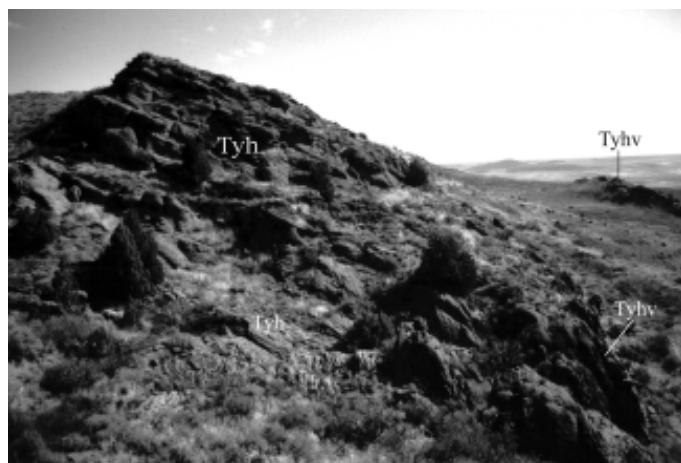
Figure 9. Monoclinical flexure on the north rim of Hog Hollow, as defined by a change in the attitudes of foliation in the Huckleberry Ridge Tuff (Ty_h). Foliation at the hilltop dips 20° to the south (right). Dips in the lower right corner of the photo are 80° south. The rocks at the extreme right edge of the exposure are vitrophyric (Ty_{hv}). Junipers are 3-4 m high for scale.

The vitrophyre exposures at the margins of Hog Hollow are consistent with the pull-apart hypothesis. These vitrophyres may be large-scale analogies of the vitrophyric zones found on joint surfaces that were pulled apart in the upper portion of the Huckleberry Ridge Tuff. If Hog Hollow is the result of large-scale extension, contemporaneous with cooling and secondary movement as seen elsewhere in the ignimbrite sheet, the exposed tuff at the edges of the open basin would have lost heat more quickly than the adjacent tuff away from the edges and would not have been devitrified. The extension of a semi-plastic partly cooled ignimbrite would also explain the foliation attitudes observed in the apparent monoclinical flexure along the north rim of Hog Hollow. As extension occurred the tuff was pinched off, thinning the unit at the edges, and producing dips toward the center of the basin (Figs. 9 & 18).

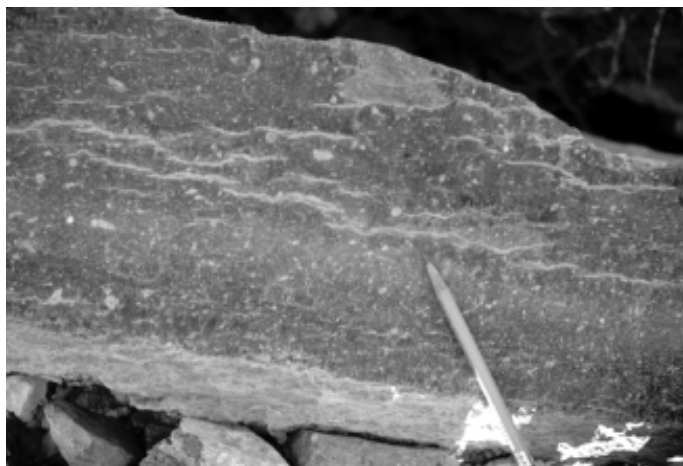
Figure 10. En échelon tension fractures in devitrified Huckleberry Ridge Tuff in Zone 2, near the bottom of the concrete boat-ramp just east of the Teton Dam. These fractures were filled with vapor phase crystals during subsequent cooling of the tuff. Most of these fractures dip gently to the northeast (left) in this area, indicating that the lower part of the unit moved to the southwest.

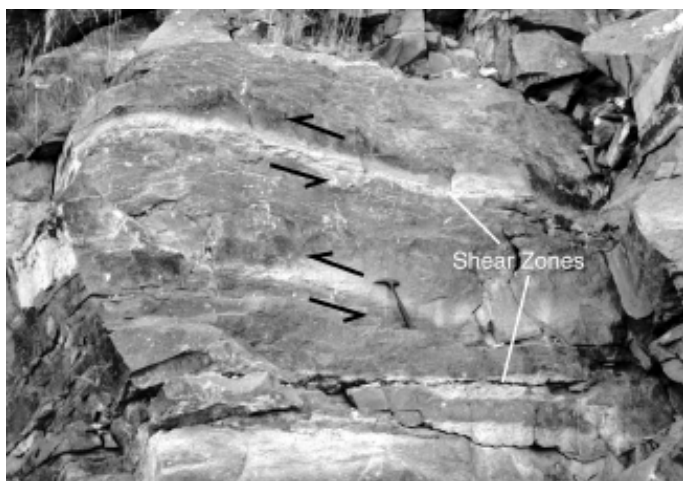
Figure 11. Vapor-phase filled en échelon extensional fractures in massive gray tuff, separated by white vapor phase filled and open shear zones. From the same location as Figure 10. Arrows indicate relative motion, see Fig 14.

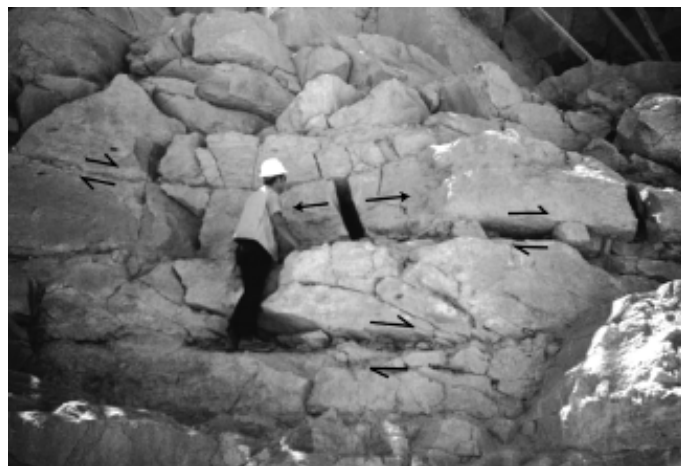
Figure 12. Open vertical to steeply-dipping cooling fractures offset by horizontal shear zones in the north key trench Zone 2. Both sets of open joints allowed piping of water from the reservoir, which eroded the core of the dam and caused its failure. Arrows indicate relative motion along shear zones, see Figure 14.

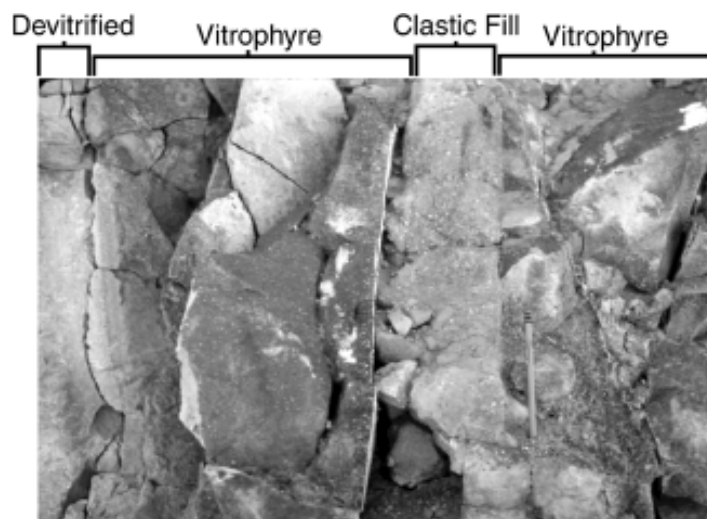
Figure 13. Section view of lateral zonation in devitrification adjacent to an open joint filled with reworked ash from above. This and several other similar joints are located near the top of the boat ramp.

The upper end of the cut exposes the zone where the tuff contains both open and sediment filled cooling joints (Fig. 13). Note the lateral gradation in welding and devitrification along the margins of these joints. Near the bottom of the concrete ramp the tuff contains numerous subhorizontal shear zones and en échelon extension fractures which have been filled with vapor phase deposits (Figs. 10 & 11). See the section on "Structural and Lithologic Zonation Within the Huckleberry Ridge Tuff" at the beginning of this paper.

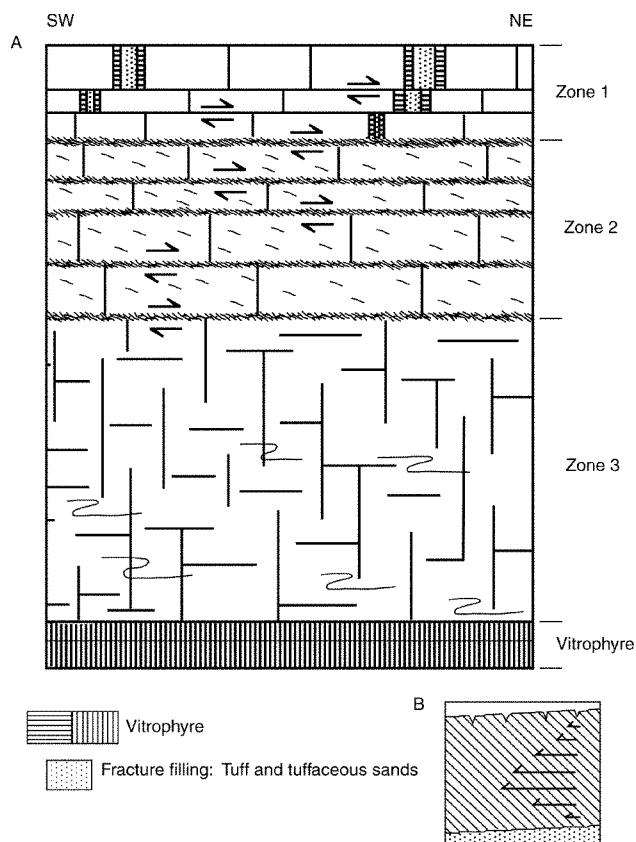
Figure 14. Schematic cross section of the Huckleberry Ridge Tuff in the Teton Canyon area. Secondary flow within the sheet is expressed by different behavior at different levels within the unit. The lower part of the unit, Zone 3, deformed by viscous flow and contains small-scale recumbent isoclinal folds. Zone 2 was dominated by shear and contains numerous brecciated, subhorizontal shear zones (Figs. 11 and 14) with relative movement indicated by the arrows. This zone also contains numerous tension fractures which dip northeast at low angles (Fig. 10). Zone 1 was cool and brittle; columnar joints in this zone were pulled apart and filled with ash and sediments from above (Figs. 12 and 13). Secondary flowage was probably to the southwest since the lower, hotter part of the unit was more mobile and flowed southwest while the upper layers lagged behind. Figure 14B is a schematic section with vectors showing hypothetical relative rates of flow within the unit.

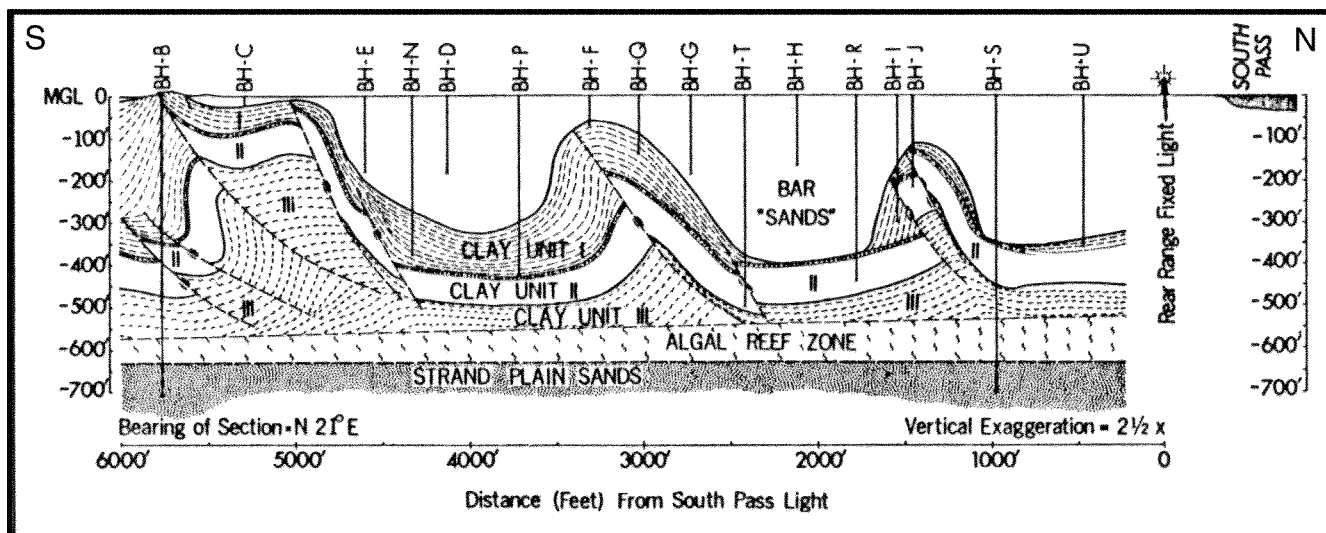
Figure 15. Cross section of large-scale load structure in Mississippi delta sediments (from Morgan, et al, 1965). Prodelta clay and shelf deposits intrude into and flow southward from beneath prograding delta "sands". Diapiric structures with 150m amplitudes formed in <100 years. The folds produced here are geometrically and genetically similar to those seen in Teton Canyon and the surrounding areas.

Something similar to the above-described process has been observed in the Mississippi delta area (Fig. 15) (Morgan et al., 1968) and in the Panama Gulf Coast area (Breen et al., 1988). In these areas, large mud diapirs or parallel folds form as a result of rapid deposition of delta sediment on the unconsolidated offshore muds. In the case of the Mississippi delta, the mud diapirs arch the overlying deltaic beds into anticlines as much as 350 m wide

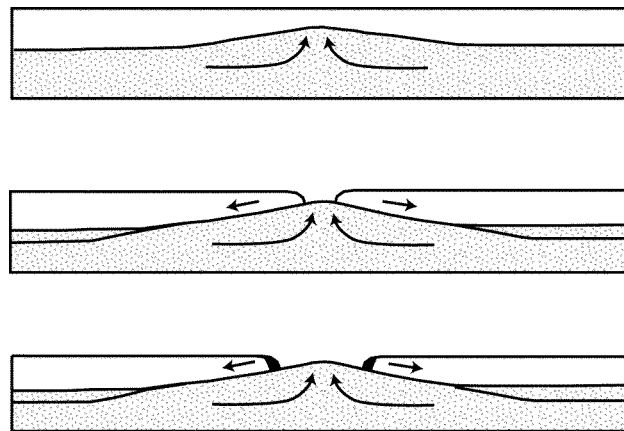
Figure 18. Stylized sketch showing the development of the Hog Hollow depression by diapiric uplift within the Tertiary sediments (stippled) and lateral spreading of the Huckleberry Ridge Tuff (white) and sediment slab above. Note the thinning and sagging of the trailing edge of the tuff due to the fact that the unit's interior was still hot and mobile. This produced the monoclinical feature on the north rim. Also, note the near vertical vitrophyre zones (dark shaded) at the trailing edge. This vitrophyre resulted from heat loss before devitrification.

Hollow may have resulted from the formation of a diapiric load structure and lateral spreading off the high (Figs. 5 & 18).

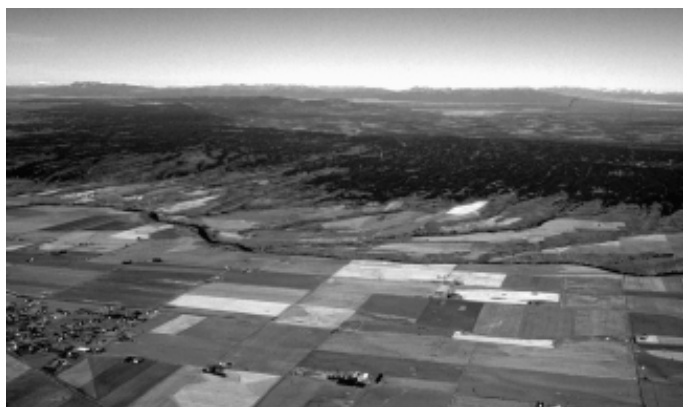
Figure 19. Oblique aerial photograph on the Big Bend Ridge caldera rim and Island Park basin beyond. Photo was taken from southeast of Ashton looking northwest.

of the oldest or first-cycle caldera (Fig. 19), which collapsed during the eruption of the 2.0-Ma Huckleberry Ridge Tuff. The Huckleberry Ridge Tuff covers an area of >15,000 km² (5,800 mi²), and has a volume of >2,450 km³ (588 mi³) (Christiansen, 1982), which is ~2500 times larger than the volume of the ash produced by the 1980 Mount St. Helens eruption.

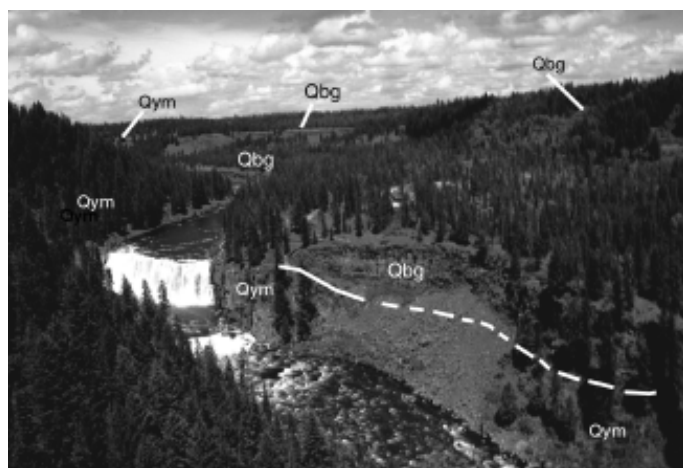
Figure 20. Upper Mesa Falls viewed from downstream on the west canyon rim. Note the paleocanyon fill of Gerrit Basalt (Qbg) cut into the Mesa Falls Tuff (Qym) and the terrace on that basalt, extending upstream on the east side of the canyon.

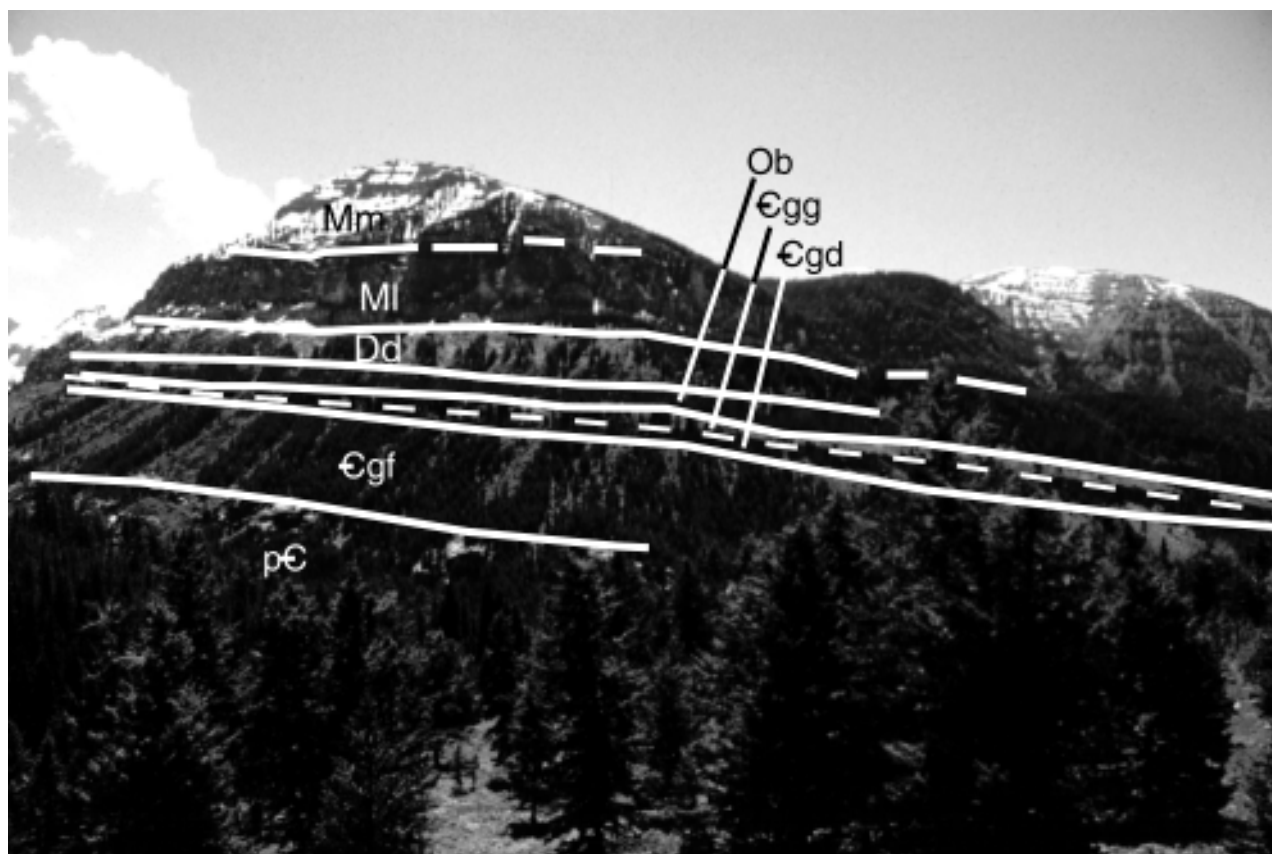
Figure 21. View of the west side of Teton Canyon, Wyoming showing stratigraphic units. At the base are Precambrian granitic and metamorphic rocks (pE) overlain by Cambrian Flathead Sandstone and Wolsey Shale members of the Gros Ventre Formation (Egf), Death Canyon Limestone member of the Gros Ventre Formation (Egd), Gallatin Limestone (Egg), Ordovician Big Horn Dolomite (Ob), Devonian Darby Formation (Dd), Mississippian Lodgepole Limestone (MI) and Mission Canyon Limestone (Mm).

The view on the opposite side of Teton Canyon shows rounded exposures of Precambrian rocks at the base of the section (Fig. 21). The major Precambrian-Cambrian unconformity occurs just above those outcrops. It is covered by vegetation. A hiatus of approximately 2 billion years is represented by that unconformity. The lower Paleozoic units that overlie the Precambrian rocks represent a transgressive sequence of sandstone, shale and limestone deposited as the Sauk Sea inundated the land approximately 500 million years ago. The middle Cambrian Flathead Sandstone (60 m), Gros Ventre Formation (300 m), and Gallatin Limestone (70 m) were laid down at that time. A regressive unit, the Ordovician Big Horn Dolomite forms the lower major cliff about half way up the canyon wall. This was deposited as the sea shallowed. No Silurian units are present in this region, indicating a disconformity between the Big Horn Dolomite and the overlying Devonian Darby Formation (150 m). The Darby Formation consists of thin marine dolomite and limestone units and forms the slope above the Big Horn Dolomite. The next major cliff-former is the Mississippian Lodgepole Limestone (135 m) which was deposited as the sea covered the land again. It contains abundant shallow water brachiopods, bryozoans, crinoids, and corals in limestone beds. Occasional trilobite remains have been found. The alternating limestone and siltstone beds at the top of most of the peaks comprise the Mission Canyon Limestone (300 m). It is usu-

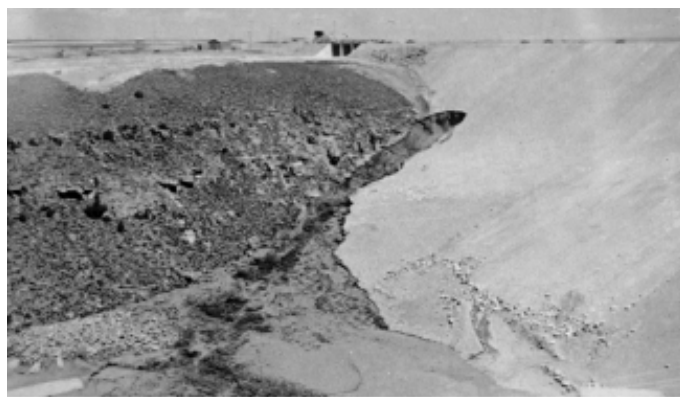
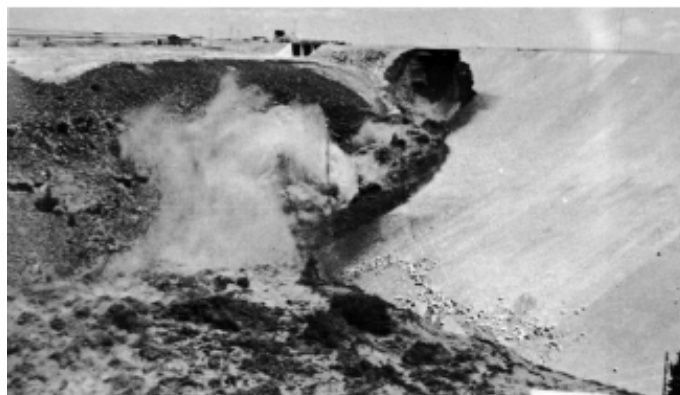
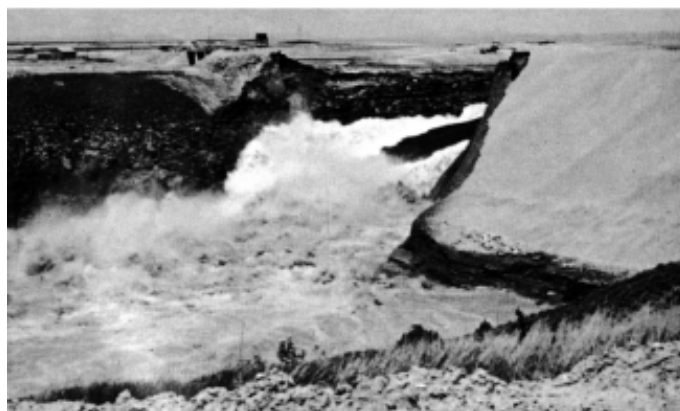
Figure 22. Sequence of photos taken during the failure of the 90 m high Teton Dam. These three photos were taken at 11:20 a.m., 11:50 a.m., and the early afternoon of June 5, 1976 (from Chadwick, 1976). Over a period of hours, piping through joints in the key trench area eroded the core material from within, undermining the north side of the dam.

The failure has been attributed to both geologic and engineering factors. The geologic factors responsible for the dam failure were: 1) Abundant open fractures in the wall rocks which allowed rapid access of water to the core of the dam during reservoir filling. 2) The material used for the impervious core was loess derived clayey silt, which was more brittle and erodible than pure clay which is usually used for such purposes. Clay is not locally available but loess is. The water flowing through the fractures eroded away the core materials in the key trench area, and even-

tually undermined the dam (Fig. 22). Hydraulic fracturing of the core materials may have aided the erosion process. Although a concerted effort was made to develop a grout curtain during construction, the open nature of the fractures and their abundance precluded the formation of an effective seal.

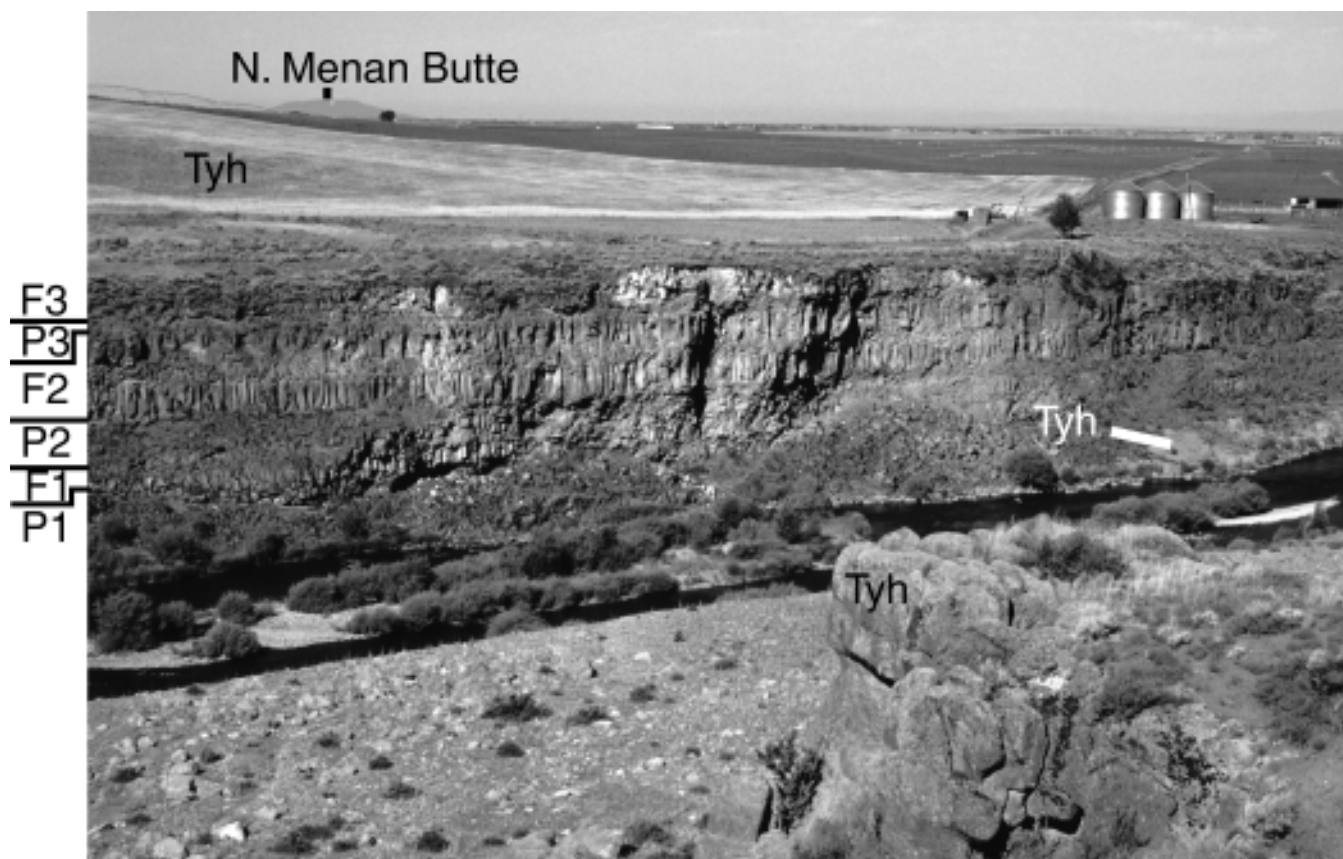
Figure 24. Three basalt flows (F1-F3) on the south side of Teton Canyon near its mouth, 2 km downstream from the Teton Dam site. Each flow has a pillow zone at its base (P1-P3). The flows came from the south, flowed around the light-colored hill of Huckleberry Ridge Tuff (Thy) in the middle distance and into a paleocanyon cut into the Huckleberry Ridge Tuff. North Menan Butte in the distance is a phreatomagmatic tuff cone.
