## **Mill Canyon Mine (Wooley Valley Unit #4)**

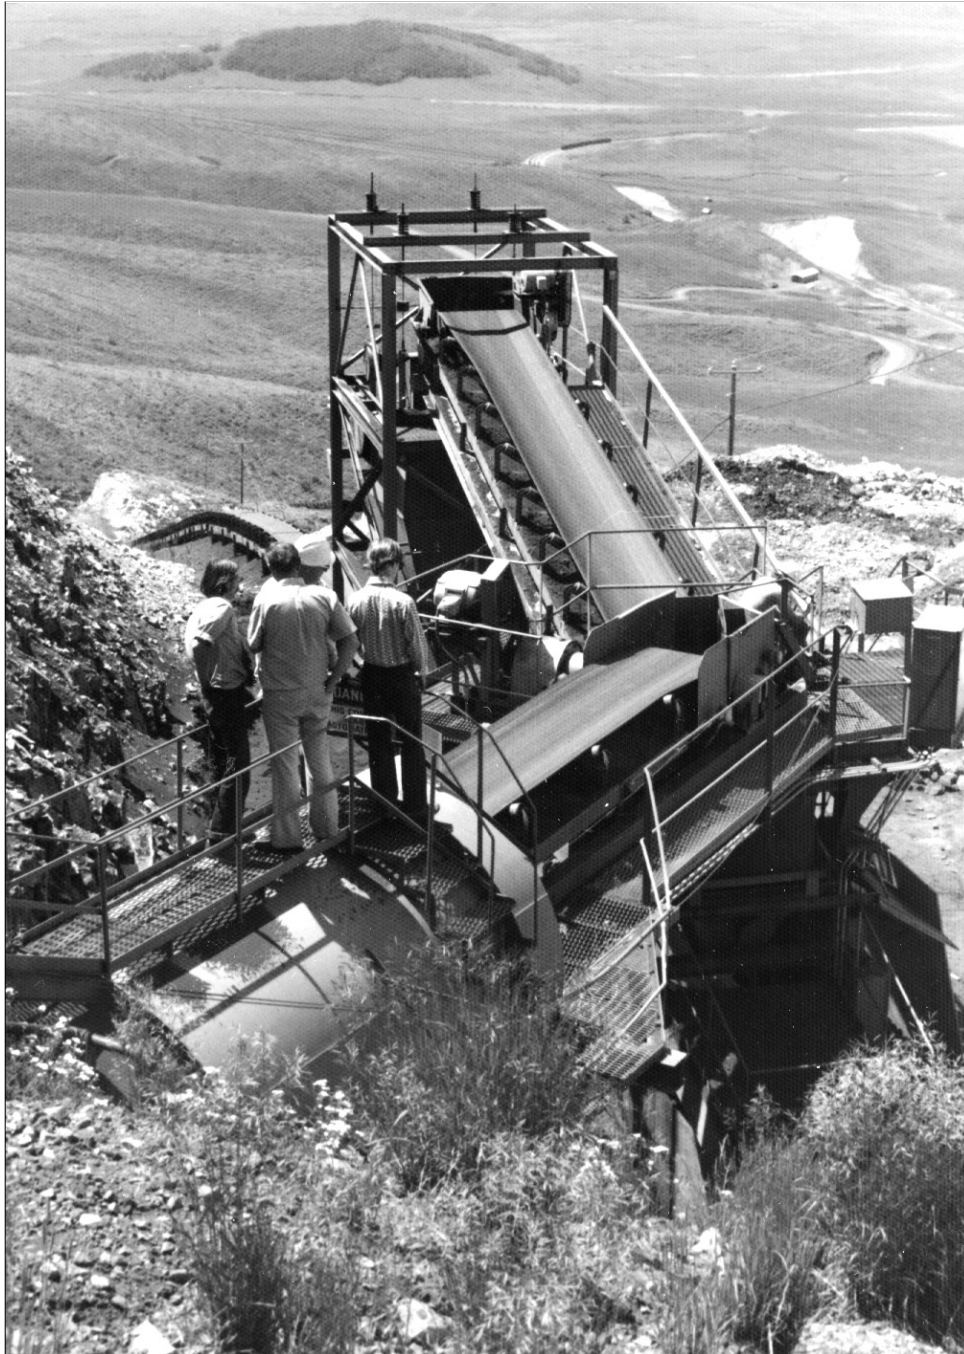
Figure 145. Ore conveyor belt, Mill Canyon Mine, July 30, 1975. BLM file photo.

Along with the advent of mining in 1969, the year also saw the construction of a conveyor belt from the mine area to the railhead (Figure 145). The belt was 30 inches wide and aligned in two segments down the hillside for a total distance of about 4,200 feet, an elevation drop of about 700 feet. Ore was fed from the stockpile area at the mine by a short 36-inch wide belt into a hopper over the tail piece of the long belt (see Figure 145). A surge bin was located at the lower end of the long belt from which the railroad cars were loaded from another 48-inch wide elevated belt. The whole conveyor system was rated at about 600 tons per hour. Scrapers brought the ore to the stockpile and bulldozers were used to load material onto the conveyor belt feeder assembly.

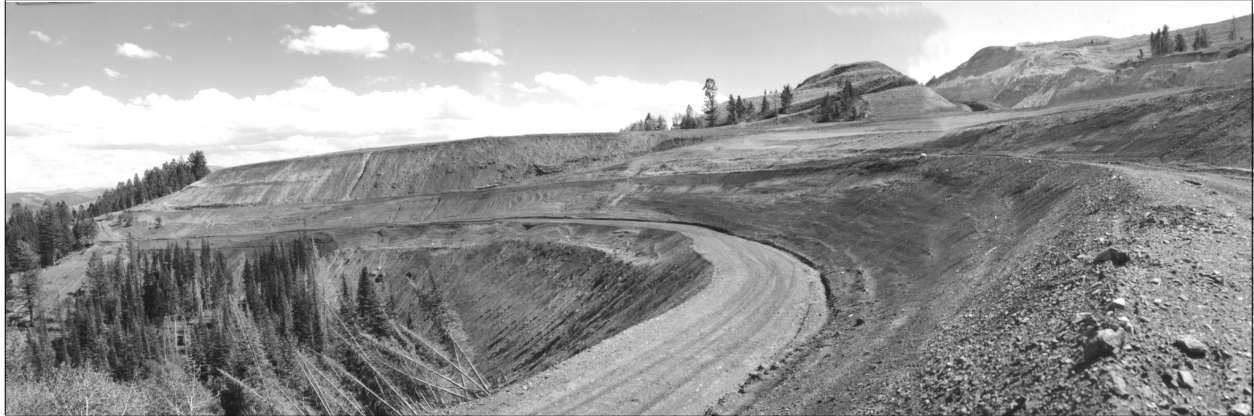
Figure 146. Dump No. 4, Mill Canyon Mine, September 7, 1973. BLM file photo.

of waste, ice, snow, frozen ore and frozen mud on the crest of Dump #4, raising the elevation of the dump by about 15 feet. This material was later pushed over the side of the dump. Toward the last part of June, 1972, the material thawed and ran down the face of the dump and into the wooded area below. Silt overfilled the retention ponds and spilled over and went into Angus Creek. There were mudflows coming from the dump that were approximately 600 feet long by 70 feet wide and three feet

deep. This dump failure caused a great amount of anxiety on the part of the mine operator, the mine owner and government officials. A large effort was made to restabilize the dump by removing about 20 feet from the top of the dump and all of the loose material on the face of the dump. Benches were cut into the face and total reshaping and reseeded of the dump was done, and by 1973, the work resulted in stabilizing Dump #4 from any further failures (Figure 146).

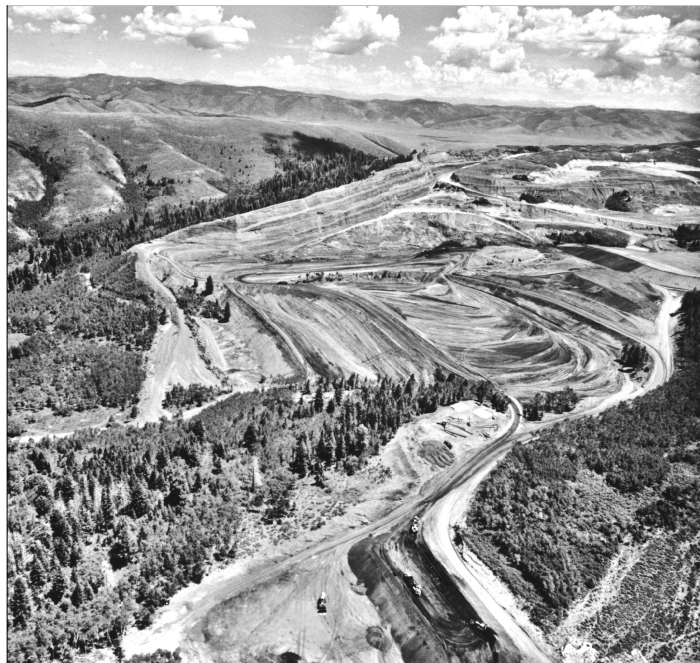
Figure 147. "The Nose" area, Mill Canyon Mine, 1975. BLM file photo.

Eventually, the Mill Canyon Mine consisted of two large pits, six waste dumps and one sub-ore pile, and approximately 2½ miles of haul and service roads (Figures 147 and 148). Surface structures

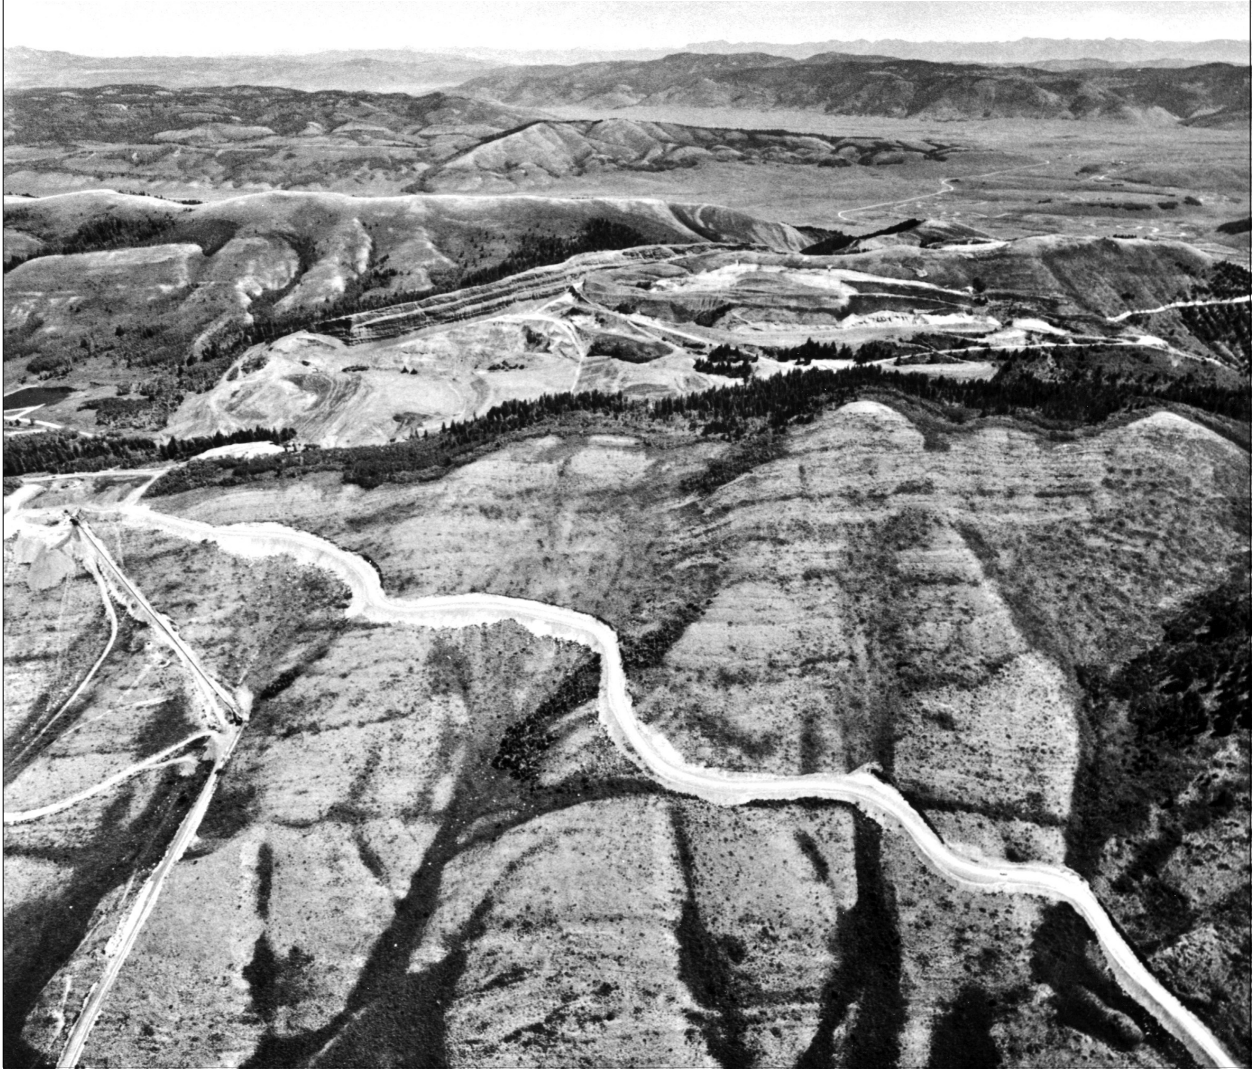
Figure 148. Mill Canyon Mine, view east, showing haul road and conveyor belt, July 18, 1984. BLM file photo.

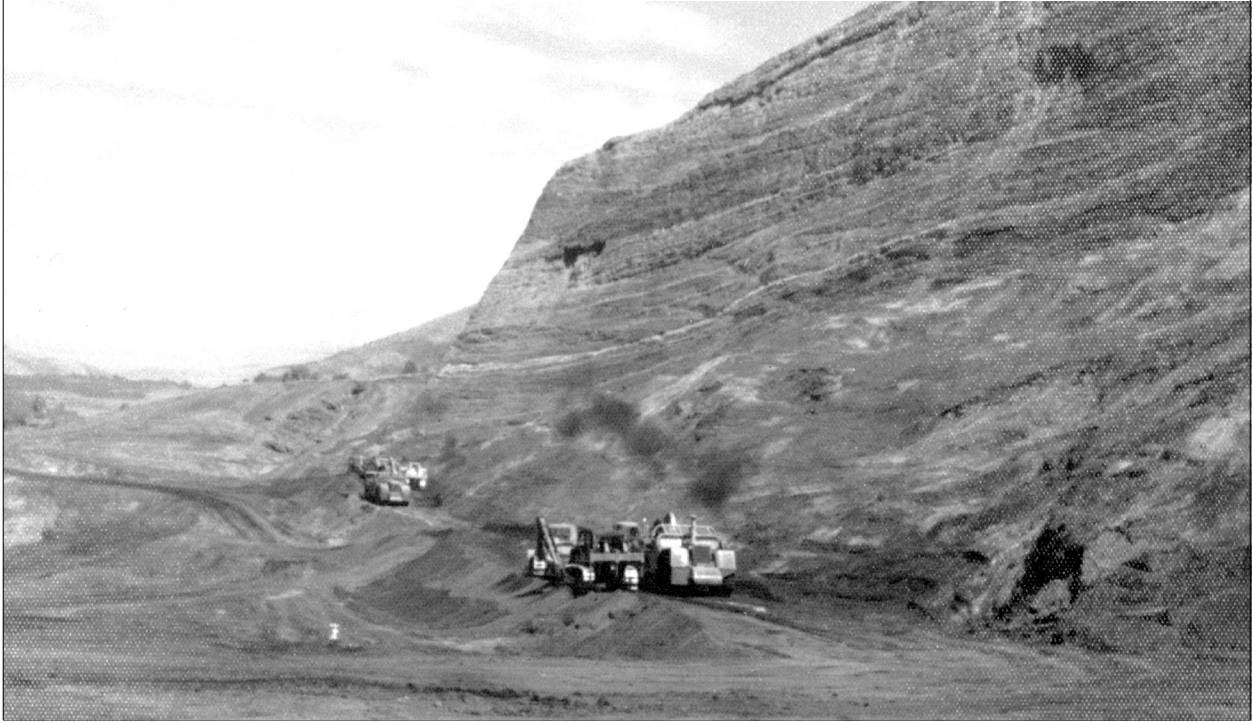
Figure 149. Mill Canyon Mine reclamation, view north, July 30, 1975. BLM file photo.

By September, 1974, all of the minable ore had been removed from the mine. Reclamation of the pit areas and the dumps was in full swing (Figure 149). Some ore remained on the east end of the lease near the Mill Canyon drainage, but it may not be economically recoverable.
