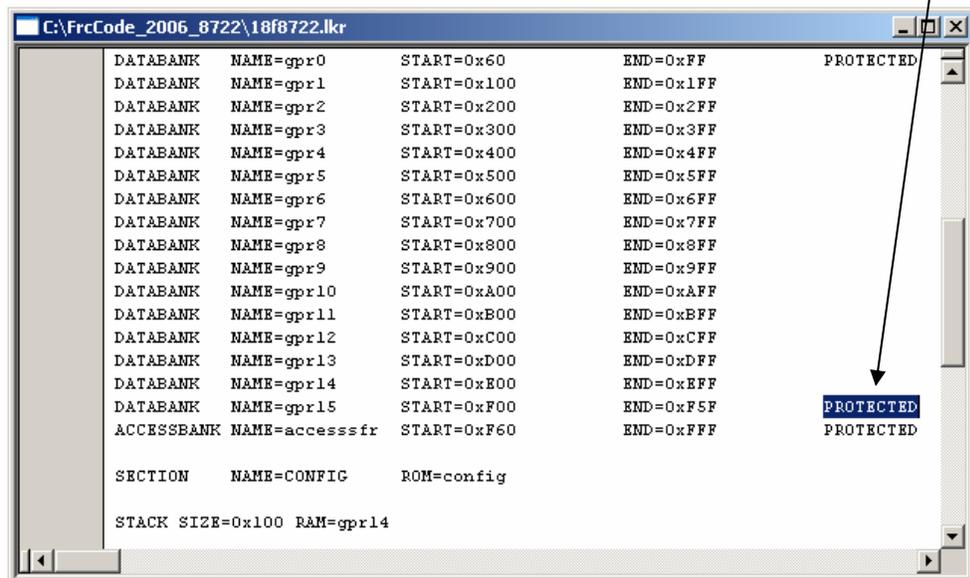
In Work: There appears to be a location on the 8722 chip that causes this problem. The following procedure is a recommended way to protect this memory area.

Double click on the 18f8722.lkr file in your project.

Add the word **PROTECTED** to the line containing gpr15.

Make sure you are using the new library file "FRC_Library_8722.lib" as well. This will fix possible data corruption issues.

After the update, do a make (F10 or CTRL+F10) then re-download your code.
