Hubble Space Telescope

(HST) Archive System

NASA Langley Research Center
Hampton, Virginia

The purpose of the Hubble Space Telescope (HST) Hardware Archive System is to make information available concerning the returned hardware from HST on-orbit servicing missions. The Introduction of this archive gives a general background about the archive while the First Servicing Mission and Post-Retrieval Analysis sections provide explicit details regarding the on-orbit servicing mission, the people who are affiliated with the post-flight investigations of the returned hardware, and a detailed disposition of the HST hardware following its returned to Earth. Images and descriptions of the HST return hardware is discussed in the Returned Hardware section. The Technical Diciplines areas address scientific research with returned hardware, while the Photographs area provides a small sampling of on-orbit HST photographs. The Workshops section lists various workshops that included topics realtedto HST Returned Hardware, and provides the opportunity to make available data and initial results which may or may not be published or reside in the public domain. Lastly, a list of related HST online sour

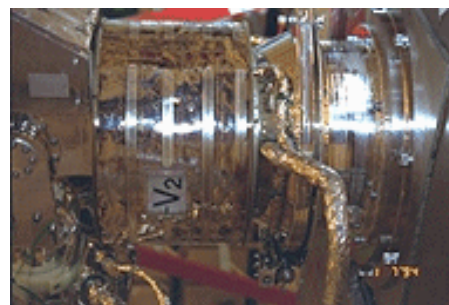
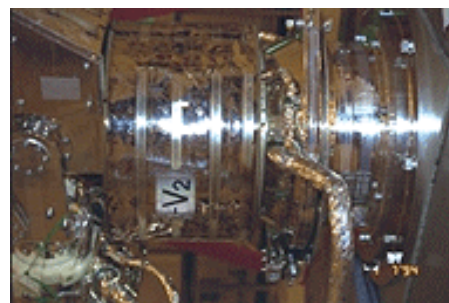
The solar arrays were replaced on-orbit due to degradation. During the repair mission, delamination of the solar array bus bars was observed and two of the hinge pins had started to creep out of the hinges. One of the arrays was returned to Earth to be studied while the second array was jettisoned into space. The returned solar array was shipped to European Space Agency.

Photographs taken during the post-flight inspection of the Solar Array

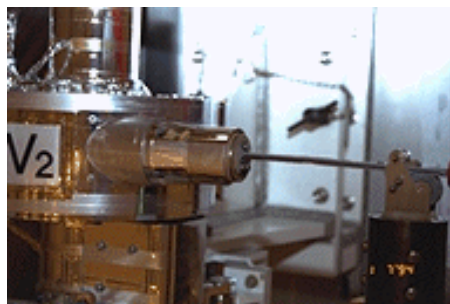
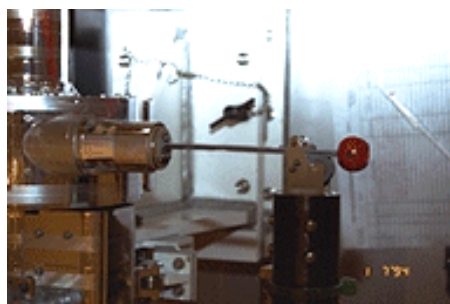
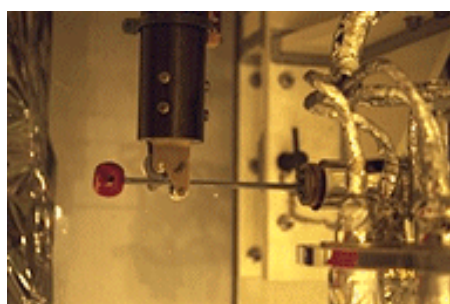
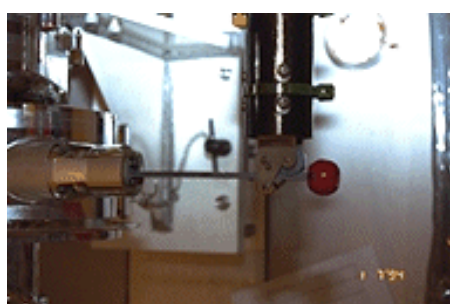
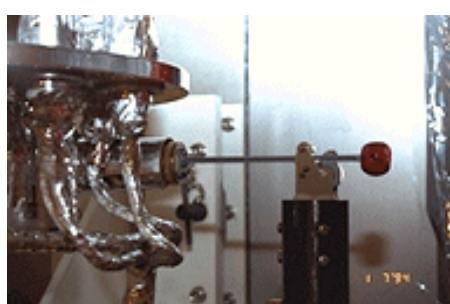
Photos of the SADM.

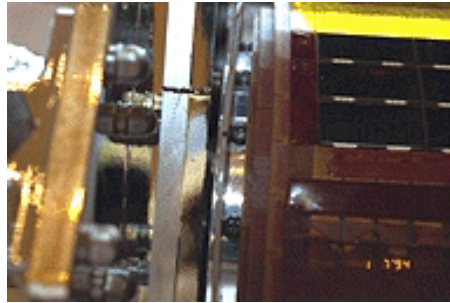
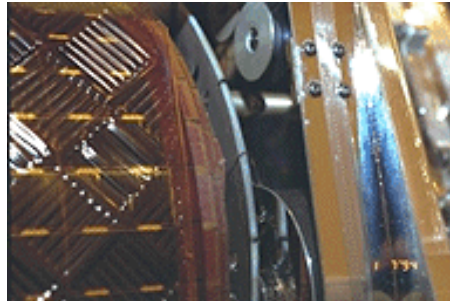
Photos of the solar array cushion and cellside.

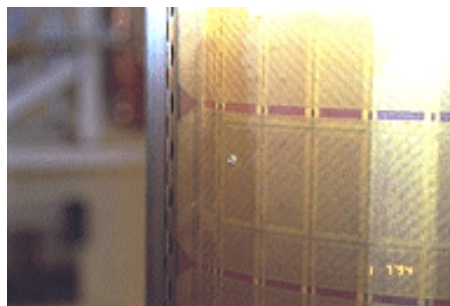
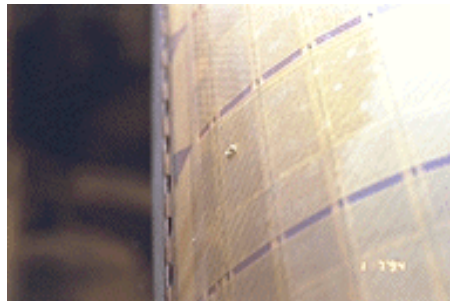
Photos of the solar array hinge pin.

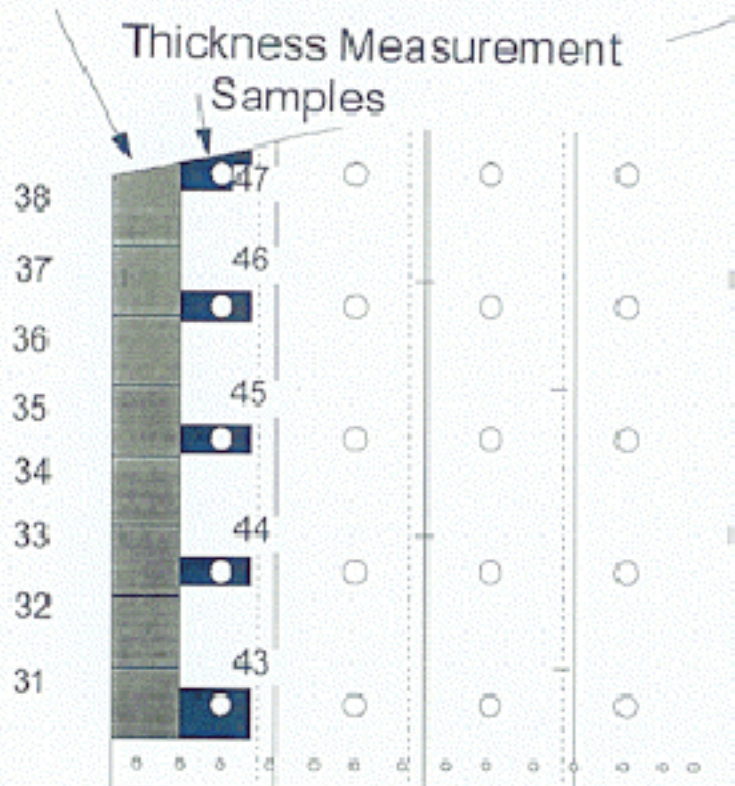
SA-I Drive Arm MLI Sample Diagram

Sample #	Cracked	Notes
31, 32, 33	Yes	High solar exposure
34	Yes	Bottom half of sample cracked, top half of sample likely covered with cable bundle
35, 36	No	Likely covered with cable bundle
37, 38	No	Lower solar exposure

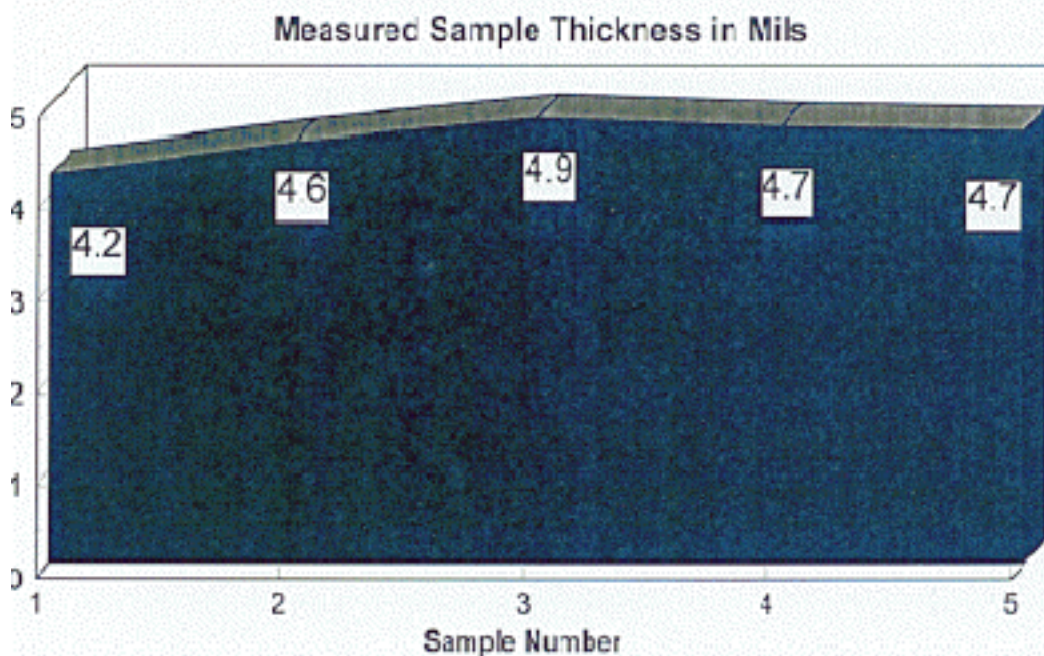
SA-I Drive Arm MLI Thickness Measurements

Non-Exposed Sample Thickness Measured to be 5.1 mils

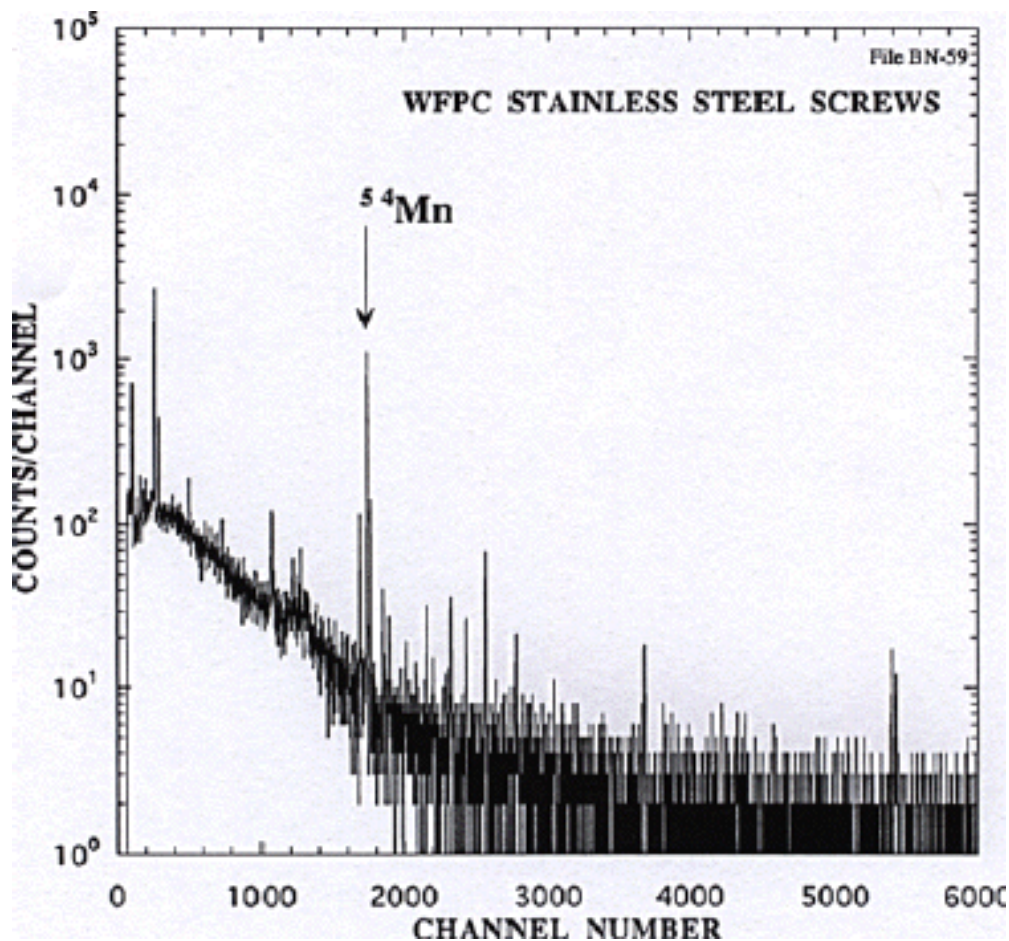
The screws contained measurable amounts of the radionuclides Sc-46, Mn-54, Co-56, Co-57, Co-58, Co-60, determined in a one-week count time with the MERLIN system at Oroville. A plot of (almost) the entire spectrum is shown on Figure 1. The peaks of interest, as well as the BKG peaks, appear as narrow vertical lines rising from a slowly descending smooth continuum.

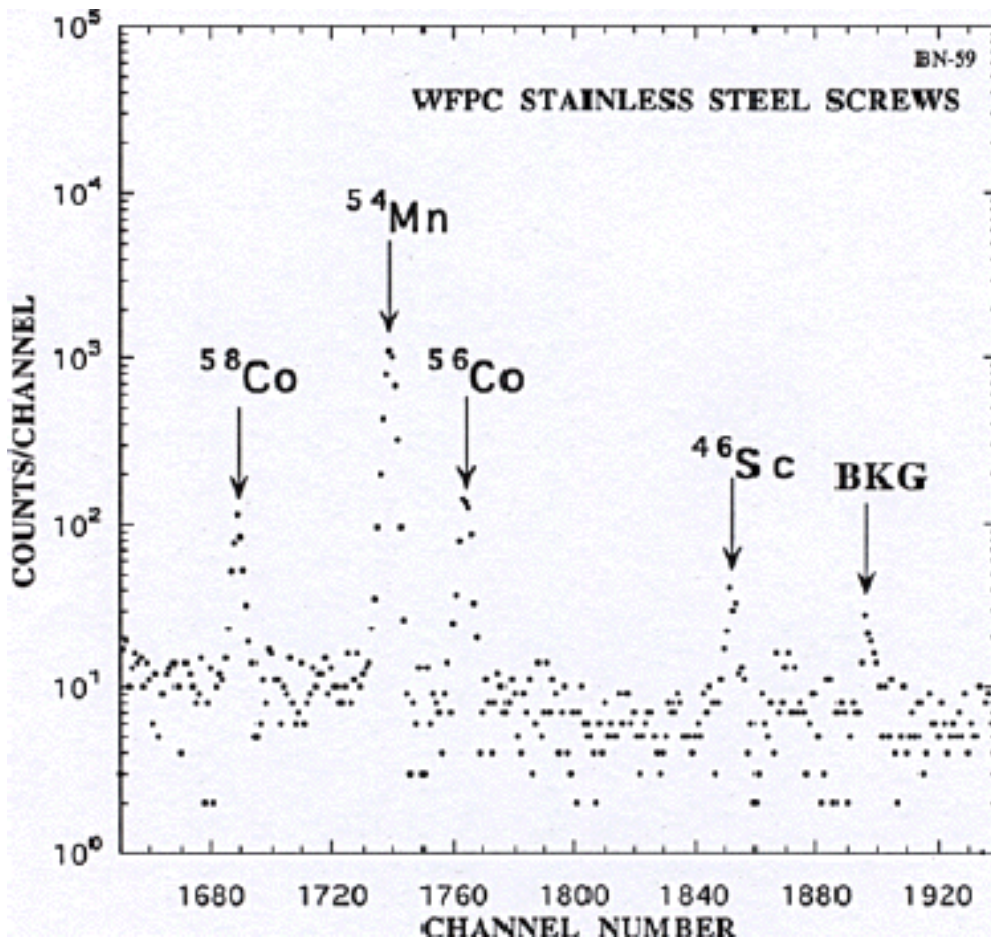
Figure 2 shows a narrow interval from this spectrum, on which four peaks of interest and one BKG peak are indicated. Detailed characteristics of the data can be seen here, including the shapes of peaks and the nature of the continuum. Table I lists the rates in diagnostic peaks for the above nuclides as observed at counting time. (No decay corrections have been applied to these values.) Uncertainties are expressed as single standard deviations on the actual data.

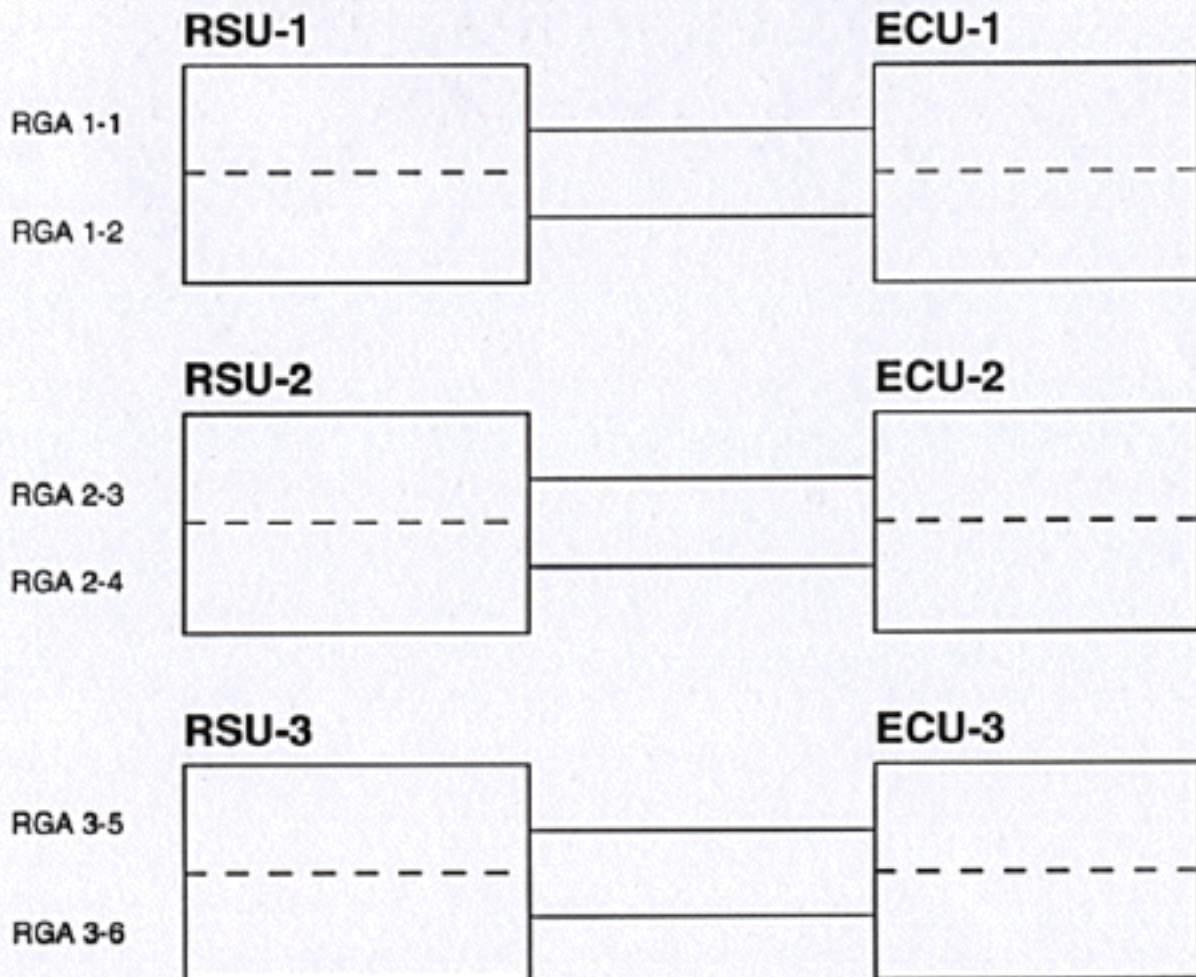
RATE GYRO ASSEMBLY (RGA) FUNCTIONAL BLOCK DIAGRAM

- Three channels failed prior to first servicing mission; fourth showed anomalous behavior.
- Post servicing mission evaluation of returned hardware isolated failure sites.

- Rate gyro channel 1
 - Signature: Motor current to zero (failure).
 - Source: Shorted capacitor in ECU.
- Rate gyro channel 4
 - Signature: Gyro output to saturation (failure).

- Source: Failed hybrid circuit card in RSU.
- Rate gyro channel 5
 - Signature: High mode scale factor transient (anomaly).
 - Source: Foreign particle in flotation fluid in RSU.
 - Signature: Motor current increase (anomaly).
 - Source: "Lube patch" on gas bearing in RSU.
- Rate gyro channel 6
 - Signature: Gyro output to saturation (failure).
 - Source: Failed hybrid circuit card in RSU.
 - Gyro motor spindown (failure).
 - Source: Open flexlead in RSU.
