# The October 17, 1989, Loma Prieta, California, Earthquake—Selected Photographs

*by* By J.K. Nakata, C.E. Meyer, H.G. Wilshire, J.C. Tinsley, W.S. Updegrove,  
D.M. Peterson, S.D. Ellen, R.A. Haugerud, R.J. McLaughlin, G.R. Fisher, *and*  
M.F. Diggles

Photographs and descriptions to accompany  
Digital Data Series DDS-29  
Version 1.1  
1999

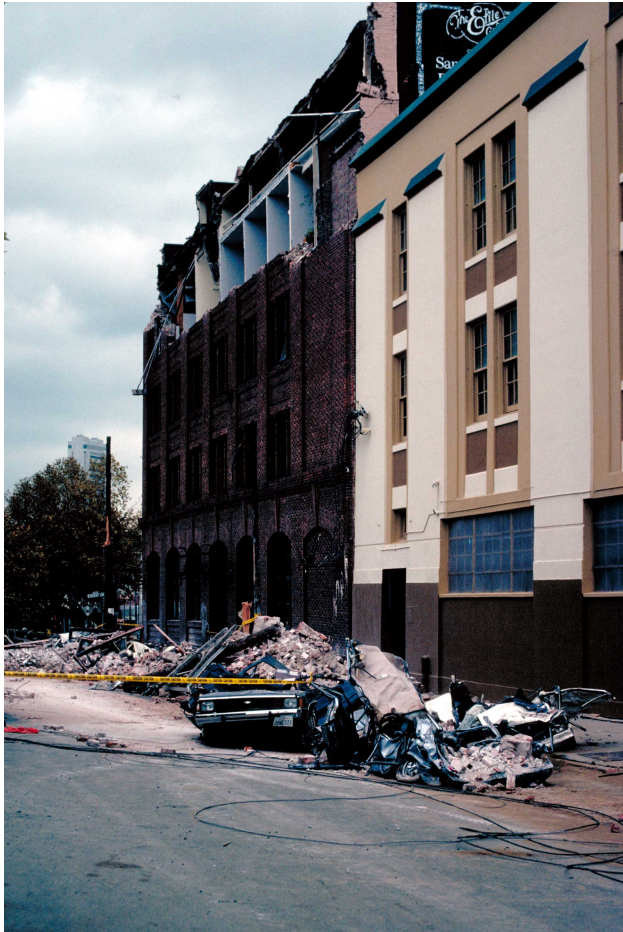
2. Cars crushed by collapsing brick facade near Fifth and Townsend Streets. At this locality, five people were killed while leaving from work. [C.E. Meyer, U.S. Geological Survey]

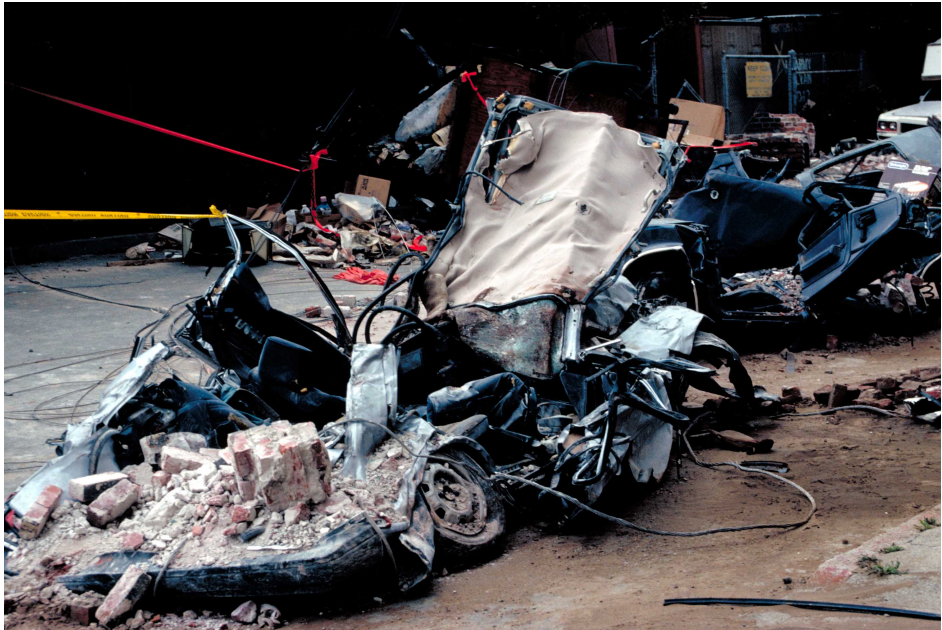
3. Crushed car near the intersection of Fifth and Townsend Streets, *South of Market*.  
[C.E. Meyer, U.S. Geological Survey]

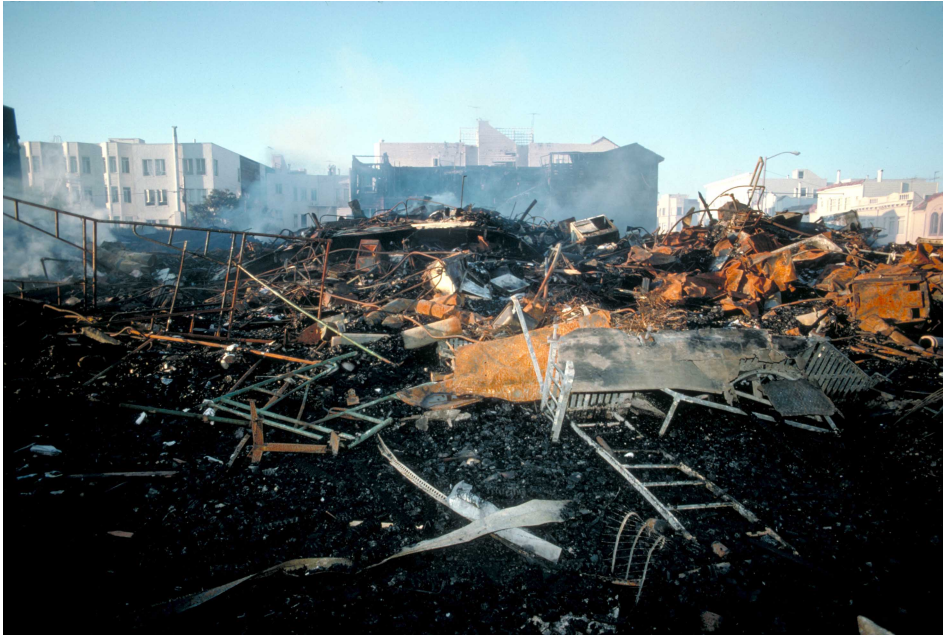
11. Smoldering remains of the apartment complex at the corner of Beach and Divisadero Streets, the *Marina District*. [J.K. Nakata, U.S. Geological Survey]

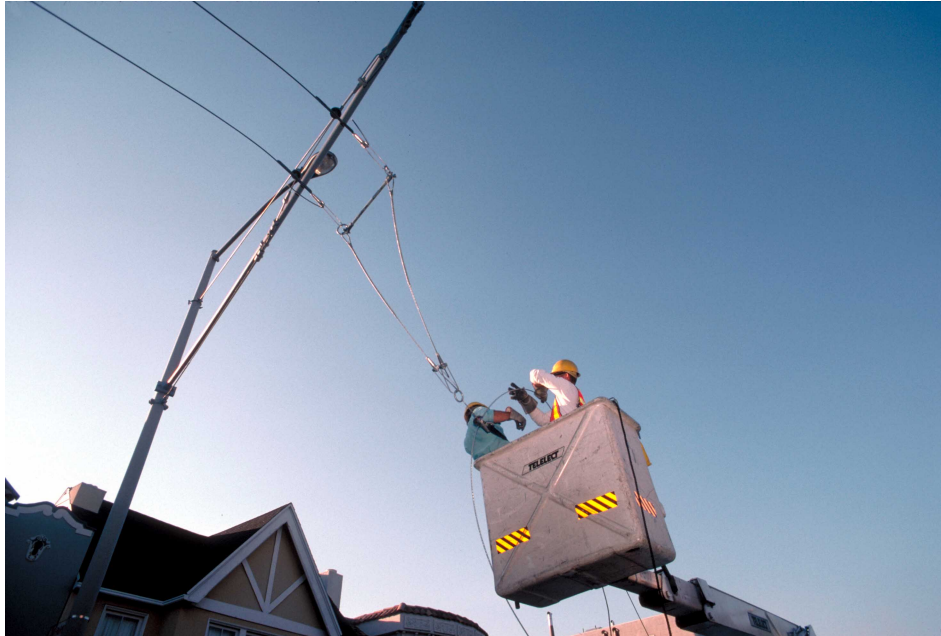
14. Electric wires being removed from unstable towers by city utility workers. Arresting sparks from broken wires was a priority in those areas with broken gas mains. [J.K. Nakata, U.S. Geological Survey]

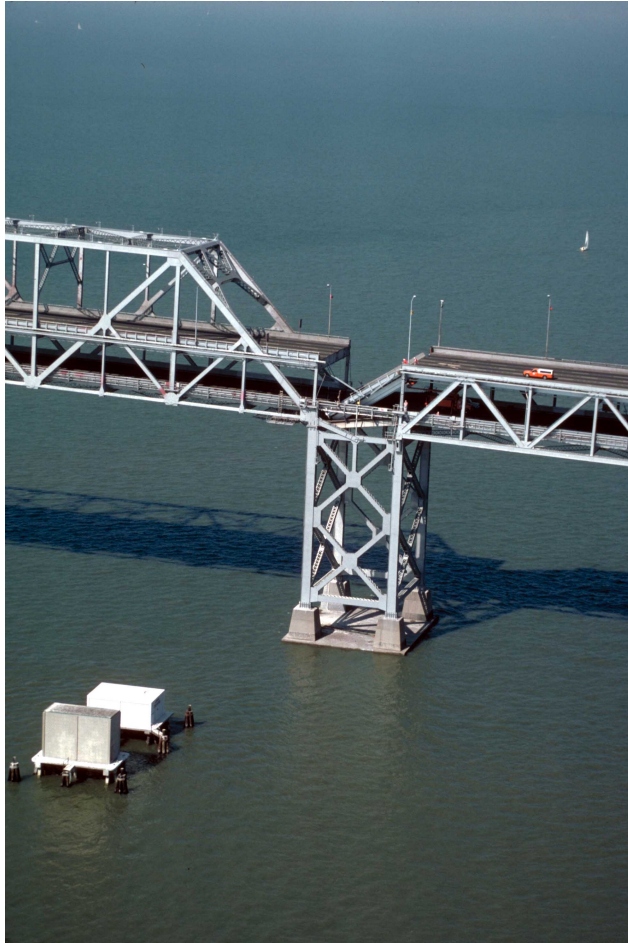
15. **Aerial view** of roadbed collapse near the interface of the cantilever and truss sections of the San Francisco-Oakland Bay Bridge. View northwestward. [C.E. Meyer, U.S. Geological Survey]

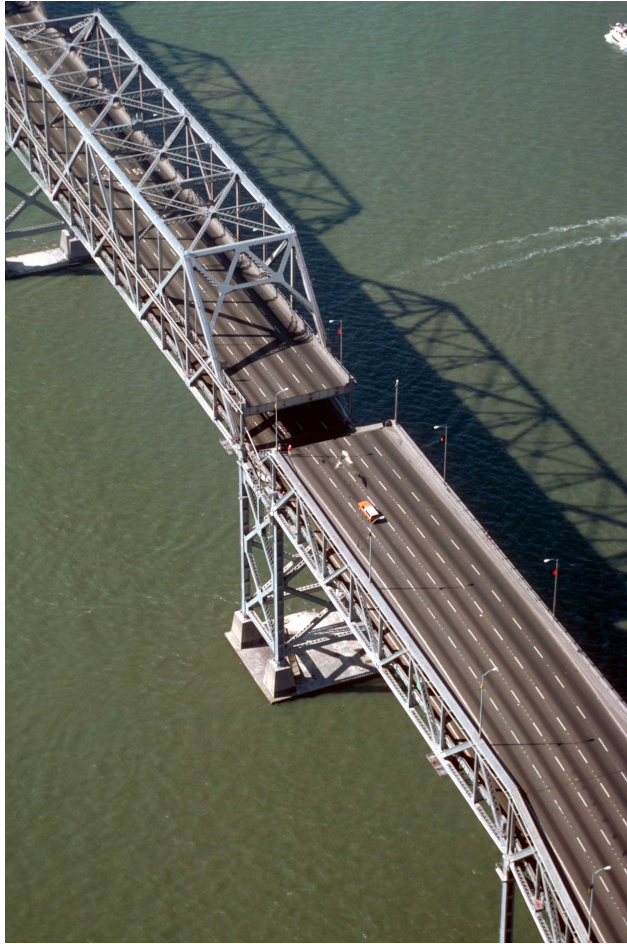
16. **Aerial view** of the collapsed section of the San Francisco-Oakland Bay Bridge. View westward. [C.E. Meyer, U.S. Geological Survey]

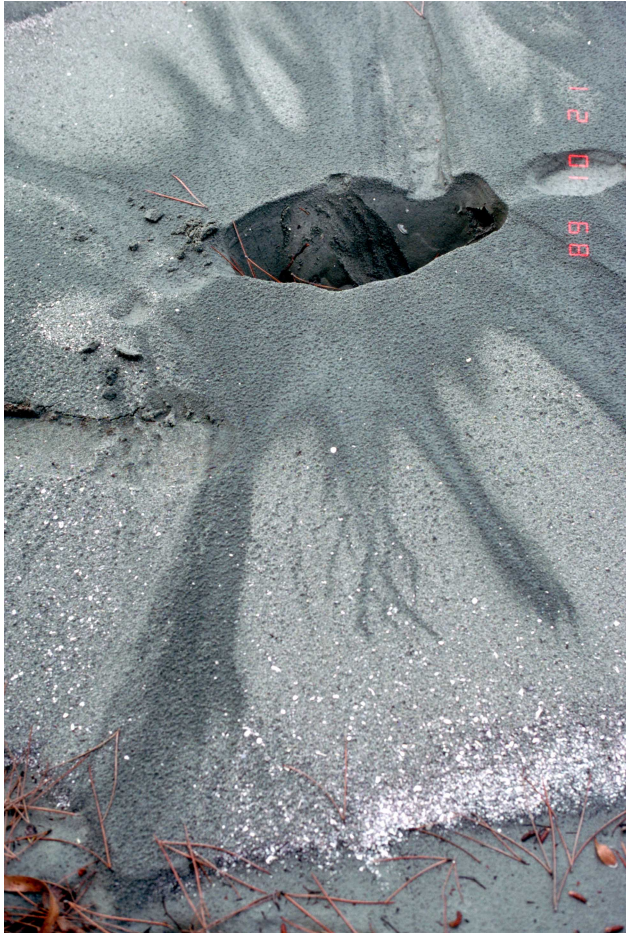
17. “Sand boil” or sand volcano measuring 2 m (6.6 ft) in length erupted in median of Interstate Highway 80 west of the Bay Bridge toll plaza when ground shaking transformed loose water-saturated deposit of subsurface sand into a sand-water slurry (liquefaction). Vented sand contains-marine shell fragments. [J.C. Tinsley, U.S. Geological Survey]

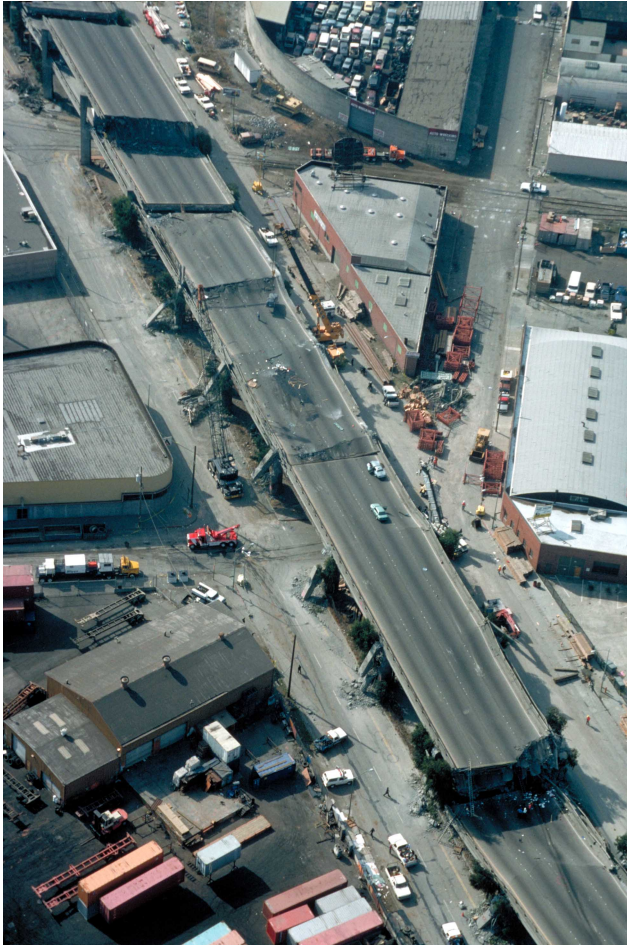
18. **Aerial view** of collapsed sections of the Cypress viaduct of Interstate Highway 880.  
[H.G. Wilshire, U.S. Geological Survey]

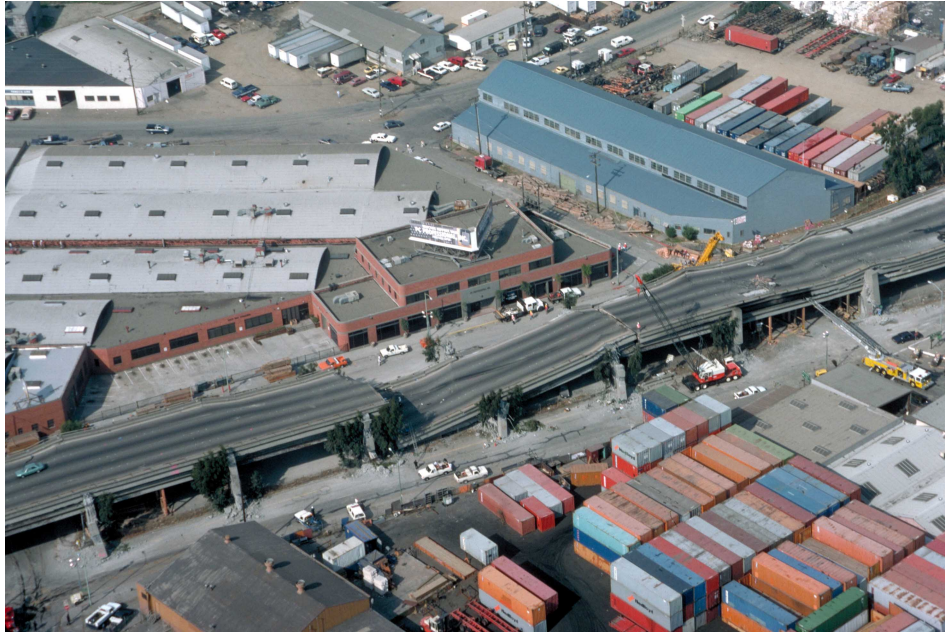
19. **Aerial view** of collapsed sections of the Cypress viaduct of Interstate Highway 880.  
[H.G. Wilshire, U.S. Geological Survey]

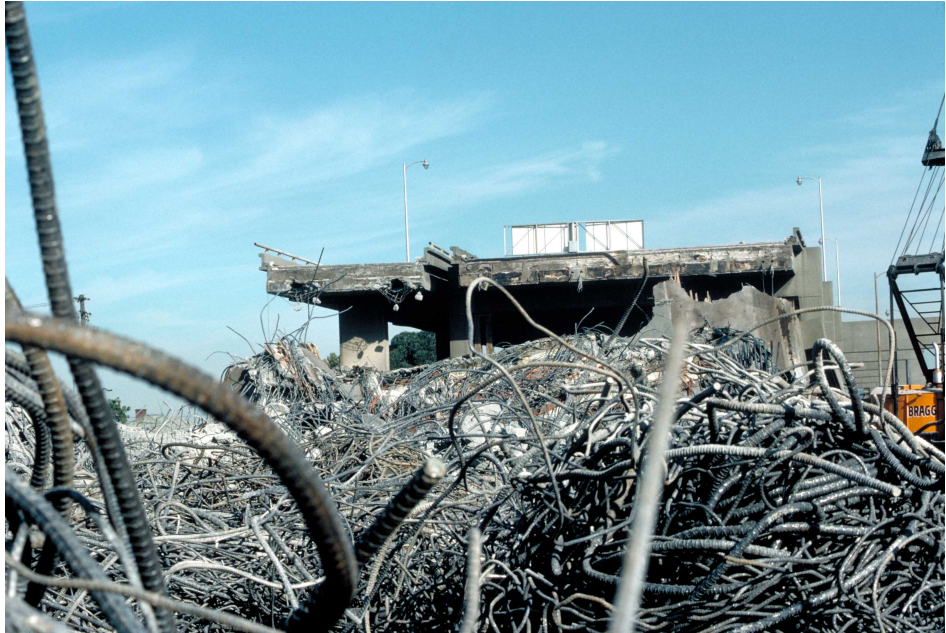
20. Reinforcement bars exposed at the base of the Cypress viaduct near 14th Street.  
[J.K. Nakata, U.S. Geological Survey]

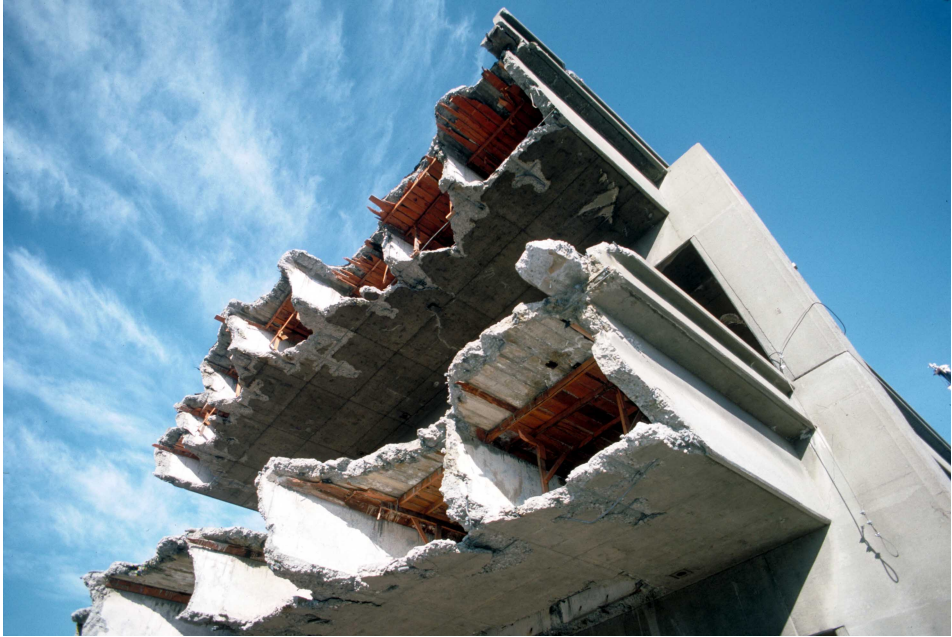
21. Remnant portion of the north- and south-bound Cypress viaduct exposing box girders near 14th Street. [J.K. Nakata, U.S. Geological Survey]

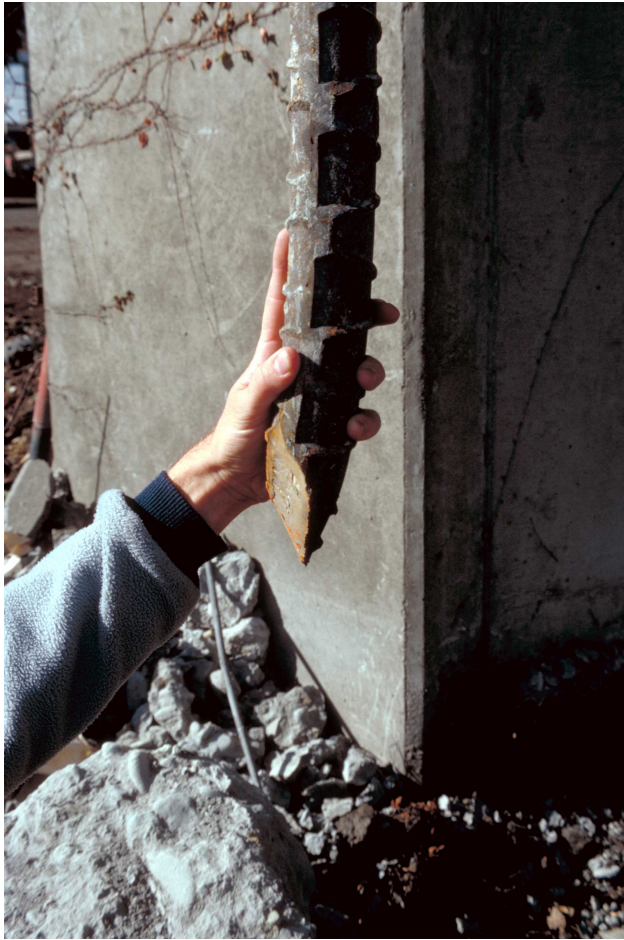
27. Sheared reinforcement bar, Cypress viaduct. [H.G. Wilshire, U.S. Geological Survey]

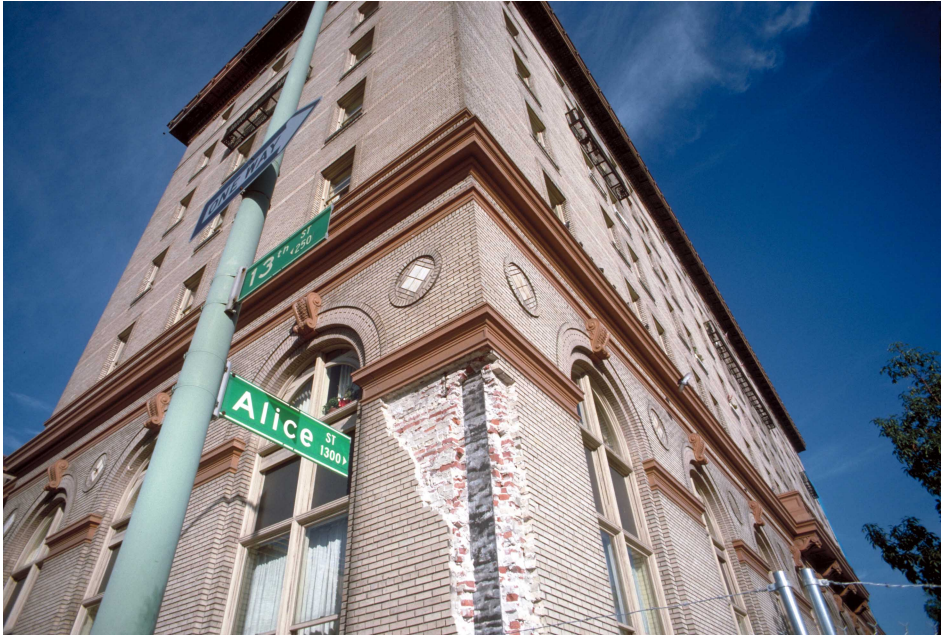
30. A downtown building at the corner of Alice and 13th Streets lost part of its unreinforced facade and brick masonry. [J.K. Nakata, U.S. Geological Survey]

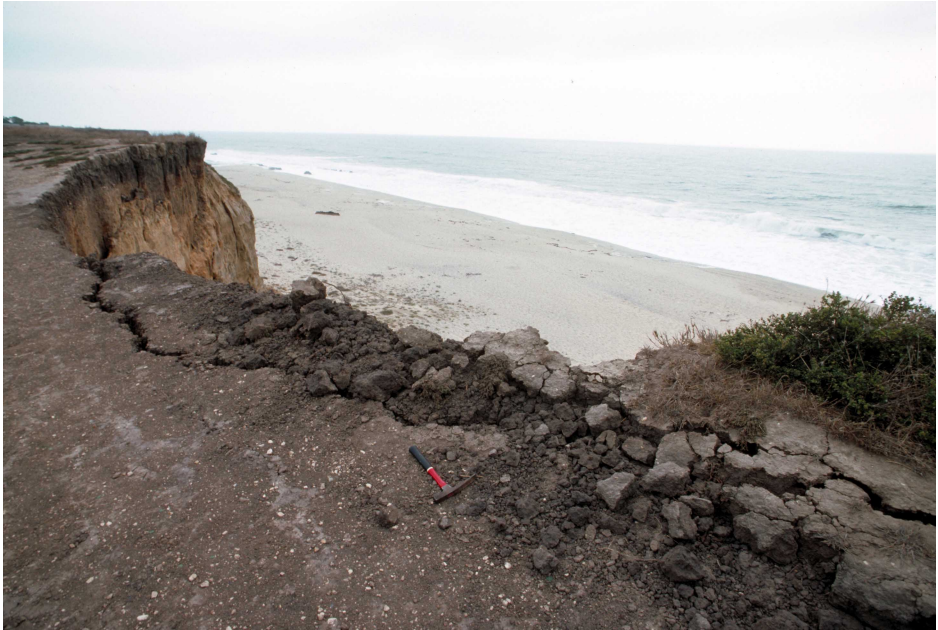
34. Head scarp of small slide at Redondo Beach. Scale is provided by the red-handled rock hammer, which is 30.5 cm (12 in.) long. [D.M. Peterson, U.S. Geological Survey]

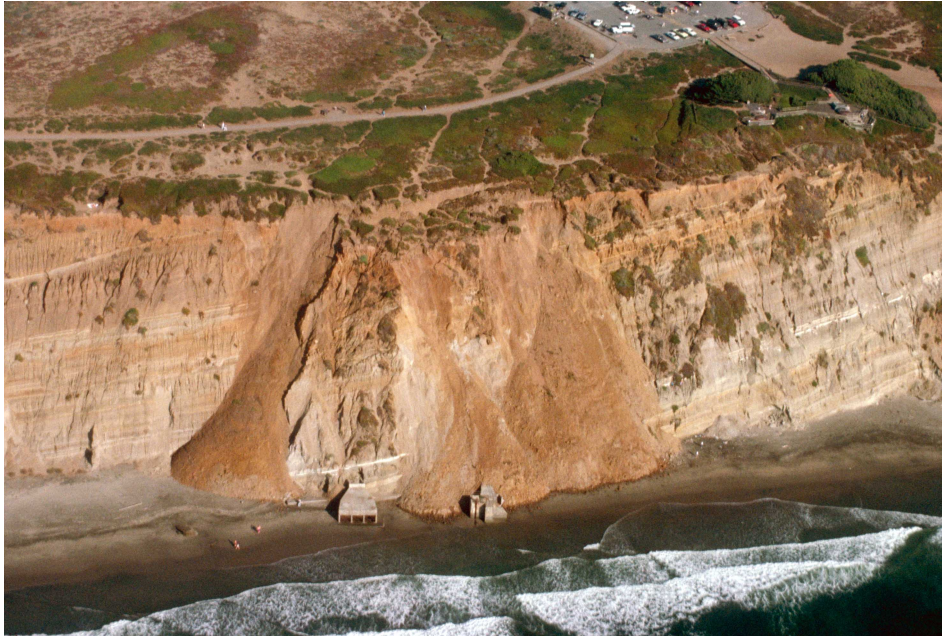
35. **Aerial view** of large slides north of Fort Funston. A ground perspective of this slide is shown in photo 33. [S.D. Ellen, U.S. Geological Survey]

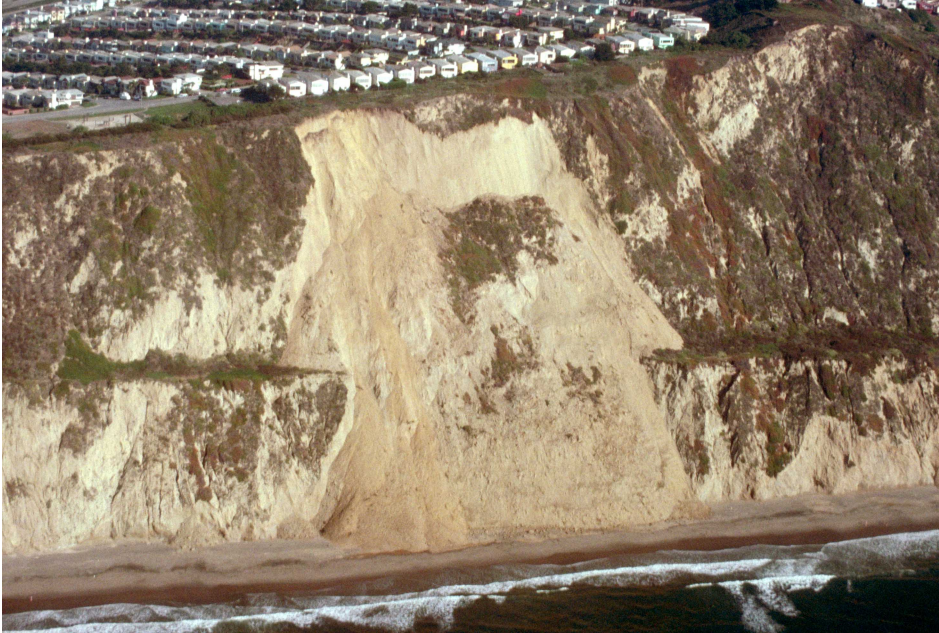
36. **Aerial view** of slide at Daly City. This is the largest slide triggered by the earthquake in San Mateo County, displacing approximately 36,700 cubic meters (48,000 cubic yards) of material. The base is about 152 m (500 ft) across at its widest point. [S.D. Ellen, U.S. Geological Survey]

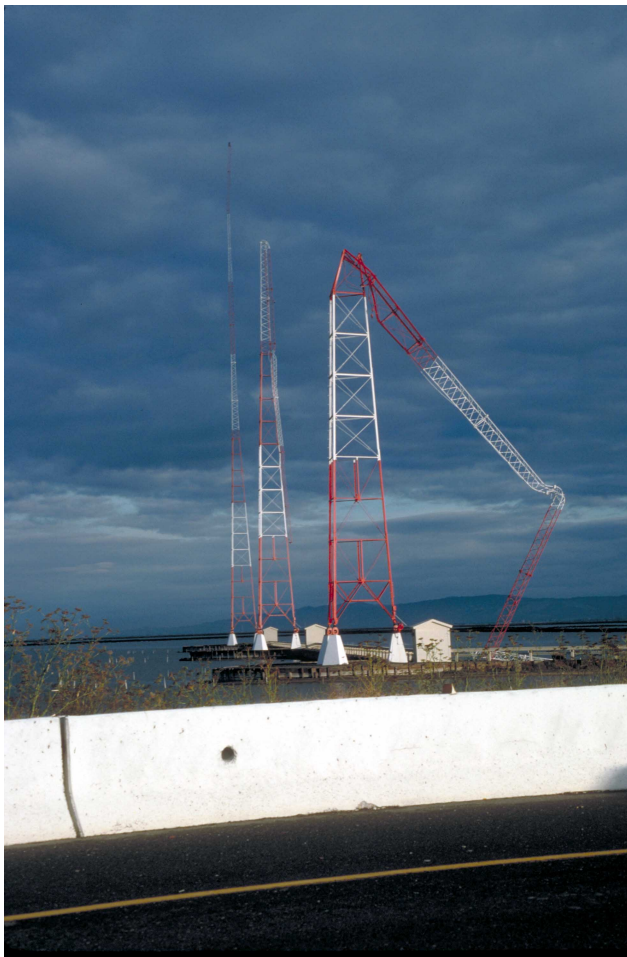
37. KGO radio transmission towers, built on *bay mud* in a salt-evaporation pond used by the Leslie Salt Company. Note progressively less damage to towers away from viewer. [H.G. Wilshire, U.S. Geological Survey]

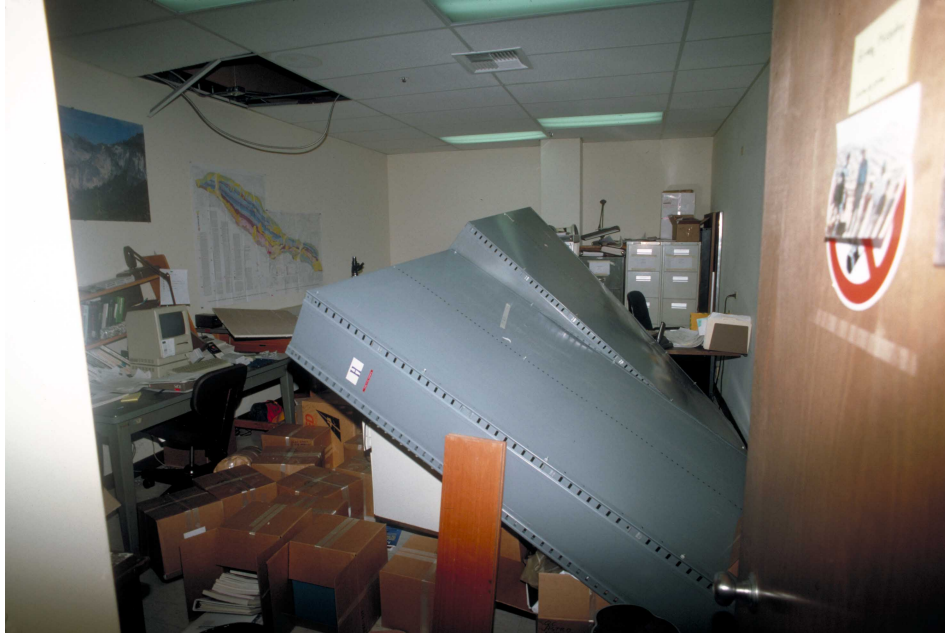
39. Unfastened bookcases in an office building fell during the primary shock. [J.K. Nakata, U.S. Geological Survey]

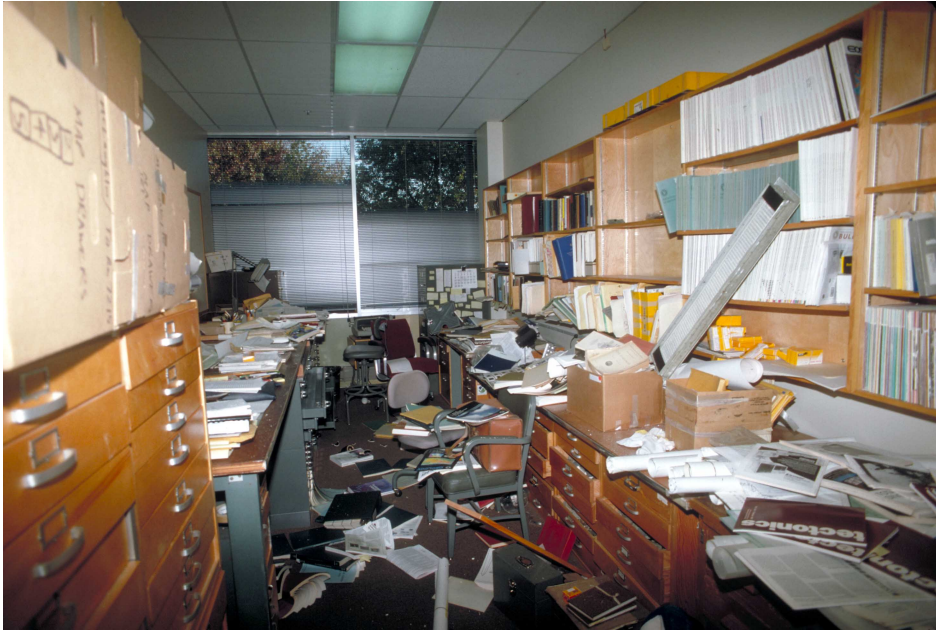
40. Books and air-conditioning duct were dislodged during the earthquake. [J.K. Nakata, U.S. Geological Survey]

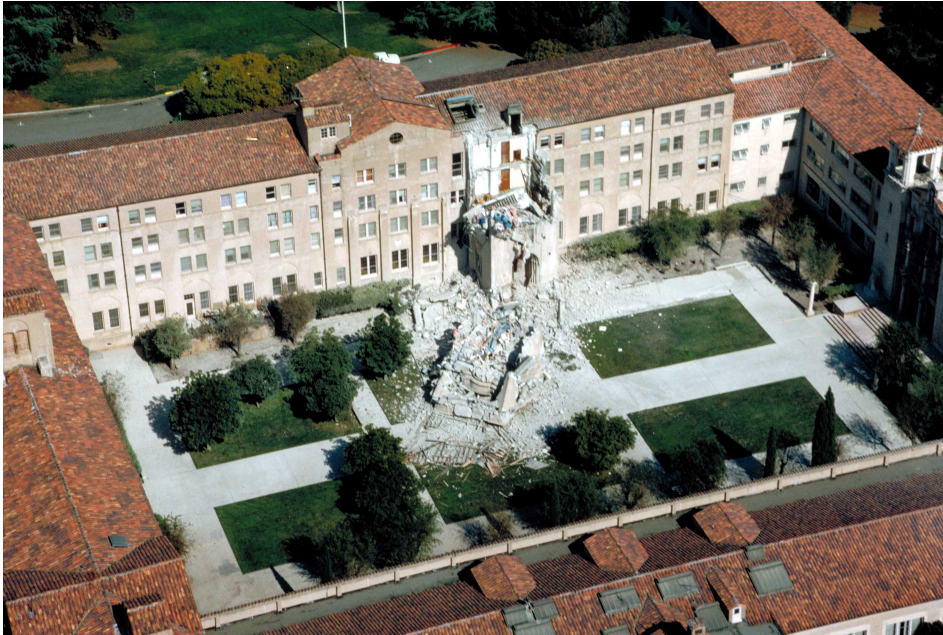
42. **Aerial view** of collapsed five-story tower, St. Joseph's Seminary. One person working in tower was killed. [H.G. Wilshire, U.S. Geological Survey]

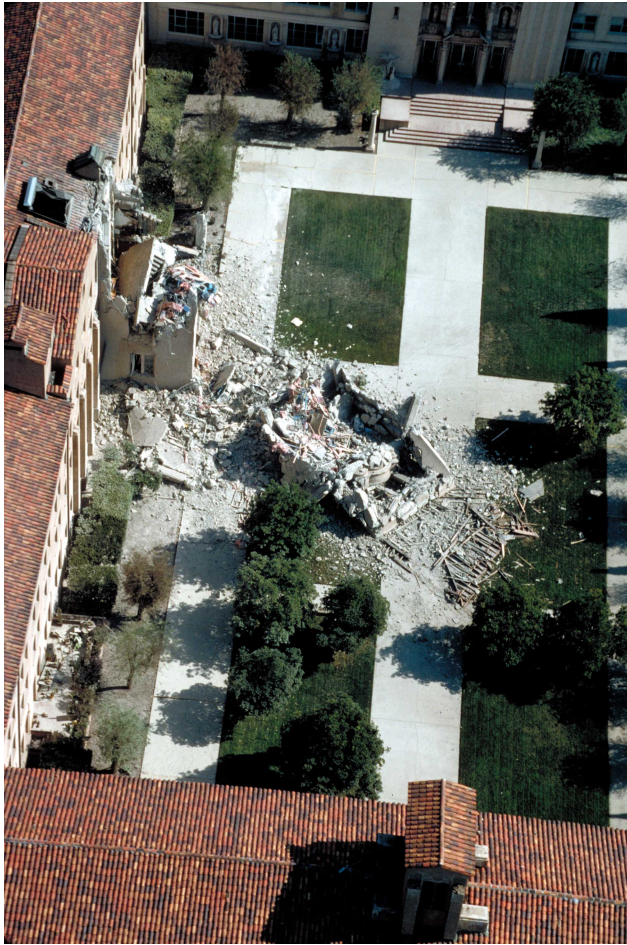
43. **Aerial view** of collapsed five-story tower, St. Joseph's Seminary. [H.G. Wilshire, U.S. Geological Survey]

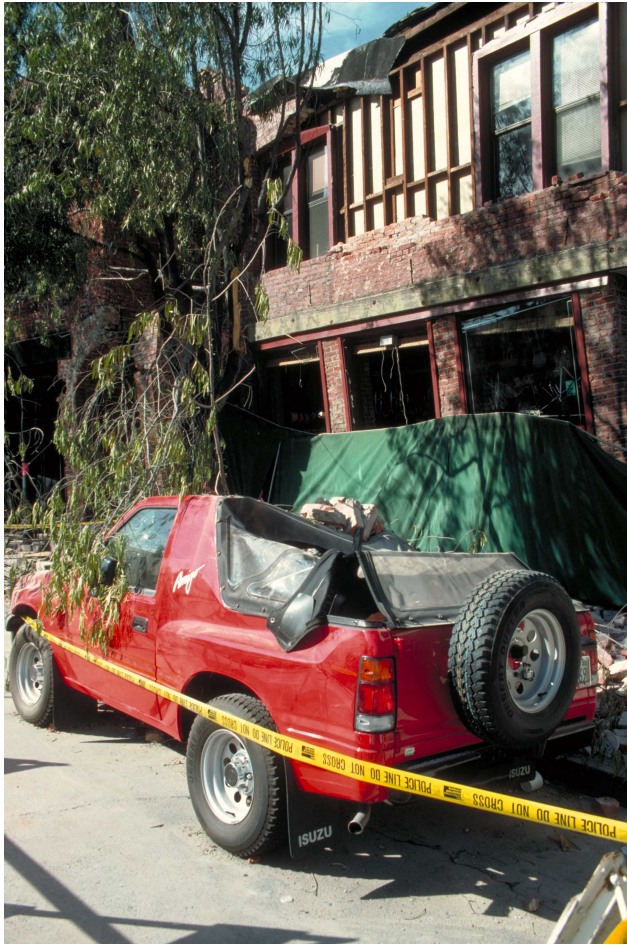
51. Vehicle crushed by collapse of unreinforced-brick masonry. [C.E. Meyer, U.S. Geological Survey]

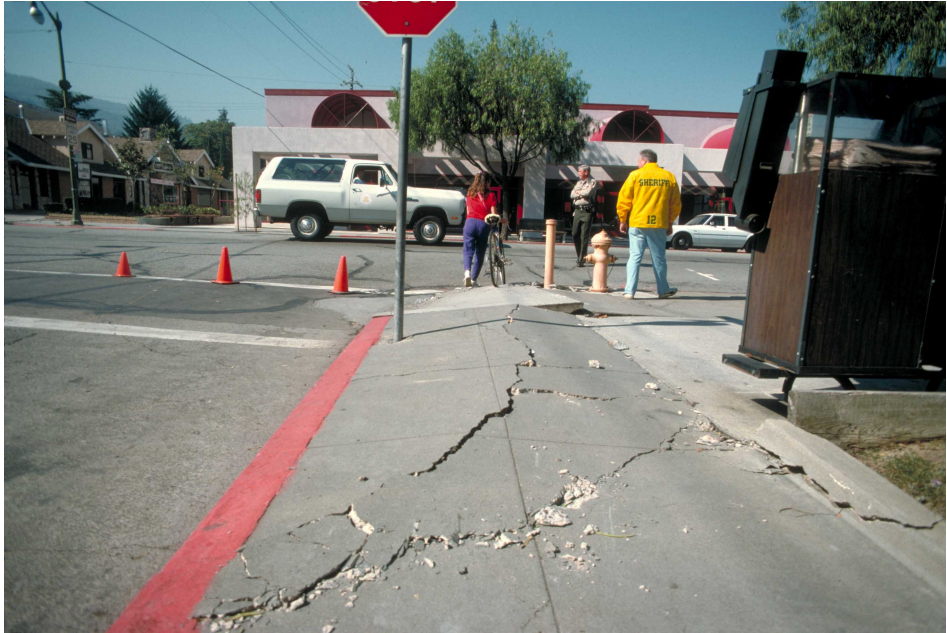
54. Downtown sidewalk buckled due to compression. [J.K. Nakata, U.S. Geological Survey]

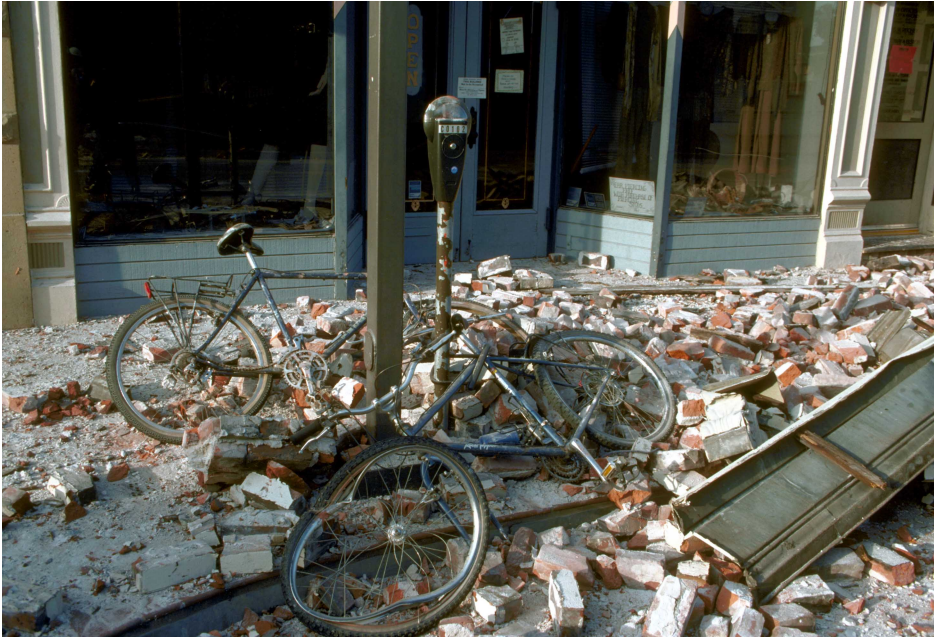
73. Bicycles crushed by falling unreinforced brick facade, Pacific Garden Mall. [C.E. Meyer, U.S. Geological Survey]

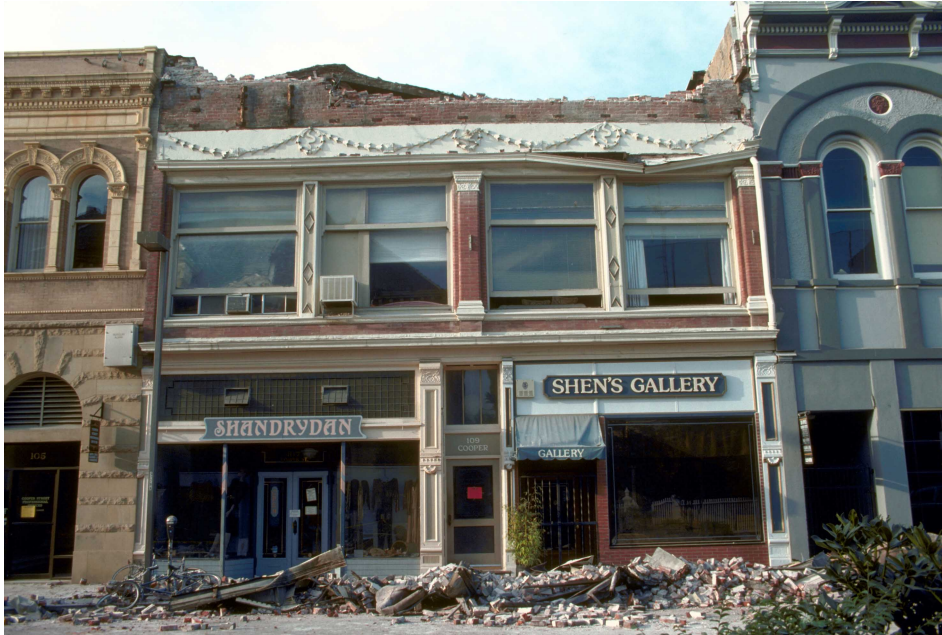
74. Collapsed unreinforced-brick facade, Pacific Garden Mall. [C.E. Meyer, U.S. Geological Survey]

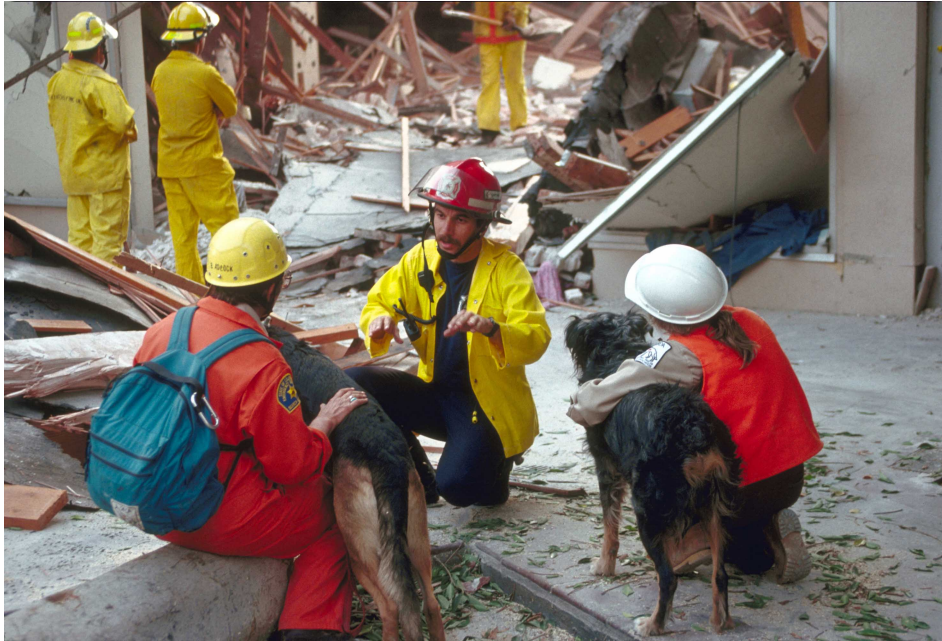
77. Searching for victims at collapsed department store, Pacific Garden Mall. [C.E. Meyer, U.S. Geological Survey]

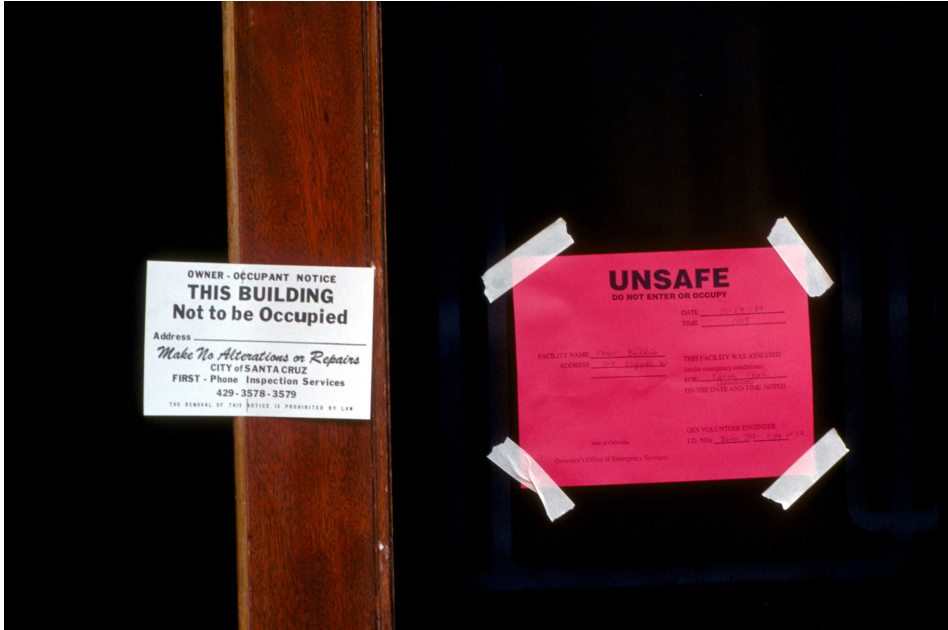
79. “Unsafe to occupy” signs were posted by the Governor’s Office of Emergency Services. [J.K. Nakata, U.S. Geological Survey]

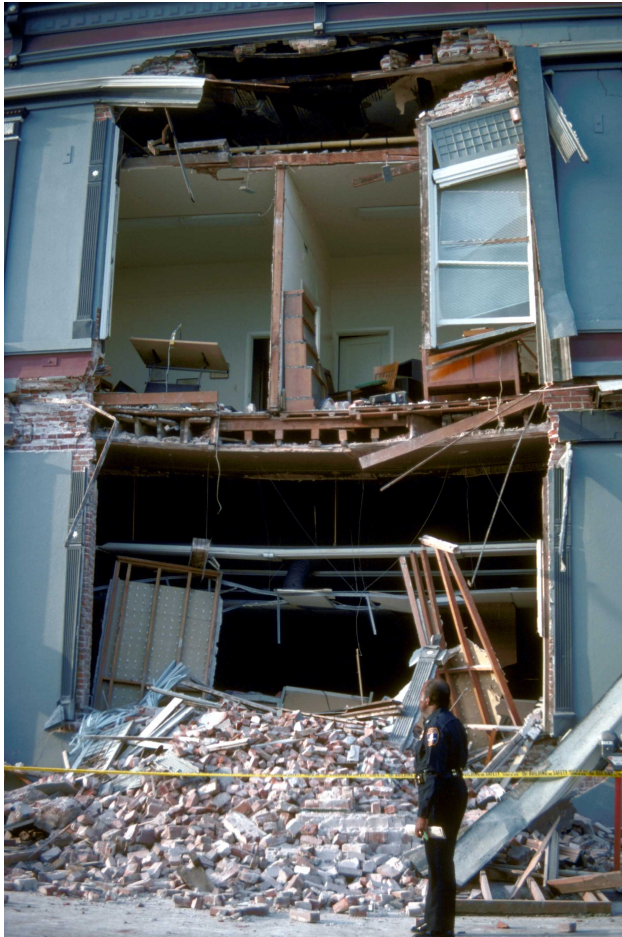
81. Close-up of collapsed wall of unreinforced masonry, *Medico Dental Building* in the Pacific Garden Mall. [H.G. Wilshire, U.S. Geological Survey]

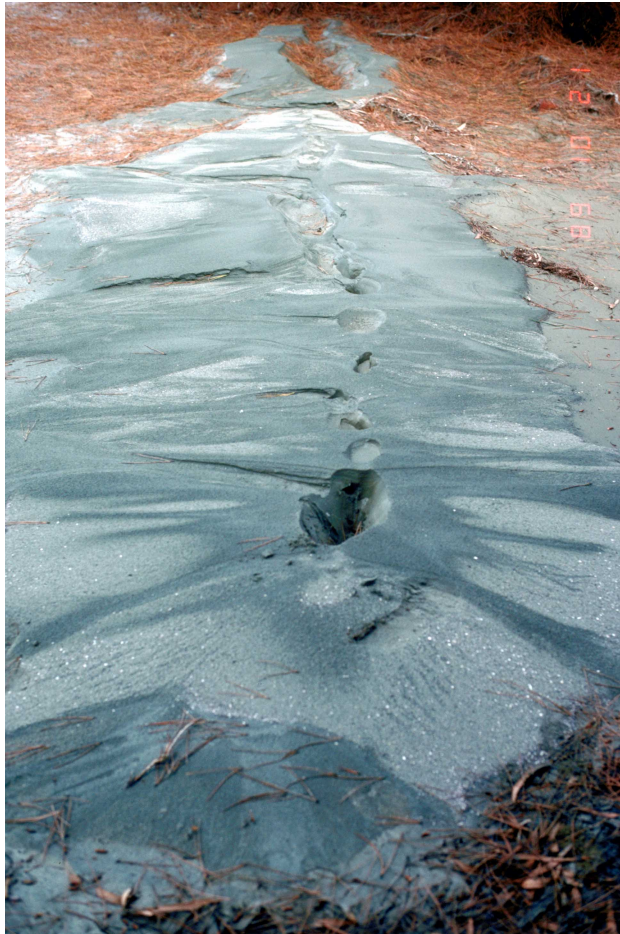
86. Liquefaction in recent deposits of the Pajaro River formed sand volcanoes along a fissure 6-7 m (19.7-23 ft) long. Variation in grain size and partial erosion of the conical deposits of sand show that venting of the slurry of sand and water was a complex series of depositional and erosional events triggered by the main shock and renewed in some instances by principal aftershocks. [J.C. Tinsley, U.S. Geological Survey]

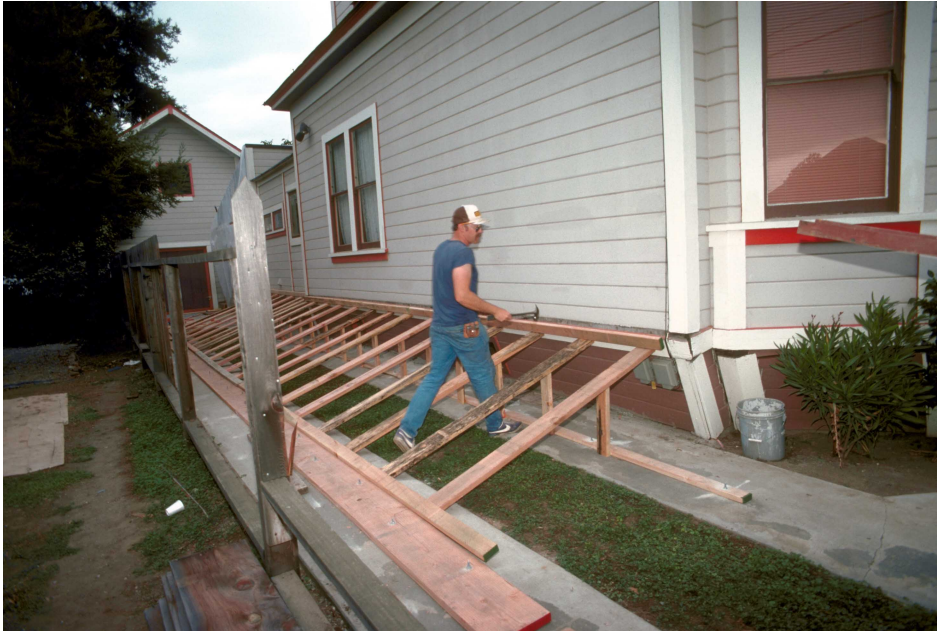
90. Many homeowners buttressed their foundations to prevent further damage from aftershocks in downtown Watsonville. [J.K. Nakata, U.S. Geological Survey]
