# Classical Details in a Harsh Environment

Craftsmen build a coastal house to withstand hurricane winds, meticulous architects and exacting clients

by Robert Weinstein

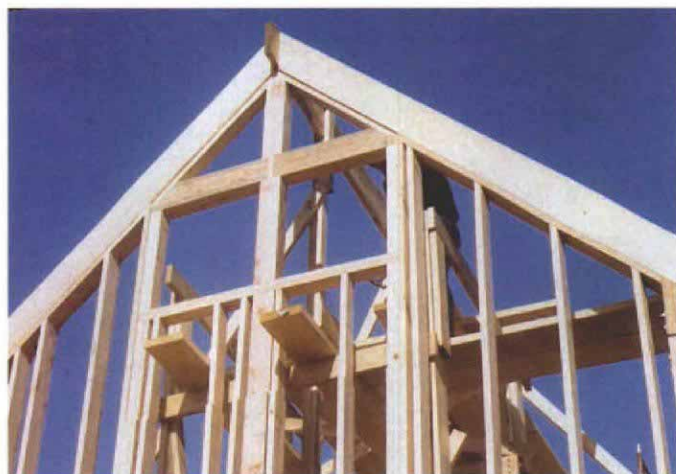
**Shear wall.** One of two shear walls in the house, this gable end was strengthened with 6x6 timbers that run from the foundation to the rafters. The wall was sheathed on both sides with  $\frac{3}{4}$ -in. plywood.

**Shear walk**—To minimize racking or lateral motion during storms, the house frame was designed with shear walls at two locations: one at a gable end (top photo, p. 82) and one centrally located in the interior of the house.

The integrity of the shear walls depends on the careful adherence to their design. From the concrete, 1-in. threaded rods were connected to Simpson hold-downs bolted with  $\frac{5}{8}$ -in. dia. bolts to the 6x6 posts that augmented the 2x6 wall framing. The shear walls were sheathed on both sides with  $\frac{3}{4}$ -in. CDX plywood that was glued with construction adhesive and nailed off every 8 in. Where the roof sheathing meets the top plate of the shear wall, the sheathing is glued and then nailed with two rows of 10d nails 6 in. o. c.

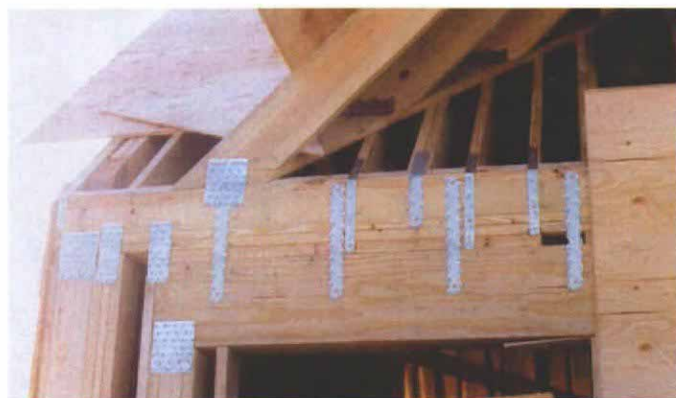
**Hurricane straps.** Typical of the detailing throughout the house, every rafter was fastened to the walls with galvanized metal straps.

The studs in the shear walls were tied to the plates with steel stud-plate ties. At the top of the walls, the rafters were held to the plates with steel hurricane anchors. The tops of all the rafters were held to the ridge with sloped or sloped-and-skewed hangers as the location required.

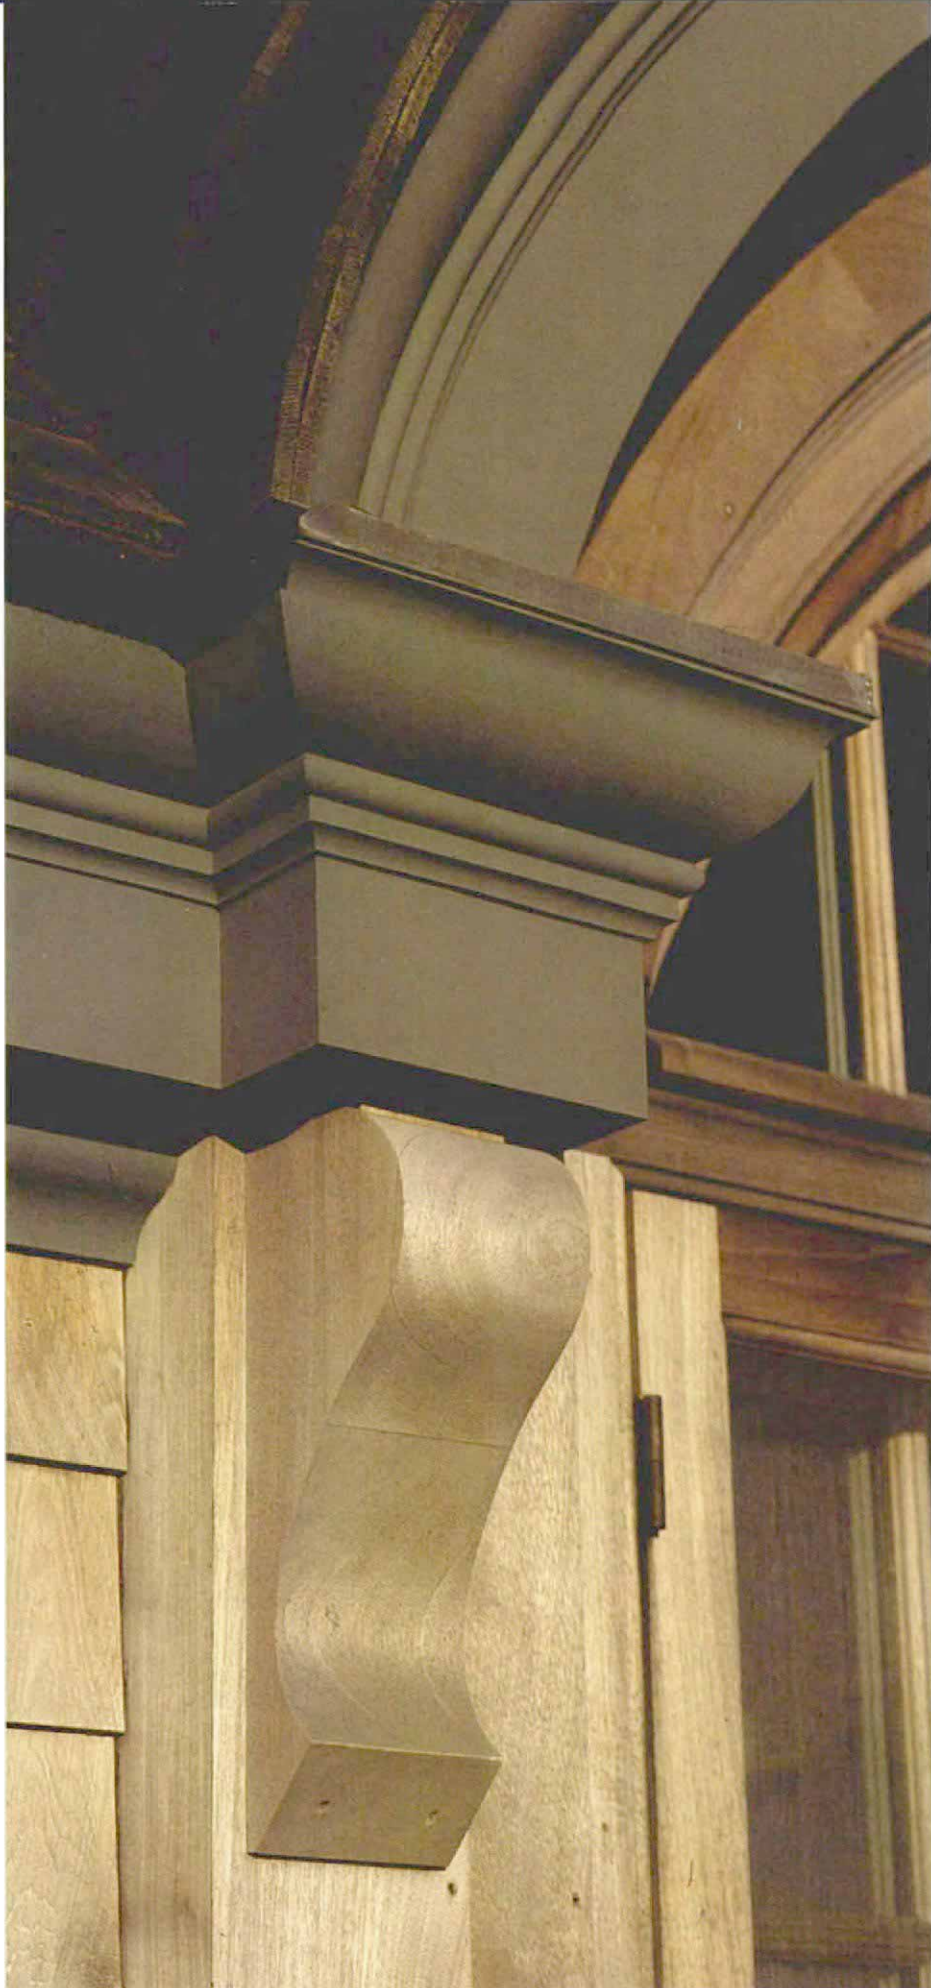
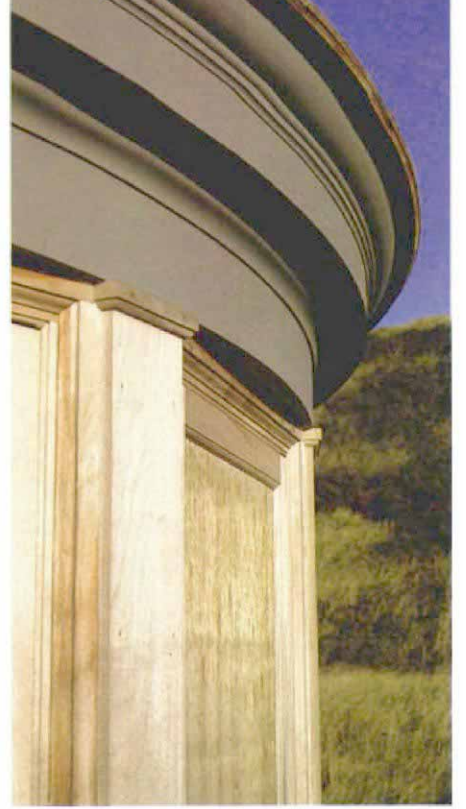
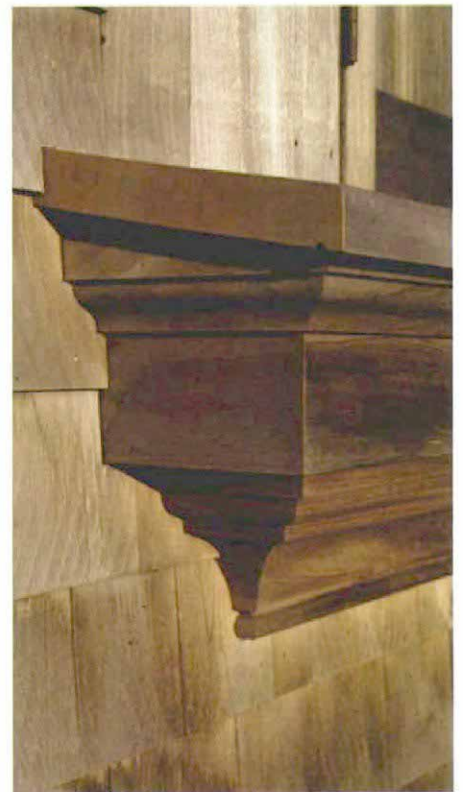
***Two miles of trim.*** Over 11,000 lin. ft. of wood, including teak, mahogany and redwood, was used for the running trim outside the house. The trim includes cornices that were radiused, curved and mitered. All of the trim was biscuited, glued with epoxy and fastened with square-drive stainless-steel screws.

All of the running trim was installed with stainless-steel screws. Screws have superior holding power over nails, but there was another reason we used them for the trim. Using screws enabled us to dry-fit the myriad pieces of cornice, columns, water tables and scotia. Because we were working to the highest standards and the smallest tolerances, we had to be able to dismantle easily any of the hundreds of trim components and adjust a particular cope or miter until the joints were perfect. All of our end-to-end joints are scarfed and biscuited and glued with a two-part West System epoxy glue (Gougeon Brothers, Inc., P. O. Box 908, Bay City, Mich. 48707; 517-684-7286). When we were working in the cold, we added a hardener that accelerates the curing process of the glue. More than two years after the completion of the construction, all joints remain perfectly tight.

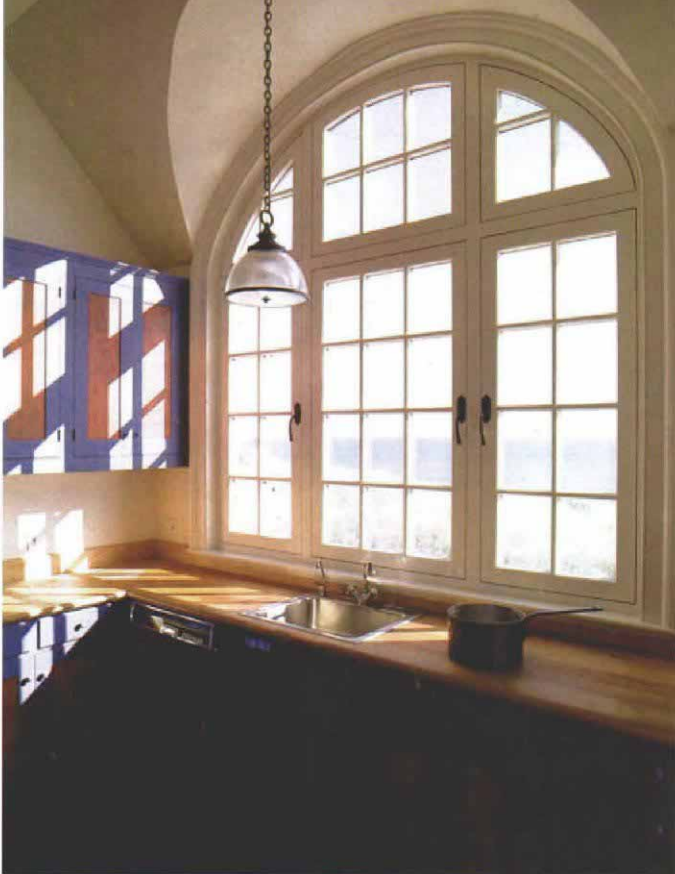
**Curved cornice in an eyebrow dormer.** The focal point of the house's ocean-side facade is the large, 40-lite kitchen window seen here from the interior (left) and the exterior (right). The curved five-piece exterior cornice terminates in bracketed water tables.

Perhaps one of the most striking features of the house is the arched kitchen window (top photos, p. 84). The construction of the rough opening and the assembly of the window unit as it came to us from the millwork shop presented quite a challenge. The unit itself is made of three rectangular, tilt-turn sash and three curved, fixed sash above. The five-piece cornice at the head

of this massive window is curved; the two ends of the curve terminate in bracketed water tables.

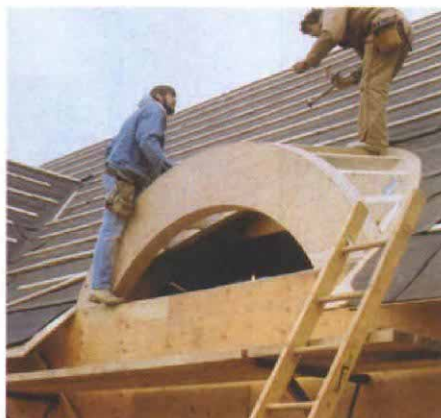
**Plywood header.** The header for the arch top kitchen window is made of seven layers of  $\frac{3}{4}$ -in. plywood cut to fit the window's curves.

If the window was installed in a flat wall, the installation would have been fairly straightforward. The rough opening complicated things because it incorporates a 3-in-12 pitch eyebrow dormer that ends flush with the sidewall. We built the header out of seven layers of  $\frac{3}{4}$ -in. plywood. Each piece was cut to the curve of the window arch as well as to the angle of the dormer pitch (bottom photo, p. 84).

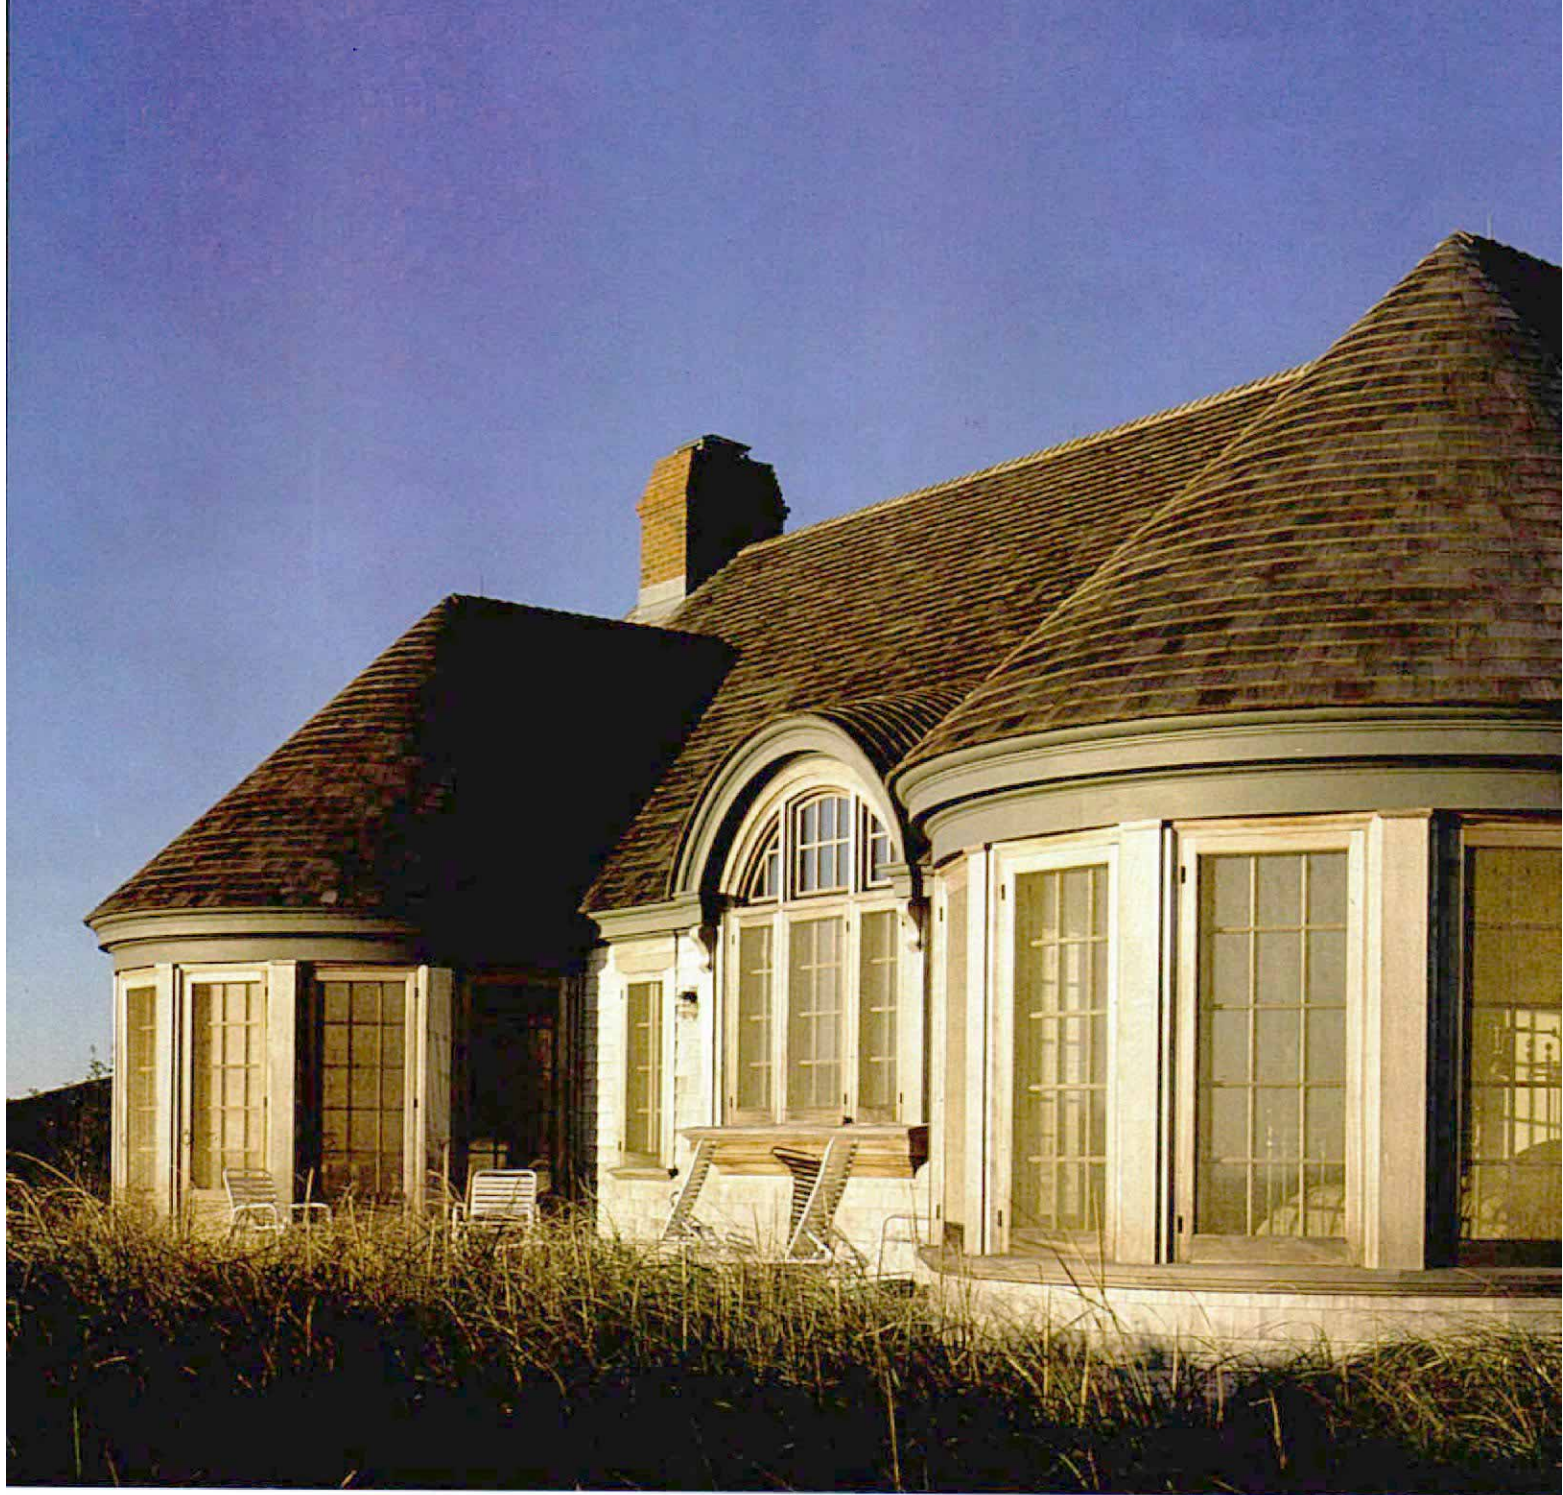
**Tight to the weather.** Utmost care was taken to waterproof the house. The soldered 20-oz. lead-coated copper shown at right is typical of the house's flashing details. All doors and windows had soldered head flashings. A soldered flashing also protects the bottoms of doors, windows and gable vents.

A soldered head flashing was used over exterior doors, windows and gable vents. A 20-oz. lead-coated copper pan was soldered in place for all the door openings. A soldered flashing also protects the bottoms of windows and gable vents.
