ISDN (BRI)

Trouble Shooting

Pacific Bell

Version 1.2

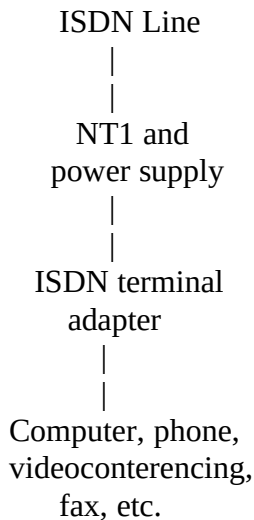
Your ISDN line is connected to Pacific Bell's network at a piece of equipment called a "switch" located in a building called a "central office" in phone company language.

On the customer end of the ISDN line you generally find three types equipment attached in this order:
