# **Pentium<sup>®</sup> III Processor Specification Update**

Release Date: April 1999

Order Number: 244453-002

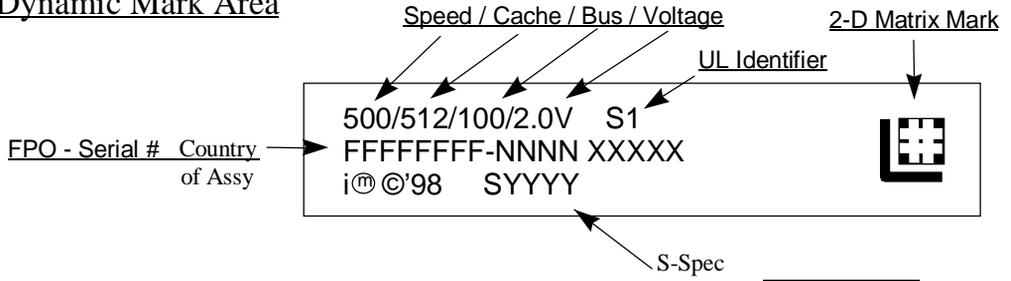
### *Pentium® III Processor and Boxed Pentium® III Processor 3 Line Markings*

#### Dynamic Mark Area
