Technical Note TN1050

System 7.5.3 Revision 2

This Technote describes the various changes offered by System 7.5.3 Revision 2 and provides information for Apple developers regarding these changes. This Note also includes references to other sources of information that further discuss these changes.

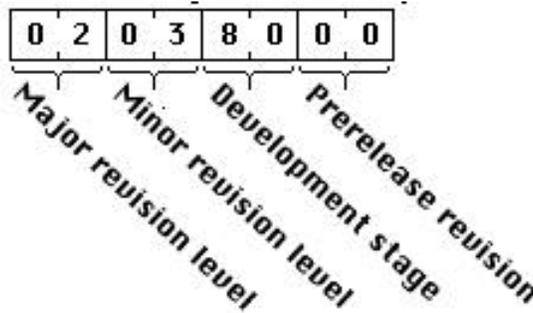
To distinguish between the multiple versions of system software, the 'sysu' Gestalt selector has been provided. It returns the version number of the currently installed system update, formatted according to the same conventions as the version numbering used in 'vers' resources, as illustrated in Figure 1.

Figure 1. The format of the Gestalt response for the 'sysu' selector.

The presence of the 'sysu' Gestalt selector allows application programs to determine if the current installed system software version was established using the system update. The 'sysu' Gestalt selector will only be defined if a system update package was used to establish the current system version: the 'sysu' selector is not defined on machines shipped with System 7.5.3 installed.

err = Gestalt(gestaltSystemVersion, &response);
if (err == noErr) {
    seven_five_three = (response == 0x00000753);
    if (seven_five_three) {
        err = Gestalt('sysu', &updateversion);
        is_an_update = (err == noErr);
    }
}
/* at this point, seven_five_three will be true if system 7.5.3
is the current operating system, and is_an_update will be true
if the current system version was established by update. if
is_an_update is true, updateversion will contain the System
update's version number (0x02038000 for system 7.5.3 revision 2). */
```

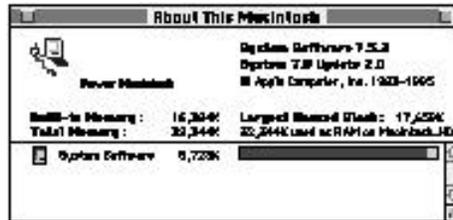
Figure 2. "About This Macintosh" dialog box with System 7.5 Update 2.0

When System 7.5.3 Revision 2 is installed, the second line of the "About This Macintosh" dialog box becomes "Updated to Revision 2." Due to some unresolved Finder issues, the copyright string displayed in the "About This Macintosh" dialog box does not change; the first release of this Technote claimed that it did.

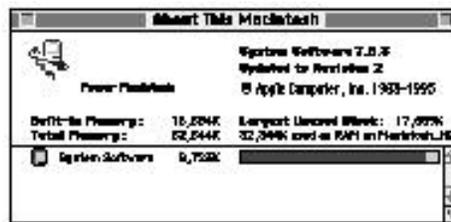
Figure 3. "About This Macintosh" dialog box with System 7.5.3 Revision 2
