TECHNOTE: System 7.5.3 Revision 2

by Brian Bechtel
devsupport@applelink.apple.com
Apple Developer Technical Support (DTS)

This Technote describes the various changes offered by System 7.5.3 Revision 2 and provides information for Apple developers regarding these changes. This Note also includes references to other sources of information that further discuss these changes.

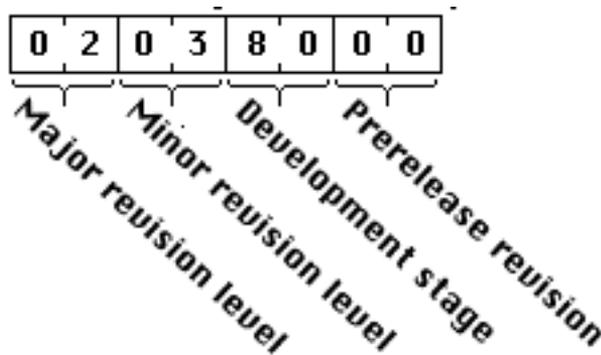
To distinguish between the multiple versions of system software, the 'sysu' Gestalt selector has been provided. It returns the version number of the currently installed system update, formatted according to the same conventions as the version numbering used in 'vers' resources, as illustrated in Figure 1.

Figure 1 The format of the Gestalt response for the 'sysu' selector.

The presence of the 'sysu' Gestalt selector allows application programs to determine if the current installed system software version was established using the system update. The 'sysu' Gestalt selector will only be defined if a system update package was used to establish the current system version: the 'sysu' selector is not defined on machines shipped with System 7.5.3 installed.

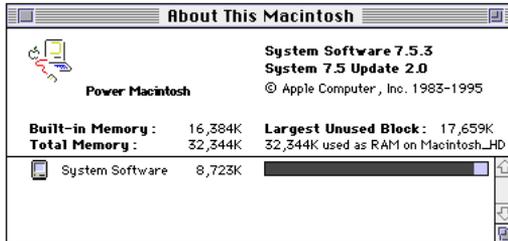
Figure 2 “About This Macintosh” dialog box with System 7.5 Update 2.0

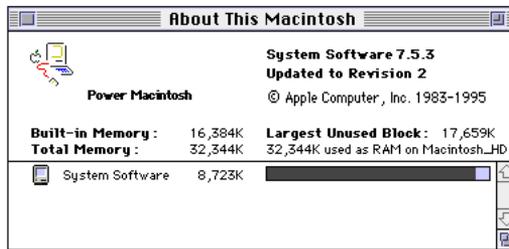
When System 7.5.3 Revision 2 is installed, the second line of the “About This Macintosh” dialog box becomes “Updated to Revision 2.” Due to some unresolved Finder issues, the copyright string displayed in the “About This Macintosh” dialog box does not change; the first release of this Technote claimed that it did.

Figure 3 “About This Macintosh” dialog box with System 7.5.3 Revision 2
