Technote Number 1135

Dealing with PCI Expansion Chassis Problems

By Gary Phillips
Apple Worldwide Developer Technical Support

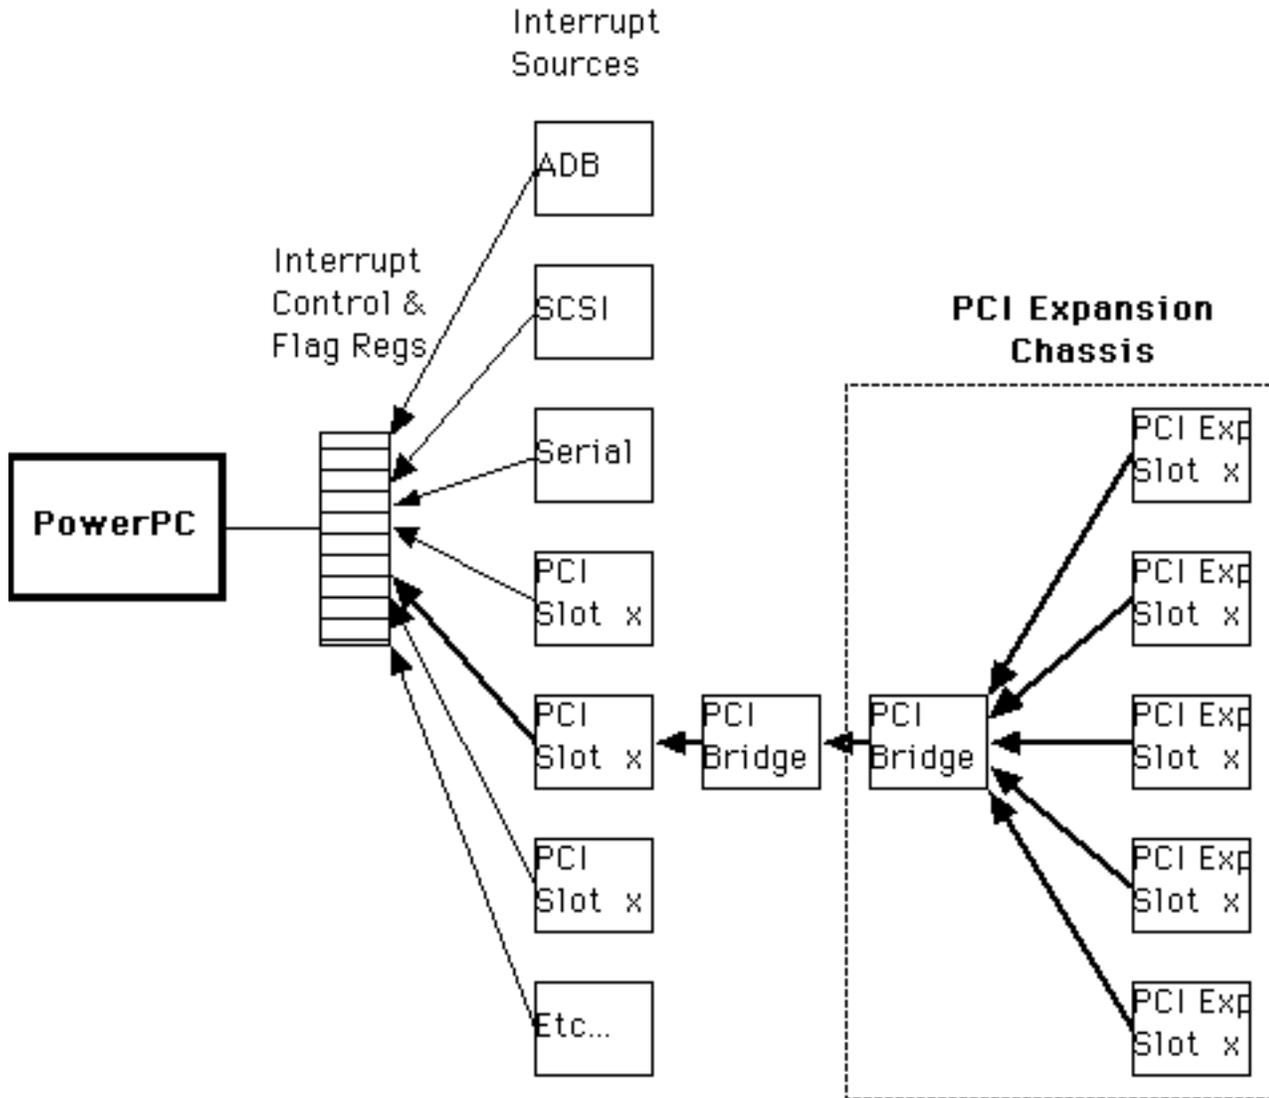
A Conceptual View Of PowerMacintosh Interrupts

First, additional propagation delay for the sub-bridge levels is introduced by the expansion chassis. A typical implementation is two sub-bridge levels deep, requiring extra PCI clock cycles for each level. Further delays are experienced if the cards themselves possess additional PCI sub-bridges. These delays

Extra time should be allowed for the hardware to properly reset interrupt flags that have been asserted, because latencies could make the interrupt look as though it is still asserted for a brief time. This is due to the accumulative full-turn delays of propagating down to the source hardware itself, then back to the host motherboard. The condition may cause the handler to be re-invoked after returning to its caller; however, when the handler regains control, the hardware interrupt has been cleared and the handler will return a `KISrIsNotComplete` status. This ultimately will cause a spurious interrupt because no proper handler will not be found. The complication in all this is that it is not easy to tell when a device is plugged into a local bus versus an expansion chassis (and sharing interrupts). The device tree could be analyzed to make such a determination, although a good general practice for a handler might be to clear the interrupt before attempting to read the hardware back to ensure it has actually been cleared prior to returning to the caller.
