Renovating a Chimney

New flue liners convert fireplaces for woodstove use

by Joseph Kitchel

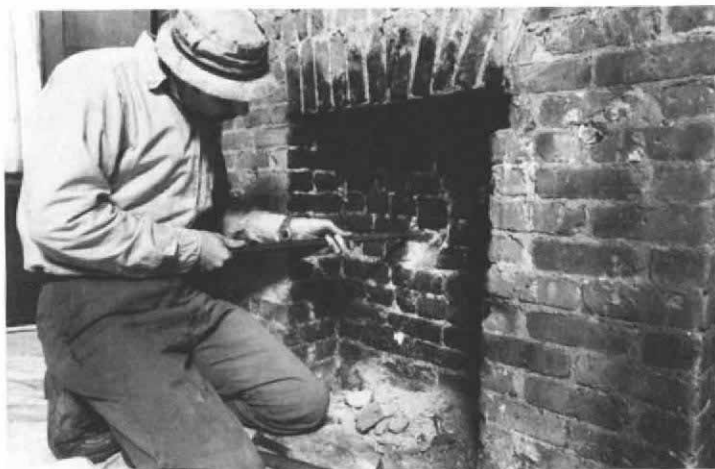
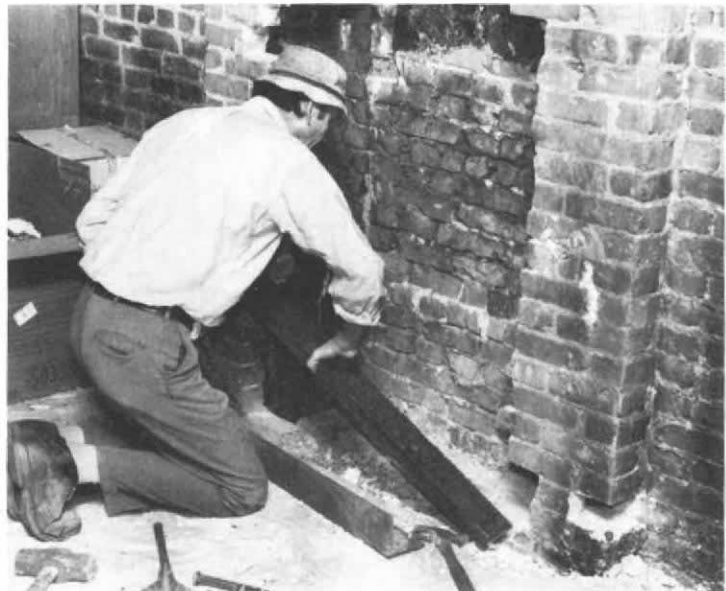
The first step in installing new flue liners is removing bricks from the second-floor fireplace to expose the chimney cavity. Hammer, railroad spike and pry bar are essential tools. A vinyl-covered canvas dropcloth over rubber carpet padding protects the floor. At right, Kitchel aligns two pieces of angle iron, which will be cemented in place across the face of the cavity to reinforce the chimney before the new liner is installed.

We cemented two 4-ft. lengths of 3-in. by 3-in. by 1/4-in. angle iron across the cavity opening below the second floor. Positioned parallel to one another (the L pointing up) and joined to the cavity wall, these iron beams form a reinforcing baseplate for both flues. We set the first-floor liner between the Ls and surrounded it with a course of cement blocks, building the cavity up level with the second floor.

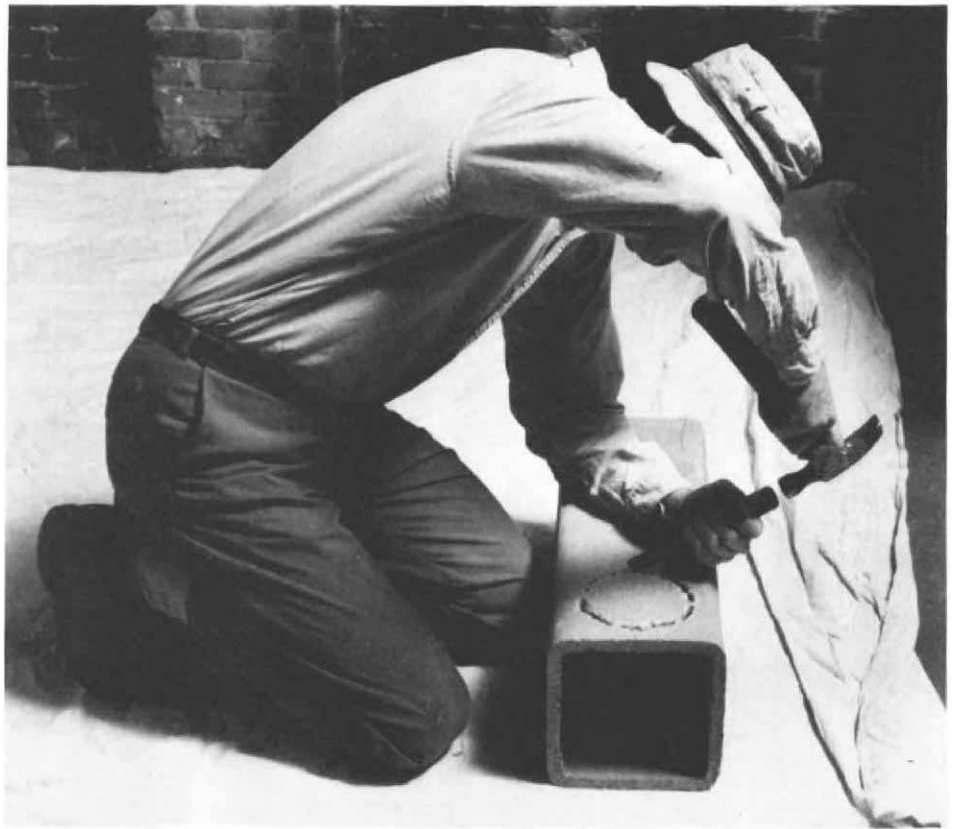
The first section of liner is cut to receive the thimble fitting, a tricky business since the ceramic material is very brittle. Closely spaced holes are first drilled along the cut-line; then the waste piece is knocked out with a hammer and chisel, as shown.

Because both the cleanout door and the stove-pipe thimble are designed to fit into a square flue liner, we had to use an 8-in. square liner as the base section for the second floor flue. Cutting openings in the ceramic pipe to receive these fittings (photo top right) is a delicate job. You can

use a rotary saw equipped with a masonry blade for the straight cuts. We made the round opening by drilling closely spaced holes with a masonry bit and then carefully chiseling out the tile between the holes.

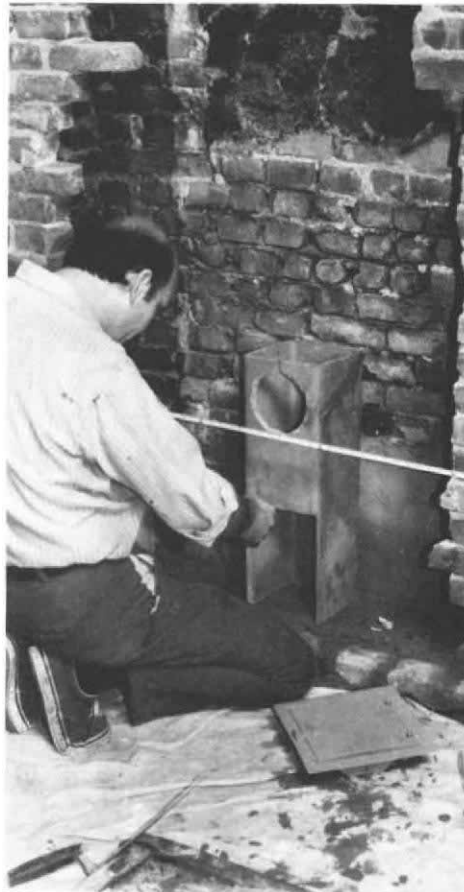
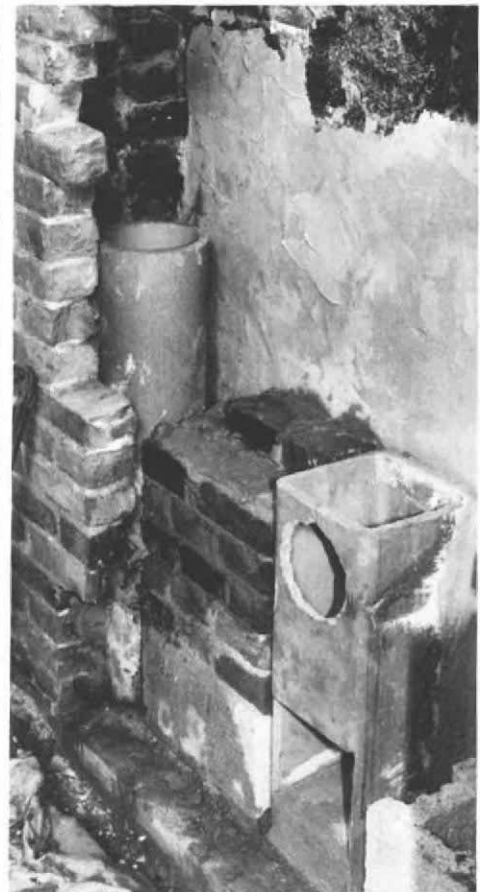
After the cavity has been built up to floor level, the first flue section can go in, left. The square opening at the bottom of the flue will receive the cleanout fitting. When both flue sections are in place, the chimney is bricked in around them, starting with a layer of cement blocks, right. The round flue section will eventually be connected to a new lining from the floor below; the square section in the foreground is for the second-floor lining. The back walls of old chimneys like this one usually require parging, or stuccoing over, before the new lining and interior brickwork can be laid in.

The next step was to brick in the chimney around both liner sections. Again we used cement blocks, since they wouldn't be visible and were easy to position and level. The solid masonry around the hearth would also hold the heat well.

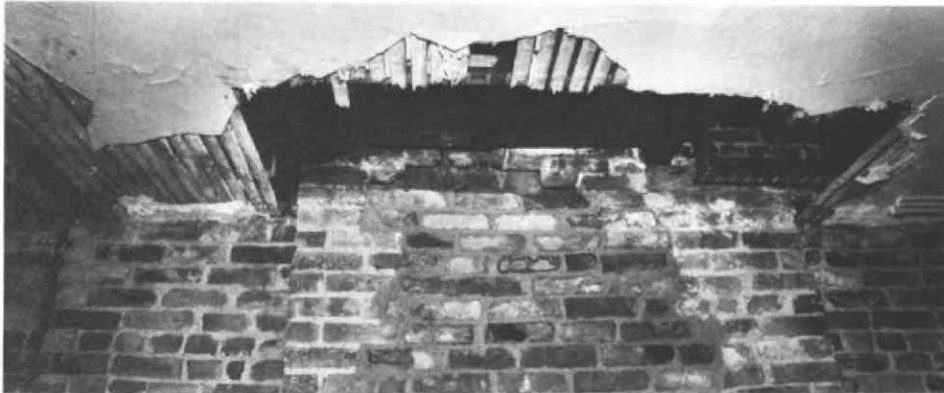
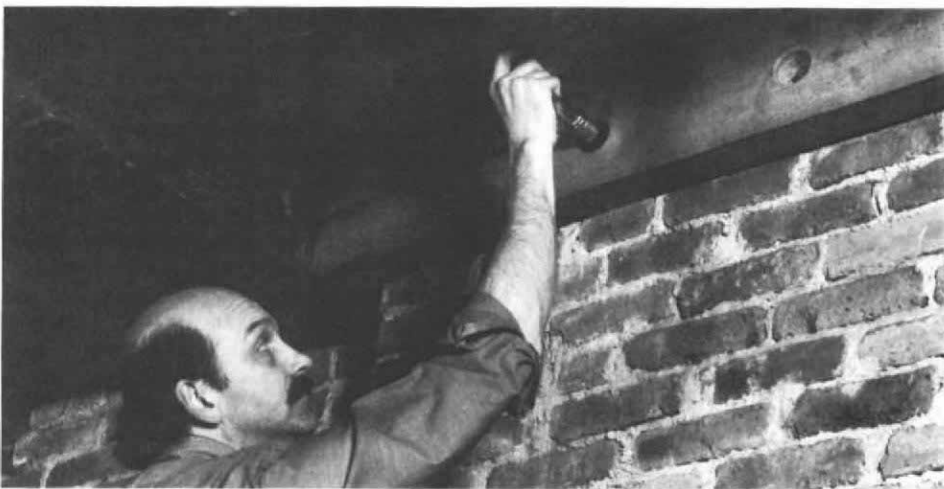
A plywood sheet, top, temporarily replaces the third-floor hearthstone. The face course below has been relaid using the original bricks and repointed to match the style of the original chimney. Above, bolts sunk in the reconstructed face course just below the third floor secure a new chimney girt, to the wall. This will support a new section of floor that replaces the third-floor hearthstone.

When we reached the ceiling of the second floor we had to remove a brick arch, which supported the marble hearthstone of the third-floor fireplace. This arch had originally been installed so that the hearthstone did not touch any of the floor joists. To make it safer and easier to work on the third floor, we temporarily covered the gap left when the hearthstone was removed with a sheet of $\frac{3}{4}$ in. plywood. Later on, when the masonry work was complete, we could frame in a new section of the floor, since no stove or flue was planned for this level. With all this in mind, I sunk three bolts in the reconstructed chimney face just below the floorline to hold the new chimney girt that would support the flooring, as shown at left.

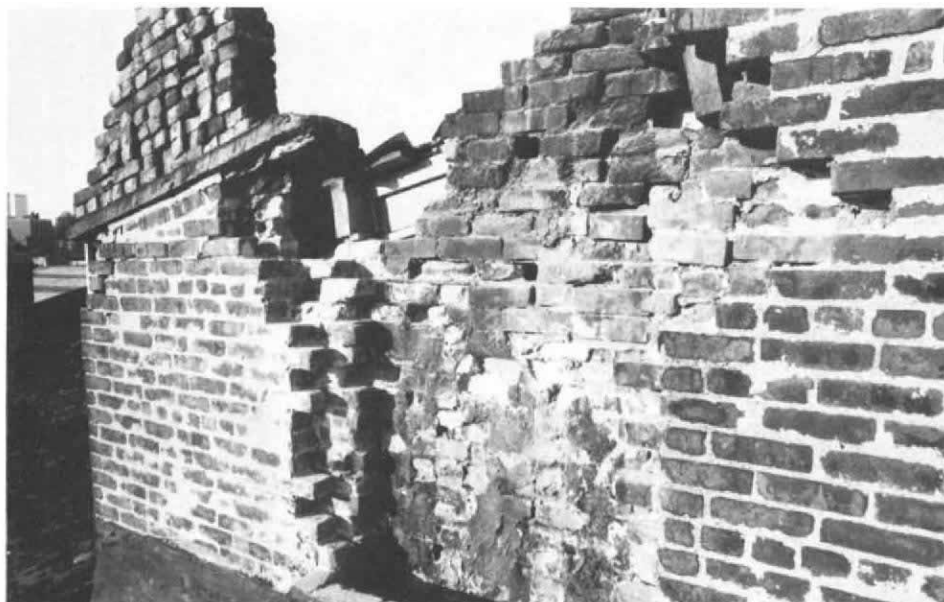
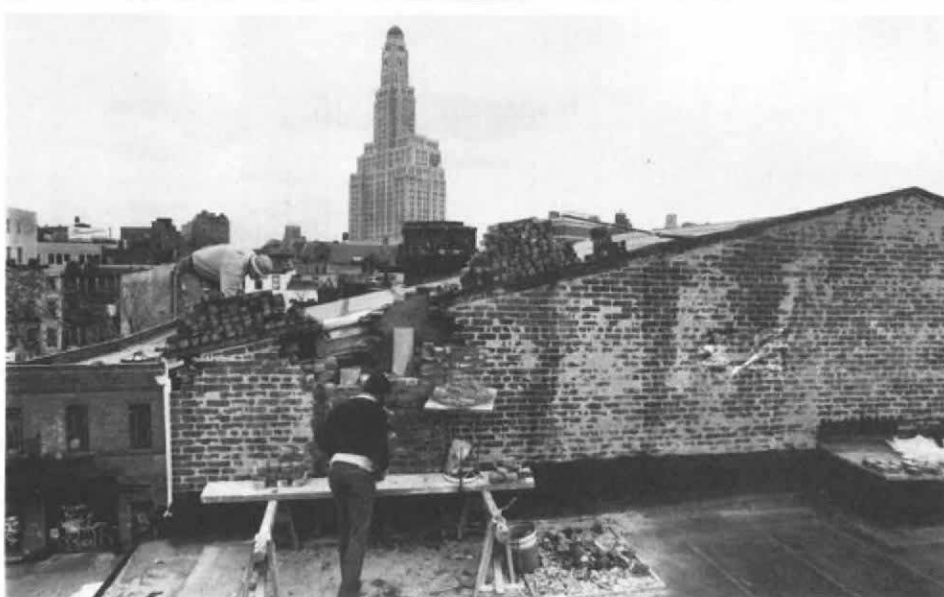
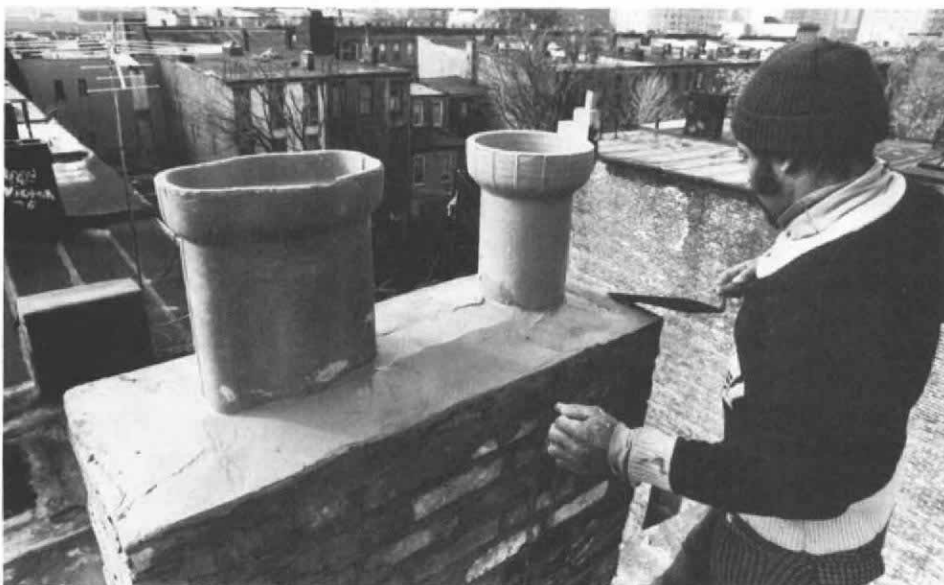
The chimney cavity, top, hollowed out at the roofline in order to accommodate the two flues. Only the top part of the chimney has been removed: the flashing joint where chimney meets roof remains intact. Center, flue-pipe installation proceeds on the roof just as it did inside the house, the only difference being that some of the adjacent wall has to be rebuilt as well. Once the final flue sections have been bricked in, the chimney gets a sloped cap, above, so that water will run off. The stucco finish on the exposed brick provides additional protection from the elements.

On the roof—The chimney wall continued above the roofline, separating our flat-roofed building from the higher gable-roofed building next door. Above the flashing, we discovered that the brickwork was not in very good condition; even the wall on either side of the chimney needed to be rebuilt. We carefully dismantled the damaged areas and cleaned out the chimney cavity above the roofline. Now all we had to do to finish the job was to install the remaining flue sections and to rebuild the chimney and wall around them.

To protect against downdrafts caused by wind deflecting off the gables, a chimney should extend well above the roofline. We built ours up about 3 ft., topping off the two flues with the bell end of a sewer-tile section and a wall-capping tile. Decorative chimney tile manufactured specifically for this purpose is four to six times more expensive than the substitutes we used. (The wall-capping tile has perforations cast into it, since each cylindrical section is meant to be divided in two. We used the paired pieces together to make the final flue piece.) High temperature resistance would not be a consideration here, since the stoves we were planning to install have internal baffles that prevent most of the heat from going up the chimney along with the smoke.

We extended the tiles about 16 in. above the brick line and topped the brickwork with a sloped cap, mixing the mortar just as we had throughout the job. The exposed chimney had been quite weathered before we rebuilt it, so we decided to give the entire chimney face above the roof line a stucco finish, as additional protection from the elements.
