When Block Foundations Go Bad

Steel bracing and improved drainage give new life to cracked and wet walls

by Donald V. Cohen

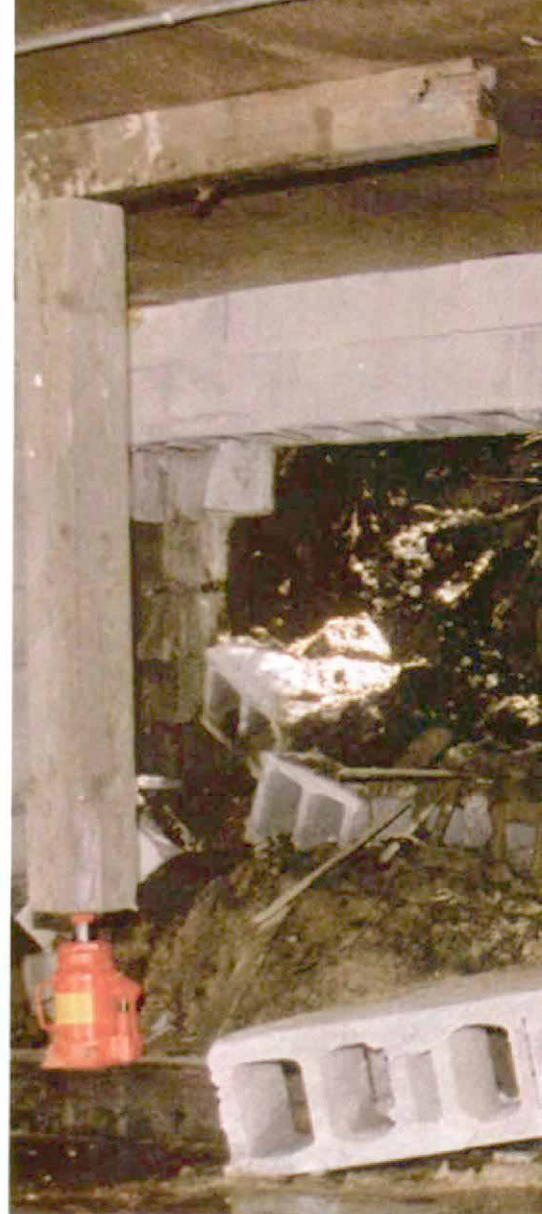
This is not to say that concrete-block foundations are always a bad idea. They can perform well with proper drainage and appropriate reinforcement, but these conditions are not always present. Gradually, time and the elements can undermine the health of a block foundation, even a well-built one, a fact I am reminded of when doing inspections for prospective home buyers. I constantly see wet basements, or foundation walls that have cracked, buckled, tipped and sometimes even collapsed (photo above).

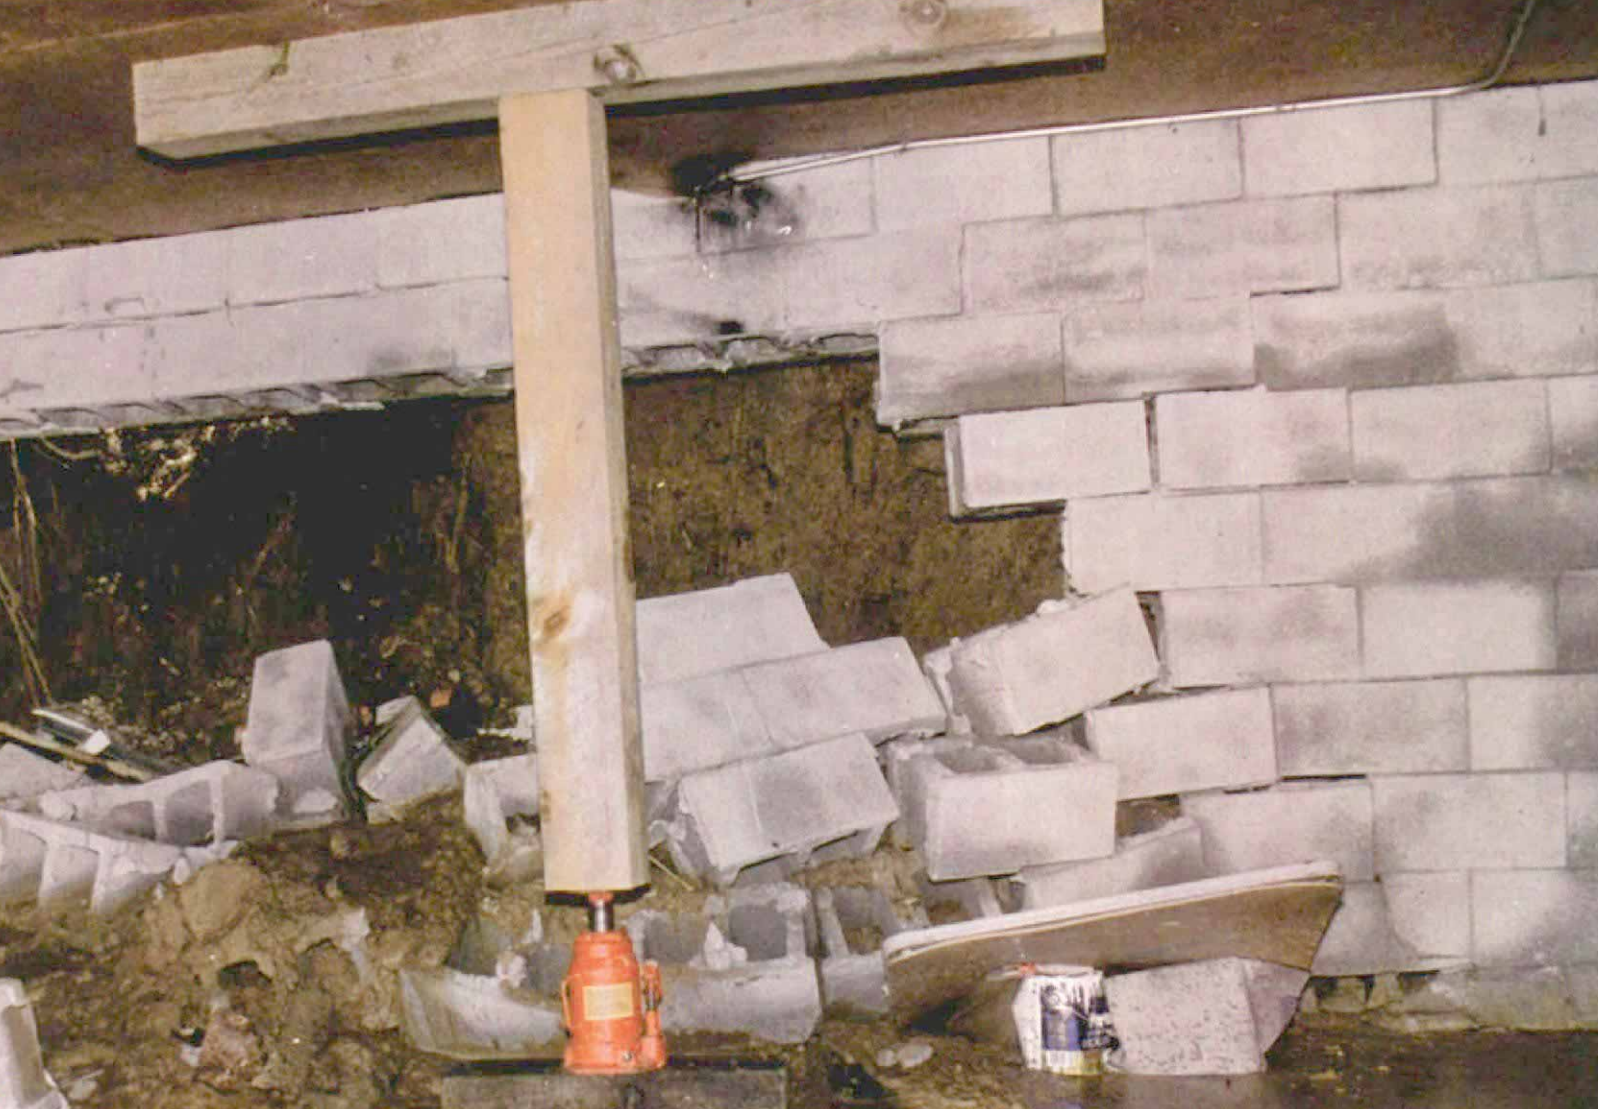
HOW DID MY BASEMENT BECOME A SWIMMING POOL?

Soil pressure can push a block wall off its footings

Without proper drainage, water gathers in the soil surrounding foundation walls, often finding its way into the basement. Sometimes disaster is unavoidable, as in the photo above, shot after a storm dumped 6 in. of rain in three hours. Other times, pressure builds slowly, particularly during freeze/thaw cycles. The drawing at right illustrates how soil pressure can tip foundation walls inward, cracking the mortar joints. Any wall displaced more than 1 in. from a plumb position must be excavated. Walls displaced less than 1 in. can be braced from inside.

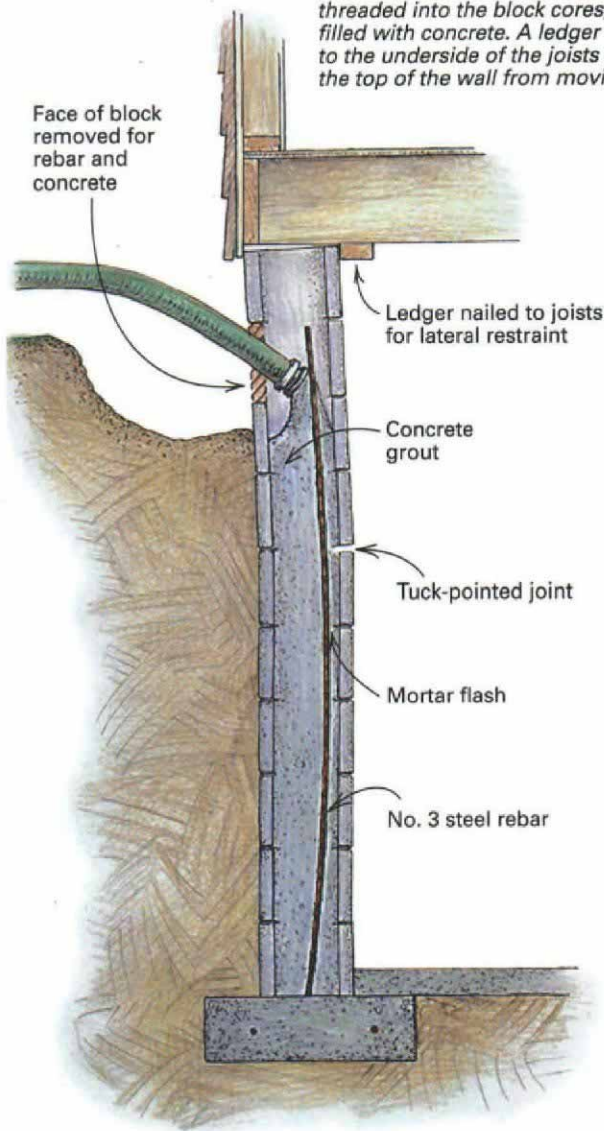
Reinforcing a wall with concrete and rebar. In this repair, rebar is threaded into the block cores, which are filled with concrete. A ledger strip nailed to the underside of the joists prevents the top of the wall from moving.

The first method—filling the core with rebar and concrete—requires removing the exterior faces of concrete blocks near the grade line (not at the top), inserting #3 steel rebar into the block cores and pushing it down to the footing (drawing above). This can be done in every core or as much as 48 in. apart (I have seen it done both ways). The cores are then filled with a concrete slurry mix.

Keep in mind that this repair will not restrain the wall at the top and the bottom. The concrete

slab—if it was poured without expansion felt—will provide support at the bottom. In new construction, a mudsill anchored to the wall (require by code) will provide lateral support at the top. But if there is no mudsill, as in many older homes, a ledger must be installed next to the wall and nailed into the underside of the joists (drawing above).

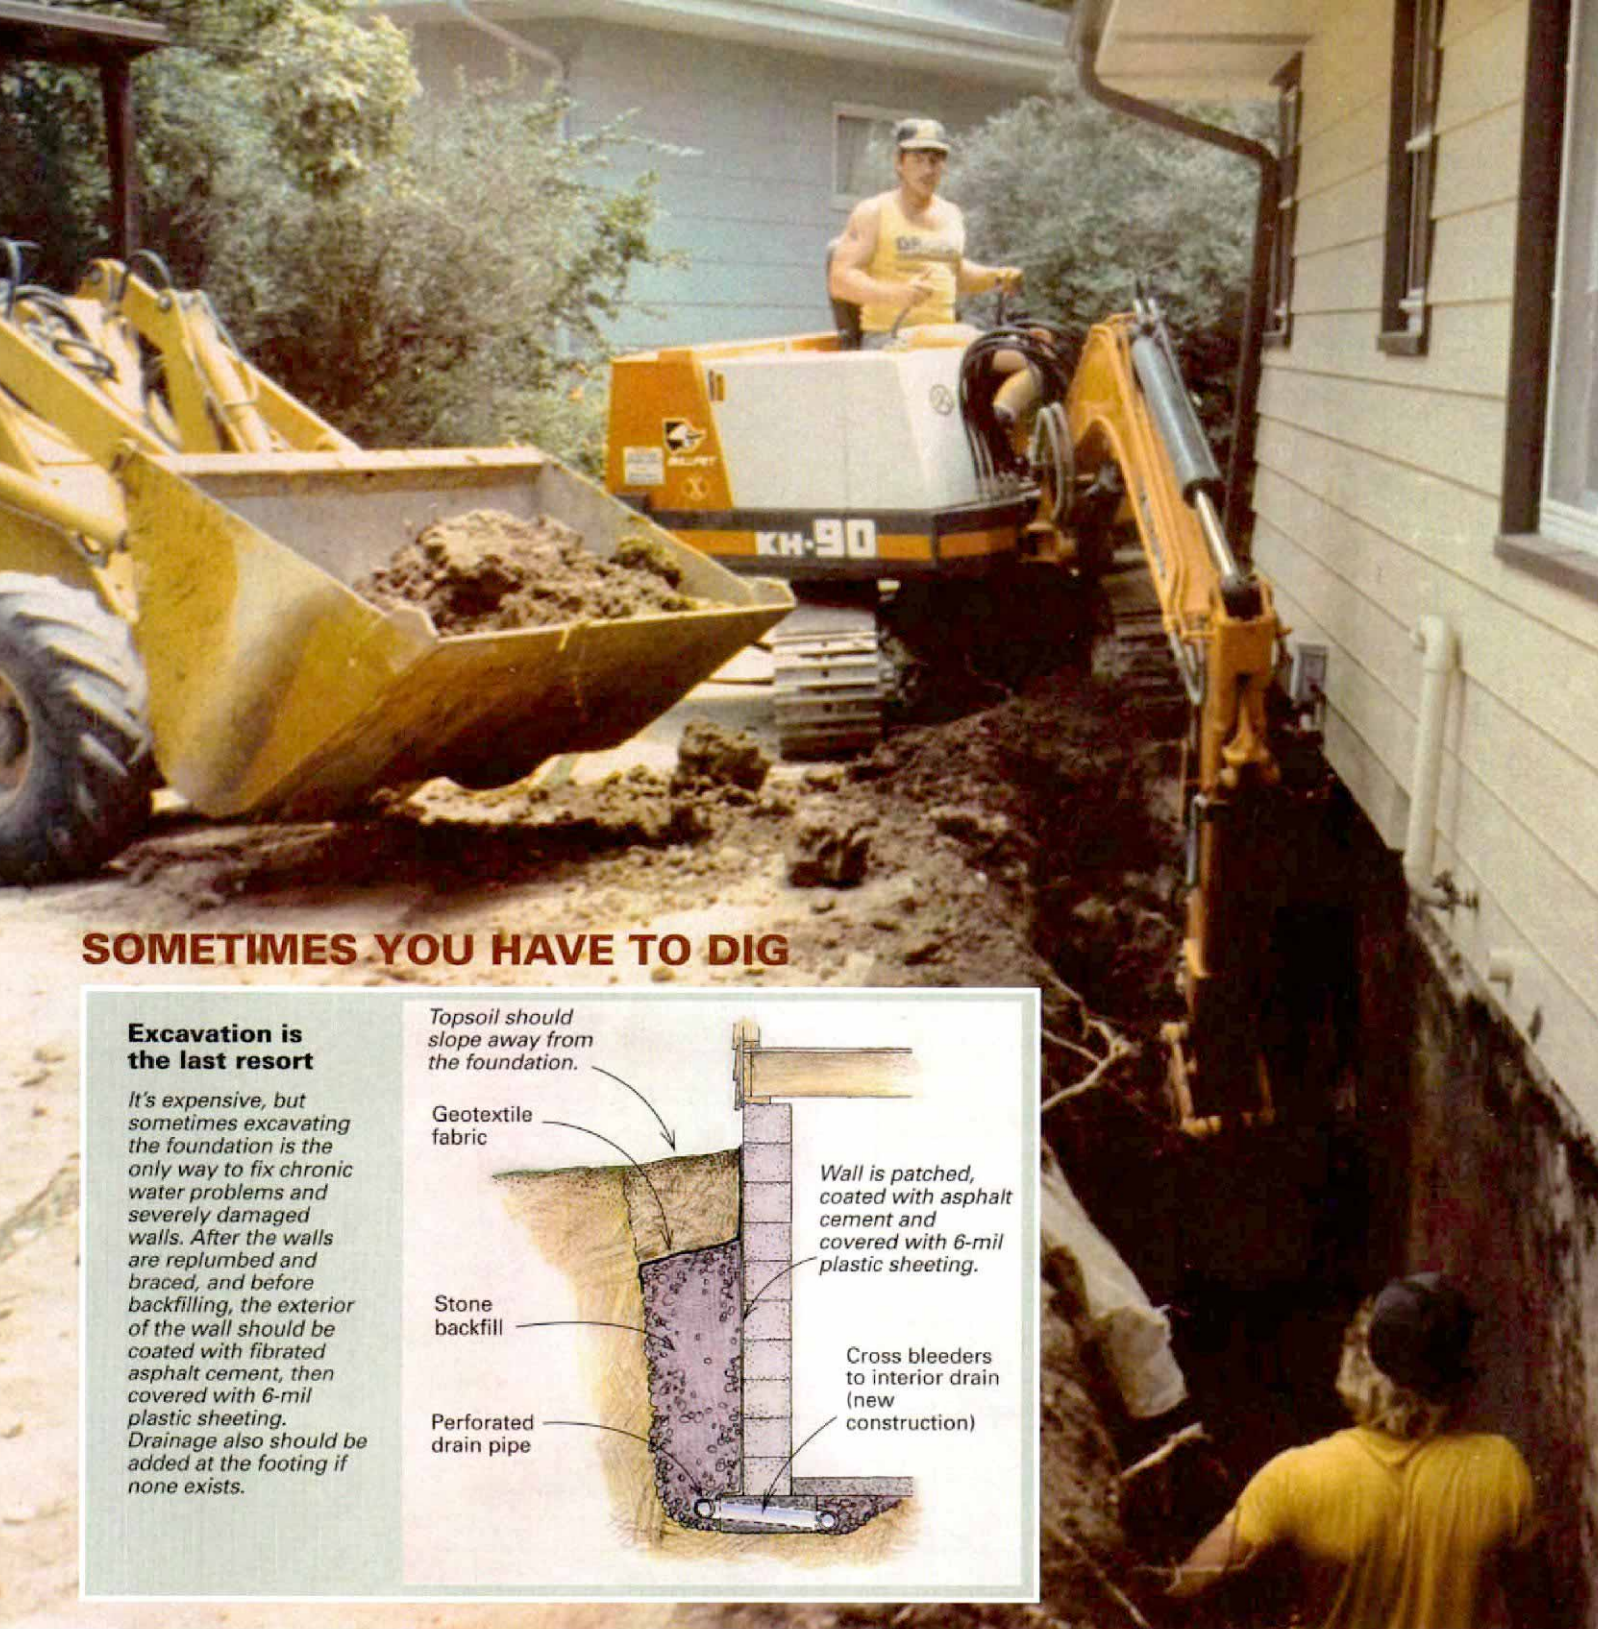
SOMETIMES YOU HAVE TO DIG

Excavation is the last resort

It's expensive, but sometimes excavating the foundation is the only way to fix chronic water problems and severely damaged walls. After the walls are replumbed and braced, and before backfilling, the exterior of the wall should be coated with fibrated asphalt cement, then covered with 6-mil plastic sheeting. Drainage also should be added at the footing if none exists.

Topsoil should slope away from the foundation.

Geotextile fabric

Stone backfill

Perforated drain pipe

Wall is patched, coated with asphalt cement and covered with 6-mil plastic sheeting.

Cross bleeders to interior drain (new construction)

Walls displaced more than 1 in. must be excavated and replumbed

If water problems go unchecked, the accompanying seasonal expansion and contraction of soil can wreak havoc on foundation walls, sometimes causing severe displacement. Building-code officials here in Wisconsin require any foundation wall displaced 1 in. or more to be excavated and jacked back to plumb (photo facing page).

After the wall is excavated but before it is jacked or pushed back in place, cracked joints must be cleared of mortar to release the joint and to straighten the wall. With the wall replumbed, the joints must be filled with new mortar. It's important to remember that excavating a finished wall is not enough. Any wall that has been excavated and repaired must be braced or reinforced to prevent future failure. Once the excavated wall has been repaired and before it is backfilled, it's also a good idea to add a drainage system or to repair the existing one (drawings right, facing page).

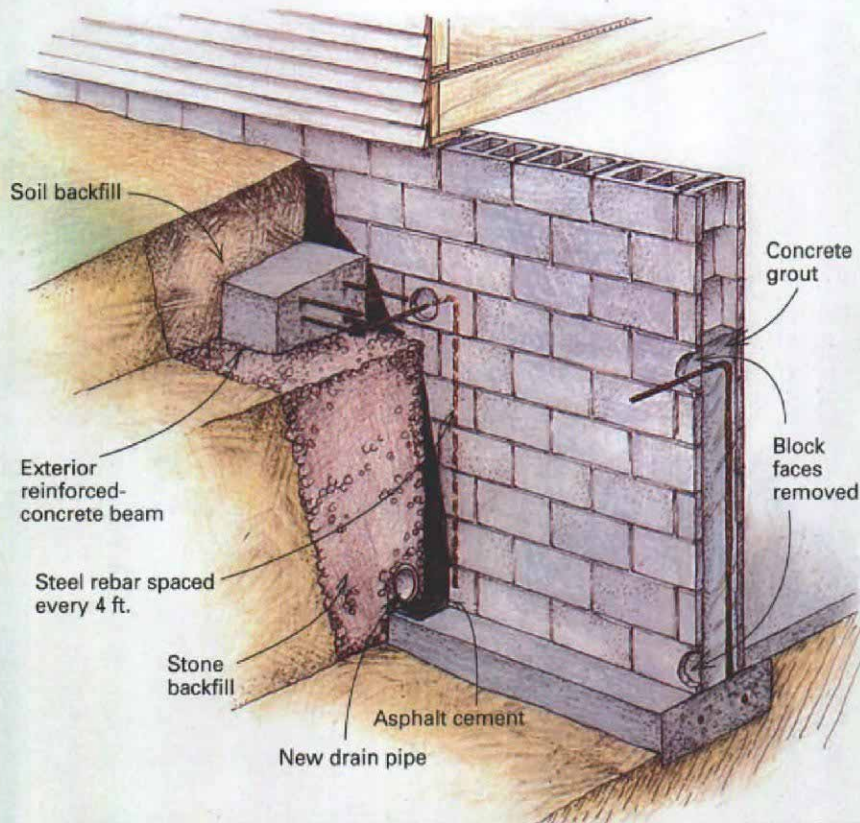
Patented grade-beam repair. A displaced wall that has been excavated and repaired must be reinforced against future failure. One method is to excavate and install a concrete grade beam. The beam is connected to concrete and to rebar placed inside the block cores.

For severely displaced walls, a Milwaukee-area contractor has developed—and patented—an alternative to traditional concrete-block foundation repairs. The repair involves excavating the foundation, inserting steel rebar into the core of the wall and attaching the rebar to a horizontal, reinforced-concrete grade beam (drawing below). The grade beam is designed to brace a damaged wall to prevent failure in the future.

The process is straightforward: After the wall is excavated and pushed back to plumb, exterior faces in the fourth course from the top are removed at 4-ft. intervals along the length of the wall. The bottom block below the top opening is also opened, and steel rebar is worked up and down inside the core to clear mortar flash at the joints. Debris can be removed from the opening in the bottom block.

With the block cores cleared of obstructions, steel rebar is placed in the cores. The rebar projects out of the block at the top opening perpendicular to the

wall, where it intersects a reinforced-concrete grade beam running parallel to the wall. The cores are then filled with concrete after which the foundation wall can be tuck-pointed and waterproofed, and new drain tile can be added.

Crushed stone is then added to within 6 in. of the projecting rebar. Then the 12-in. high concrete grade beam is formed on top of the stone fill, sloped away from the foundation wall. (The width of the beam can be determined by an engineer but is never less than 12 in.) Soil fill can be placed over the beam to restore the surface to its original condition.
