Revision Total Hip Arthroplasty: The Acetabular Component

Pasquale Petrera, MD, and Harry E. Rubash, MD

J Am Acad Orthop Surg 1995;3:15-21

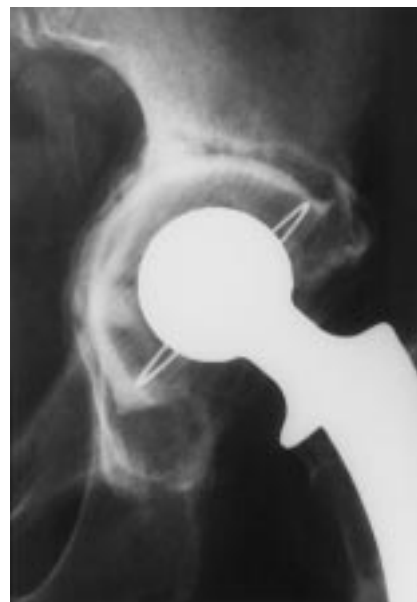
Fig. 1 Ten-year follow-up radiograph of a loosened cemented all-polyethylene acetabular component in a patient scheduled for revision THA. Note the continuous bone-cement radiolucency, the crack in the bone cement, and the evidence of superior cup migration (zone III).

This finding points out the relative “forgiveness” of the acetabulum in THA and the fact that a loose cup does not necessarily indicate a need for revision (Table 1). However, longer follow-up has corresponded with higher failure rates for cemented all-polyethylene acetabular components, as documented by radiographic evidence of loosening (Fig. 1) and the need for revision surgery.^{7,8,11-13}

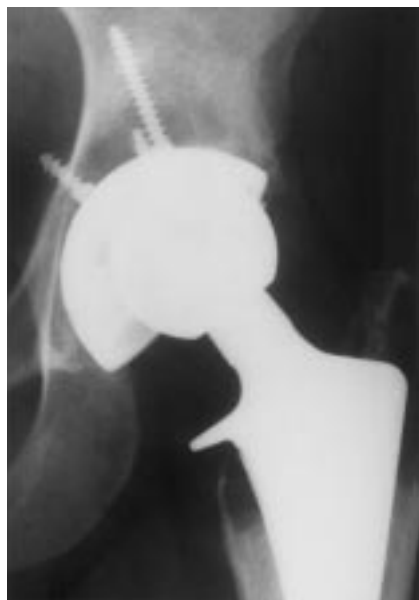
Fig. 2 Anteroposterior radiograph of a titanium-mesh ingrowth-cup (HGP I) uncemented acetabular component used for acetabular revision. At 8-year follow-up, there is no evidence of migration, radiolucencies, or pelvic osteolysis. Note the asymmetric polyethylene wear of the cup liner with the 32-mm femoral head.

favor the use of hemispheric components with some additional form of supplemental fixation, be it fins, spikes, or screws (Fig. 2).
